# Eastport CCU Administration

## Hurricane Damage Data

## Post Hurricane Deficiencies

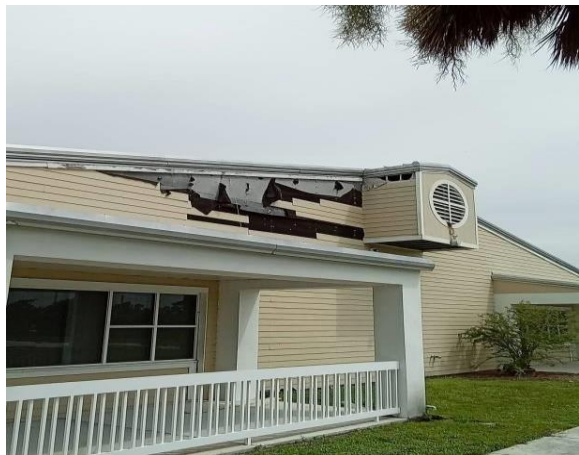
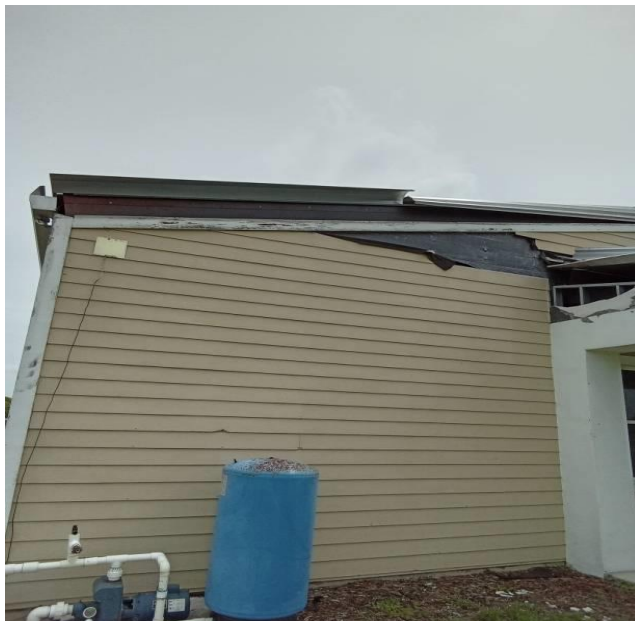
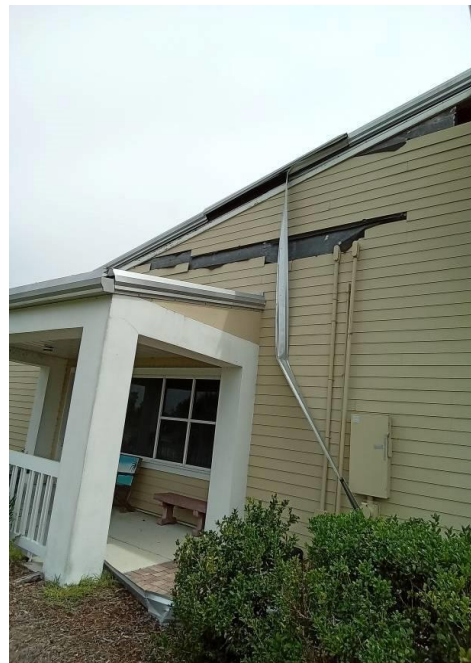
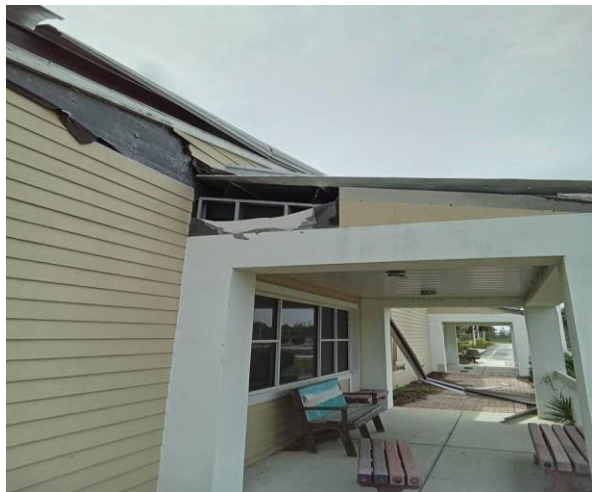
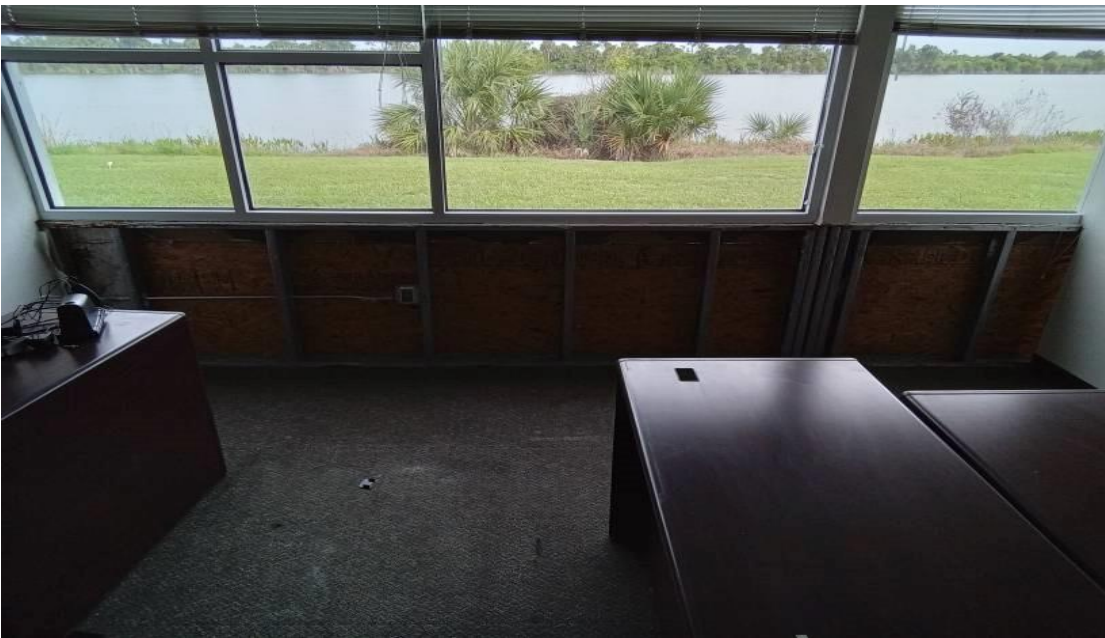
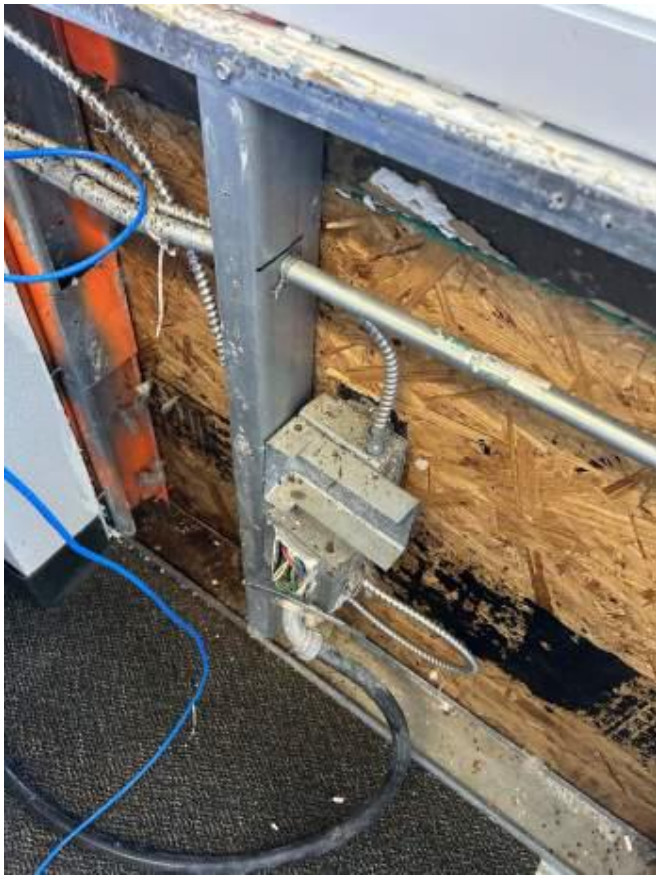
- Hurricane Ian
  - Significant wind damage to the building envelope.
  - Wind driven rain resulted in water damage in several areas.
  - Site drainage is inverted causing water to drain back to the building.
  - All areas of the structure that were built in between columns were not designed to be weather resistant.
  - Significant damage to the building HVAC systems.
- Hurricane Idalia
  - Additional water intrusion and minor wind damage.
  - Further damage to the building HVAC systems.
- Hurricane Helene/Milton
  - Additional water intrusion and minor wind damage.
  - Further damage to the building HVAC systems.
