Updates to the Preservation
Plan for the

Placida Bunk House

Charlotte County
Department of
Community Services

2024 Updated
Report

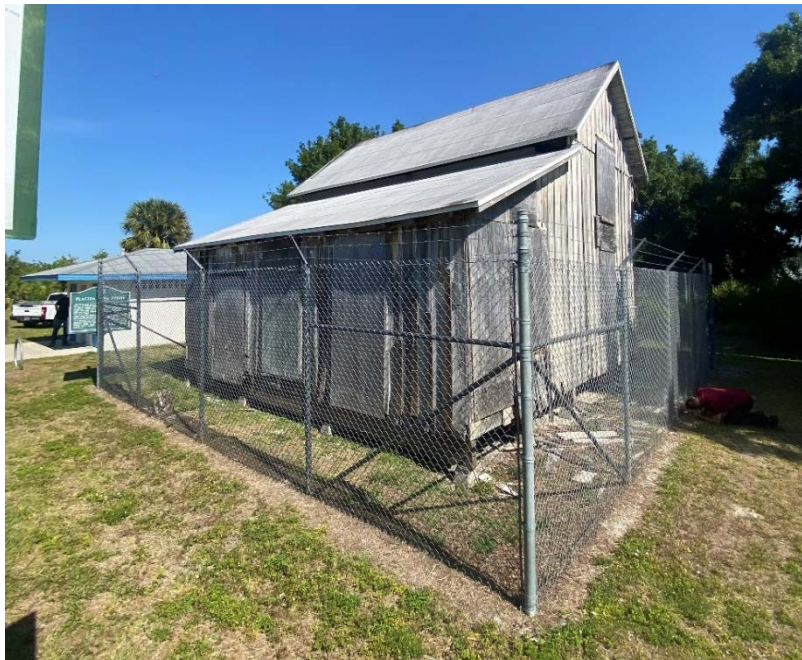
Condition: The roof covering, related flashings and aluminum drip edges have aged as anticipated since their installation are in fair condition.(age- 12+ years) (2024).

View of southeast corner, with roof covering in fair condition. (2024)

Detail of roof membrane system and aluminum drip edges installed as part of the 2012 stabilization project. Some rafter ends were replaced as part of the 2012 stabilization project. (2024)

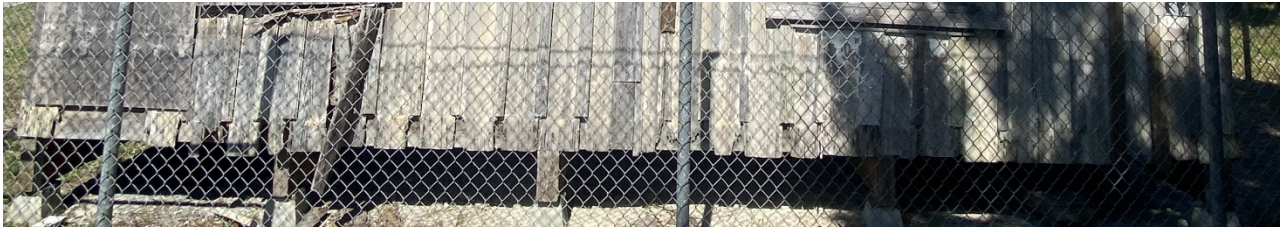
Condition: Some of the original beveled battens have been replaced with various sizes and types of batts. Condition of batts have deteriorated since 2017(2024)

East Side Board and Batten siding severely deteriorated at base of structure (2024)

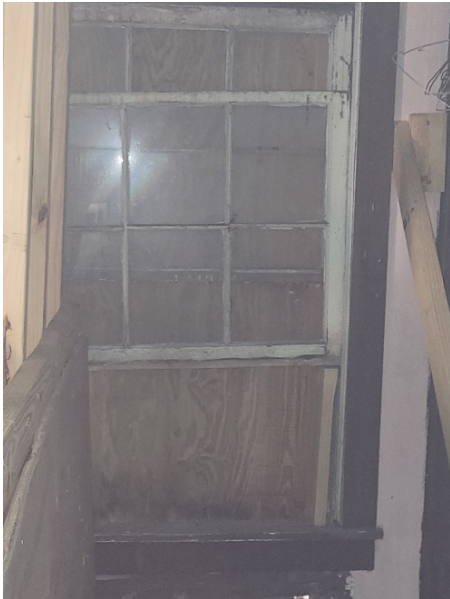
Condition: The windows are overall in poor condition and will need extensive restoration/reconstruction to be re-used in any future endeavor.(2024)

Second Floor East window typical 6/6 sash (2024)

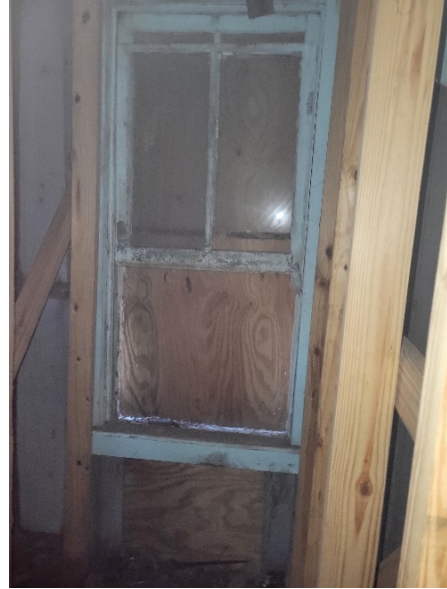
Second floor North window 2/2 sash at east dormer (2024)

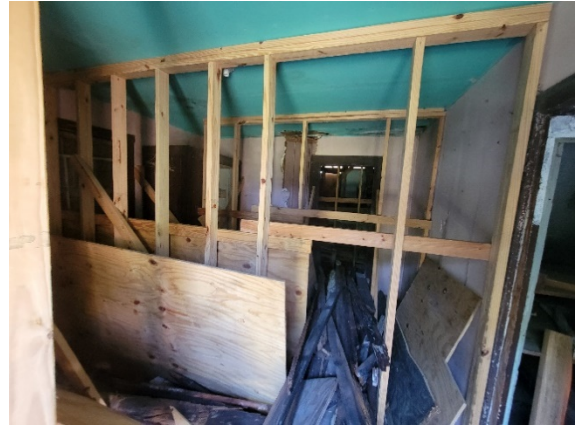
Shoring and Debris at Southeast corner(2024)

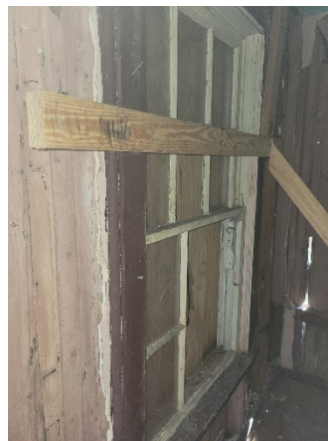
Northeast Corner with Shoring (2024)

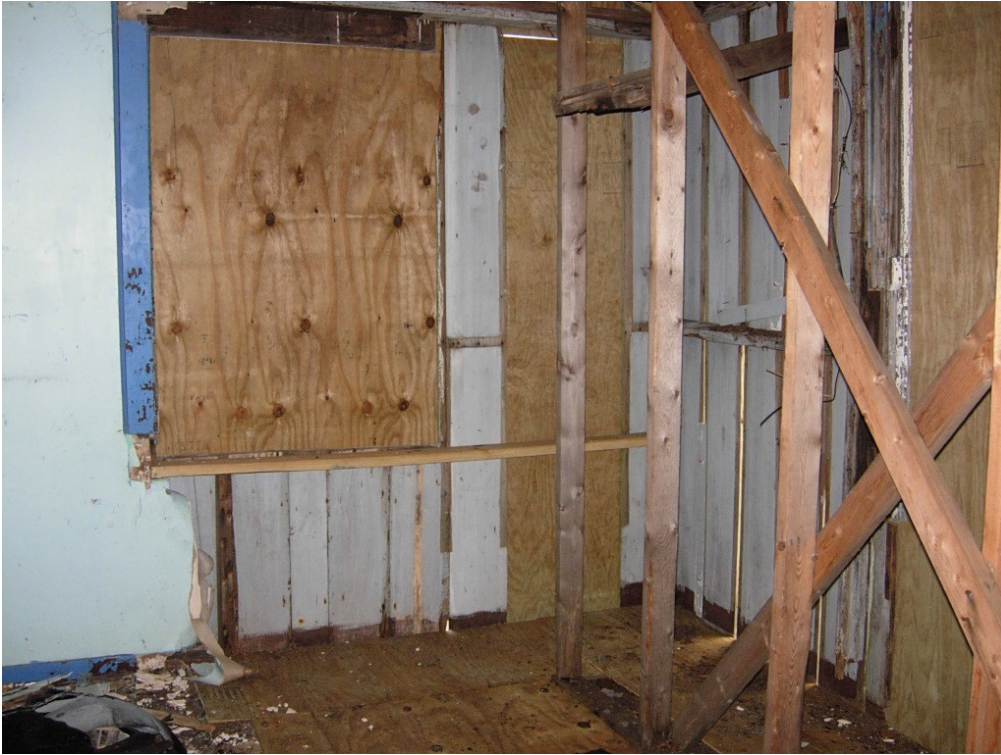
East wall of south room with wallboard removed (2008)

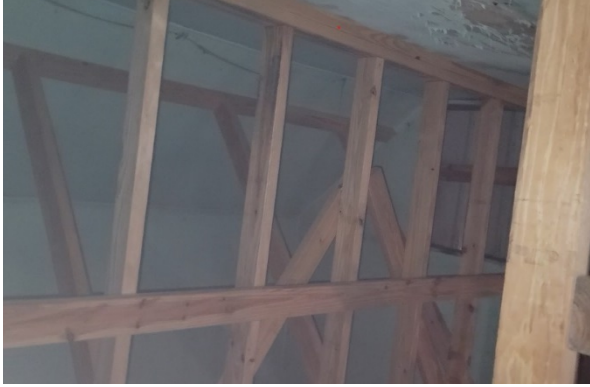
Loft west side, shoring and diagonal braces (2024)

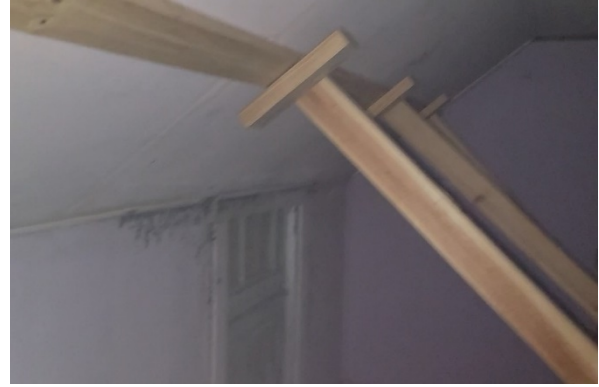
Loft east side, shoring and diagonal braces

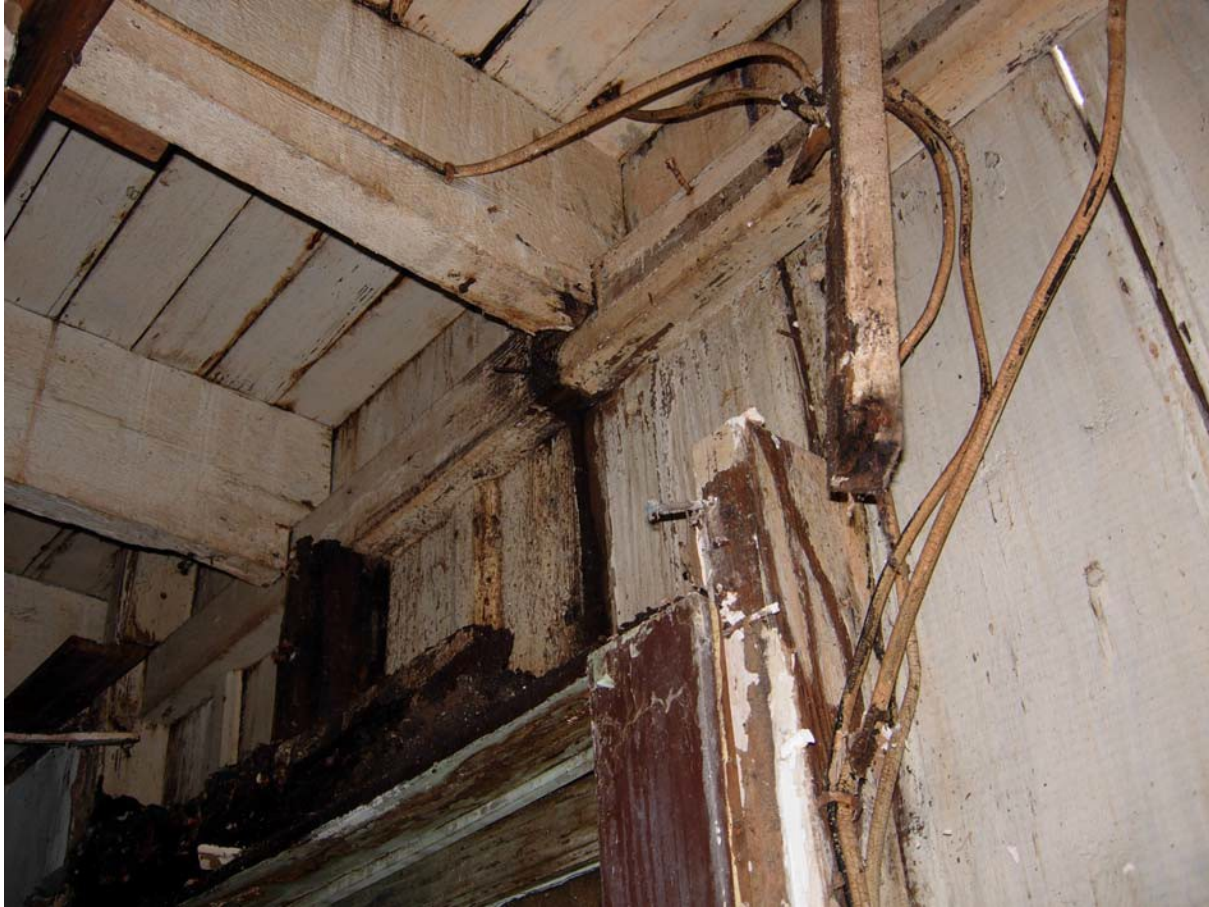
(2024) Water intrusion is apparent in many locations surrounding windows and doors, at that the Second Floor joist bearing locations. The joists are notched and bear on a continuous 2 x 4 ledger. The ledger and the exterior wall framing has deteriorated in many locations due to water intrusion. The ledger will need to be assessed and replaced as warranted.

Second floor joists, north wall, notched over ledger which is notched into the studs. Note stud to right of opening was cut off. (2008)

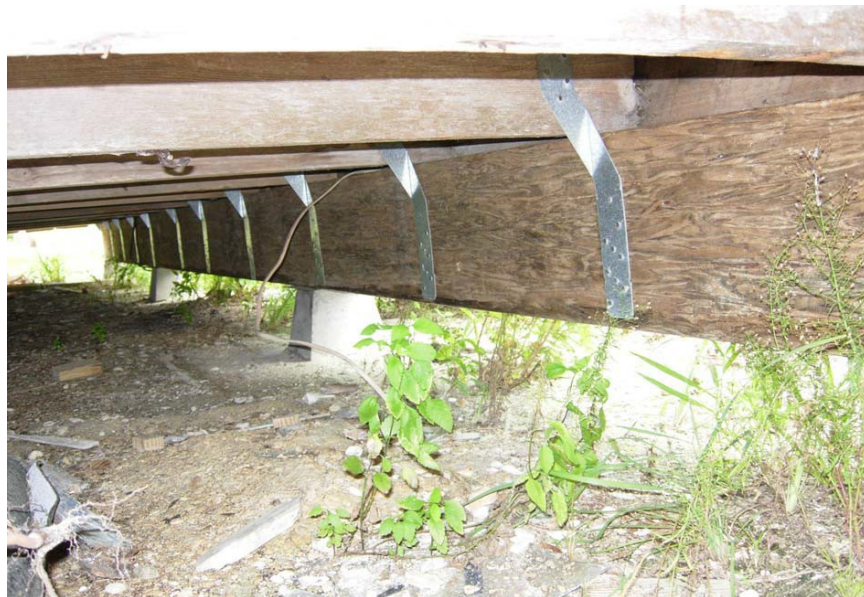
Condition:(2024) The joists are generally in good condition and have been connected to the new floor beams with metal connectors. Some joists have cracks and damage and need to be repaired or reinforced with new pressure treated "sistered" joists (several perimeter joists were replaced with new pressure treated 2 x 8s).

Floor joists on new foundation system with galvanized connectors (2008)

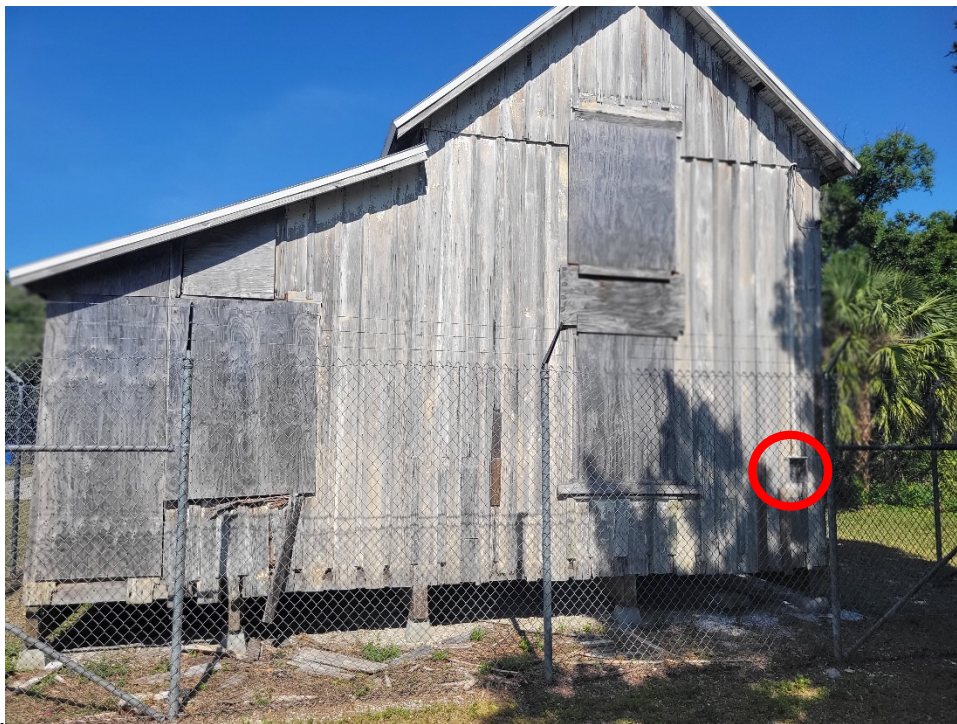
Description: The original electricity was installed in 1950, with the original service fuse box without a cover still in place on the east façade. The interior electrical system consisted of six surface mounted lights and two outlets, all of which are in place. Additional outlets were added after the later 1950s. The electrical system is not functional at this time

East wall with fuse box (2024)

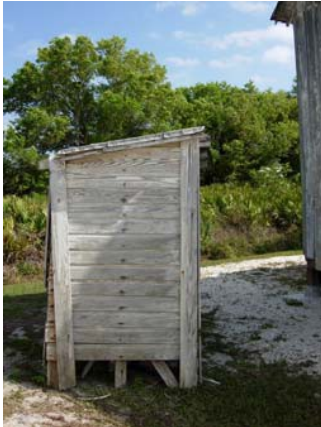
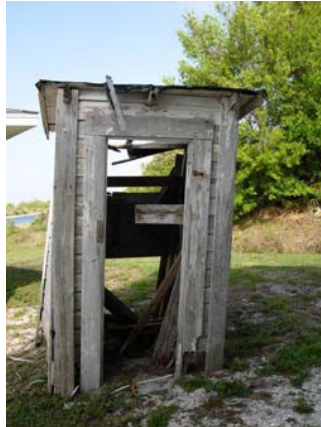
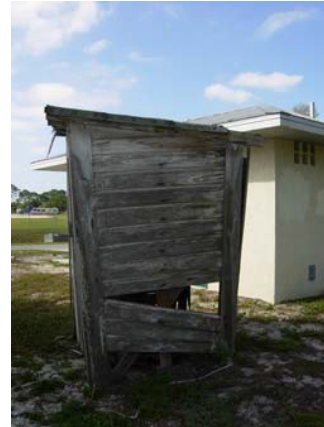
Outhouse: Due to its extremely poor condition, the wood outhouse structure has been deconstructed and parts of the structure area stored within the building.

Outhouse south side East side North side
(Photographs from 2008, prior to deconstruction of the outhouse.)
