**Site Inspection Report for  
Charlotte County –  
East Port Environmental Campus  
Administration Building A  
Cost Benchmarking Revision 3  
Florida Hurricane Ian (DR-4673-FL)**

Prepared for:  
Charlotte County, Florida

February 26, 2024

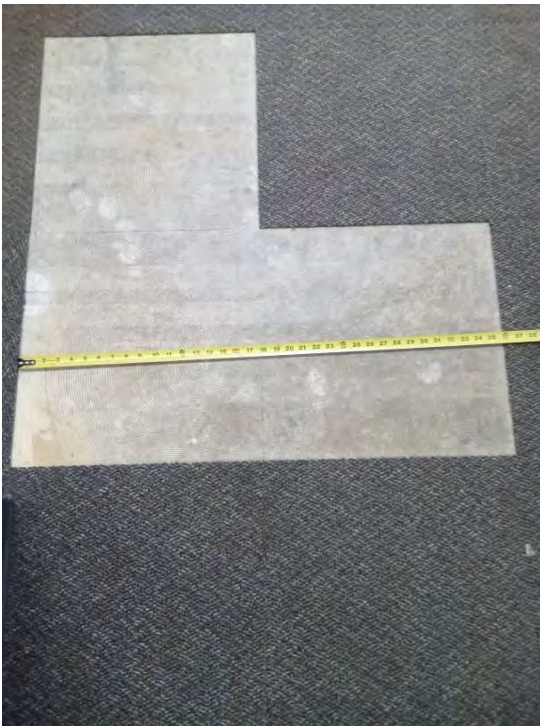
(8)

**Created:** Thu 27 Jul 07:41 2023  
**Group:** 130 Engineering 1  
**Cause of Damage:** Wind Driven Rain and Surface Water Flooding  
**Component Description:**  
 - Carpet

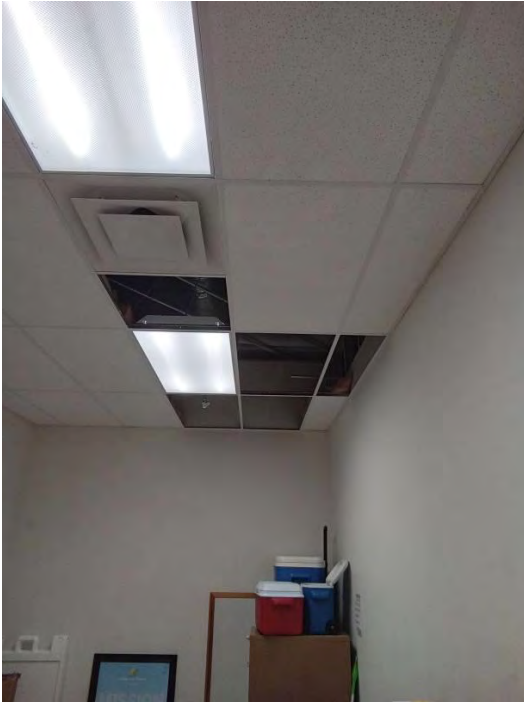
(9)

**Created:** Thu 27 Jul 07:43 2023  
**Group:** 135 Storage 1  
**Cause of Damage:** Wind Driven Rain  
**Component Description:**

- Acoustical Ceiling Tiles
- Ceiling Batt Insulation

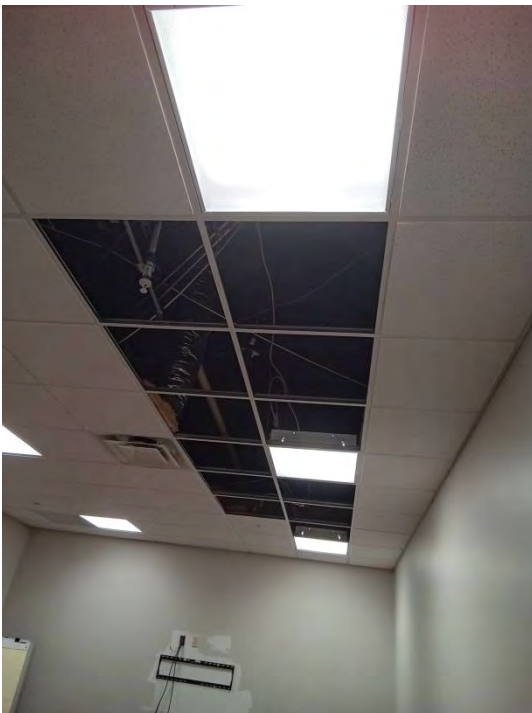
(10)

**Created:** Thu 27 Jul 07:46 2023  
**Group:** 138 Conference Room 1  
**Cause of Damage:** Wind Driven Rain  
**Component Description:**

- Acoustical Ceiling Tiles
- Ceiling Batt Insulation

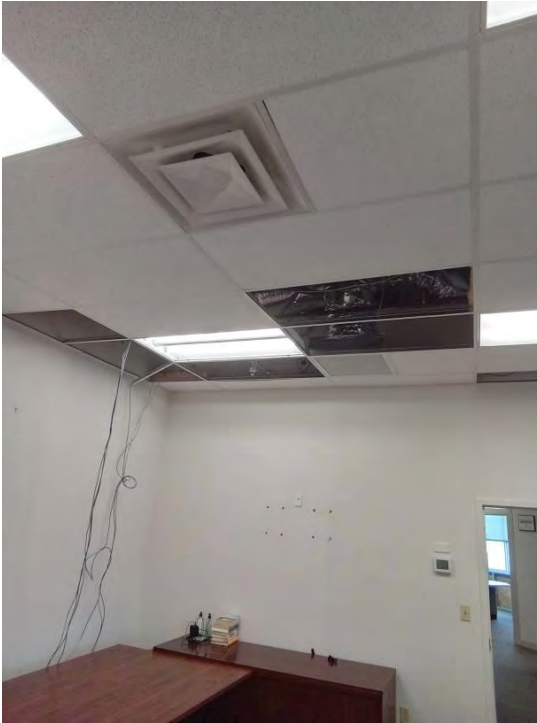
(11)

**Created:** Thu 27 Jul 07:53 2023  
**Group:** 141 Fiscal Manager  
**Cause of Damage:** Wind Driven Rain  
**Component Description:**

- Acoustical Ceiling Tiles
- Ceiling Batt Insulation

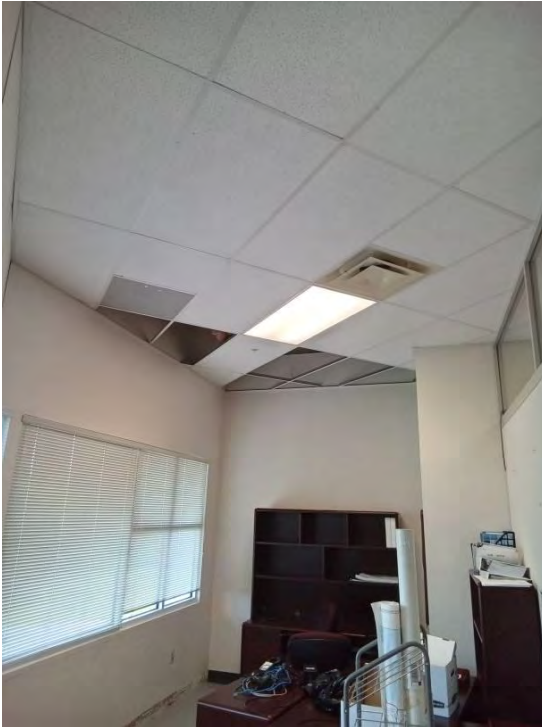
(13)

**Created:** Thu 27 Jul 07:56 2023  
**Group:** 139 Director Conference  
**Cause of Damage:** Wind Driven Rain  
**Component Description:**  
 - Acoustical Ceiling Tiles  
 - Ceiling Batt Insulation

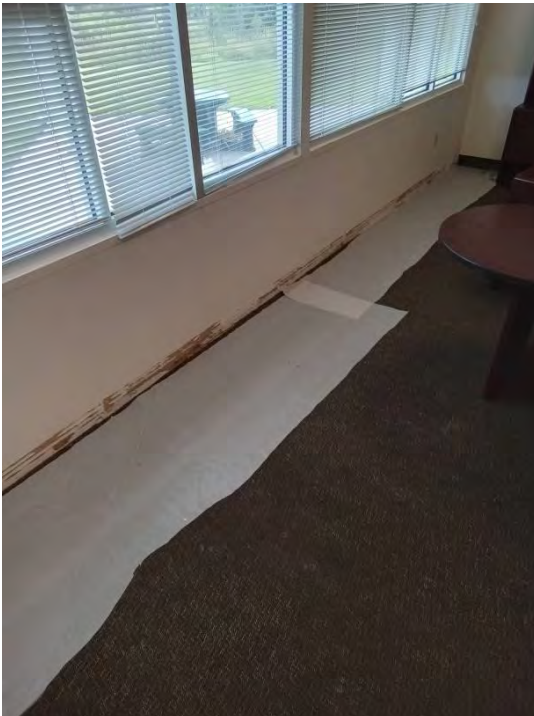
(14)

**Created:** Thu 27 Jul 07:59 2023  
**Group:** 139 Director Conference  
**Cause of Damage:** Wind Driven Rain and Surface Water Flooding  
**Component Description:**  
 - Vinyl Baseboards

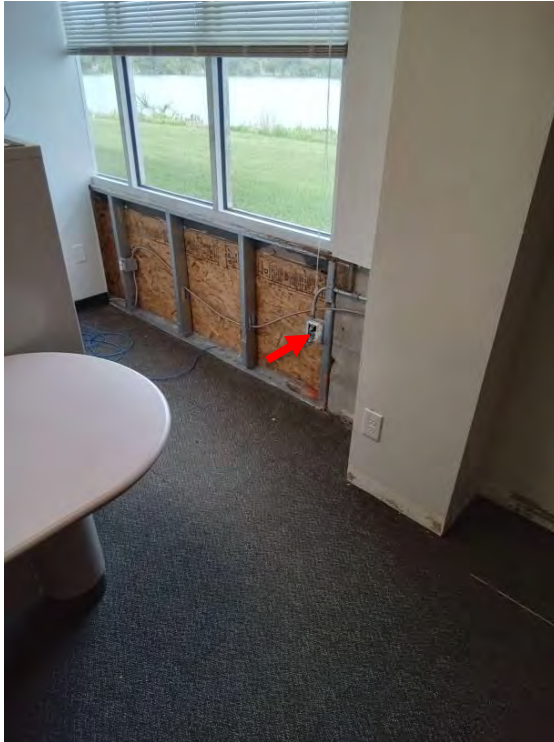
(17)

**Created:** Thu 27 Jul 08:05 2023  
**Group:** 139 Director Conference  
**Cause of Damage:** Wind Driven Rain and Surface Water Flooding  
**Component Description:**

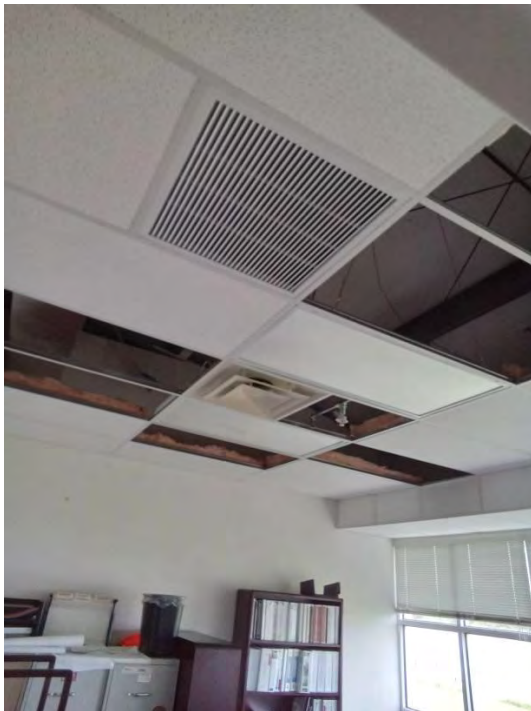
(18)

**Created:** Thu 27 Jul 08:07 2023  
**Group:** 140 Office 2  
**Cause of Damage:** Wind Driven Rain  
**Component Description:**

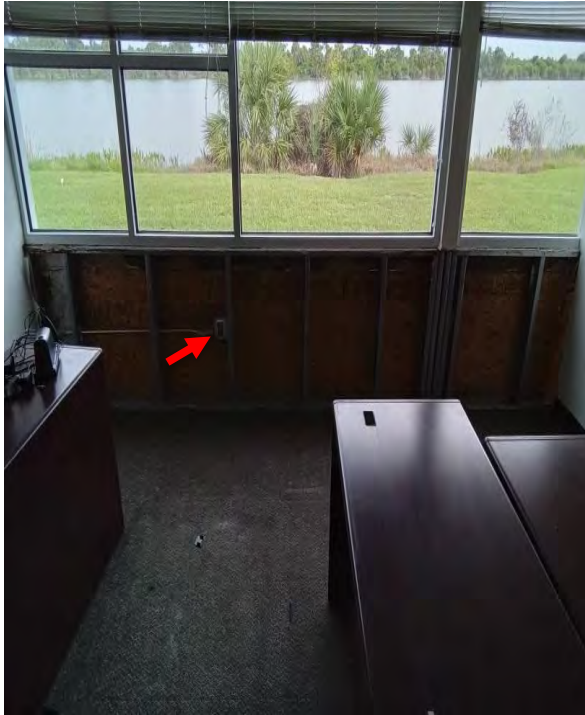
(19)

**Created:** Thu 27 Jul 08:09 2023  
**Group:** 140 Office 2  
**Cause of Damage:** Wind Driven Rain and Surface Water Flooding  
**Component Description:**

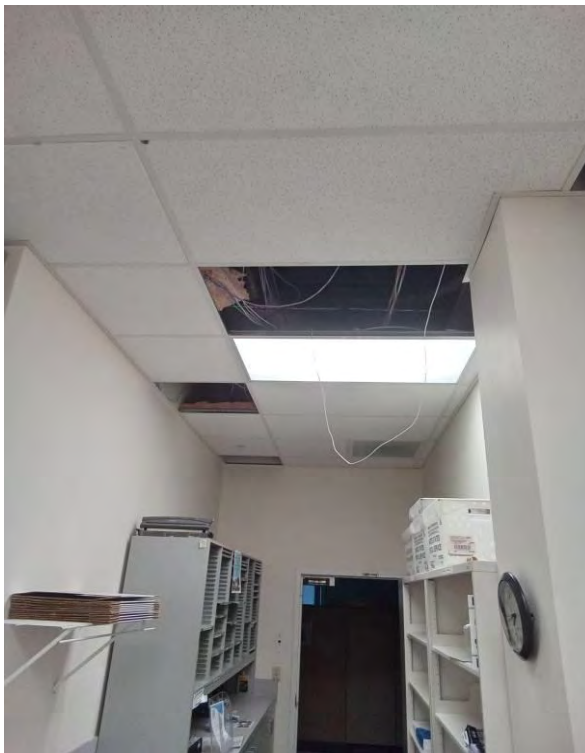
(20)

**Created:** Thu 27 Jul 08:15 2023  
**Group:** 121 Copy Room  
**Cause of Damage:** Wind Driven Rain  
**Component Description:**

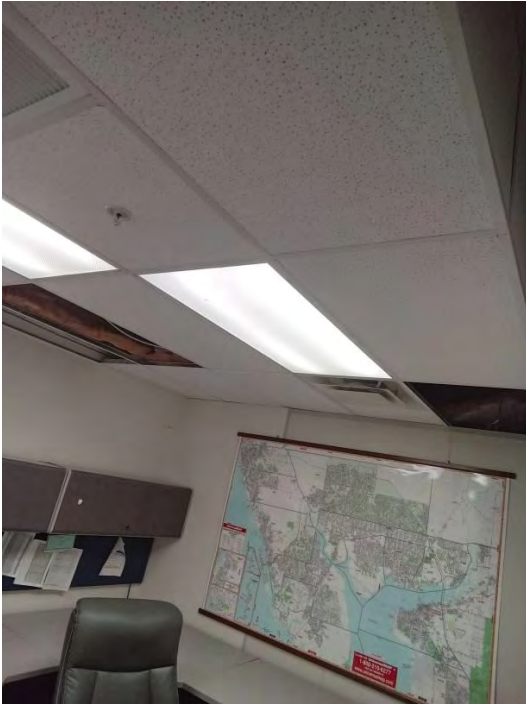
(21)

**Created:** Thu 27 Jul 08:16 2023  
**Group:** Office 1 Close to Exit  
**Cause of Damage:** Wind Driven Rain  
**Component Description:**

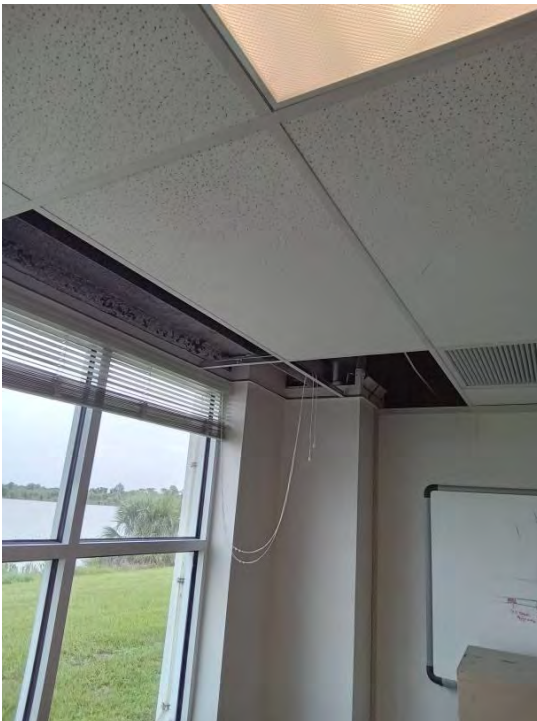
(22)

**Created:** Thu 27 Jul 08:18 2023  
**Group:** Office 2 Close to Exit  
**Cause of Damage:** Wind Driven Rain  
**Component Description:**

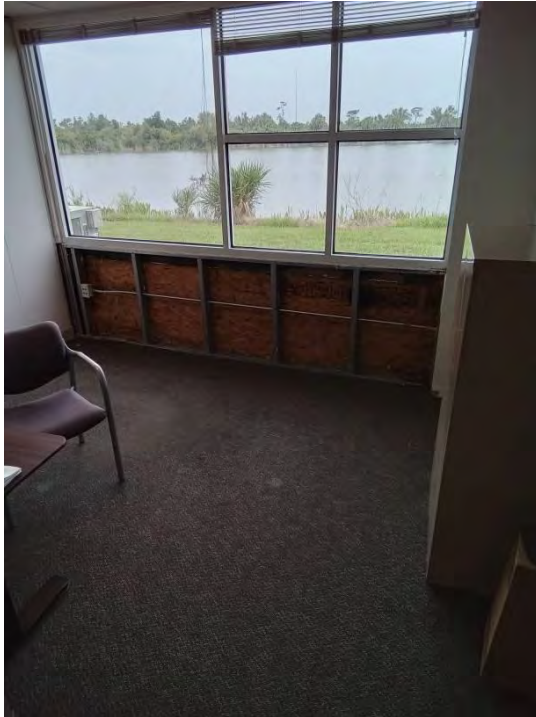
(23)

**Created:** Thu 27 Jul 08:21 2023  
**Group:** Office 2 Close to Exit  
**Cause of Damage:** Wind Driven Rain and Surface Water Flooding  
**Component Description:**

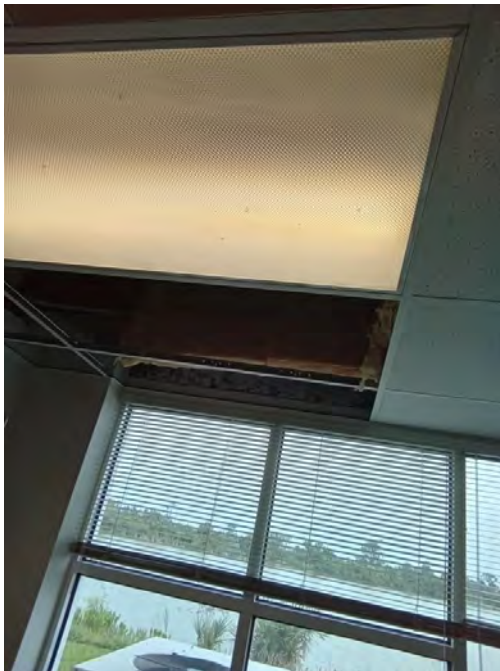
(24)

**Created:** Thu 27 Jul 08:23 2023  
**Group:** Office 3 Close to Exit  
**Cause of Damage:** Wind Driven Rain  
**Component Description:**

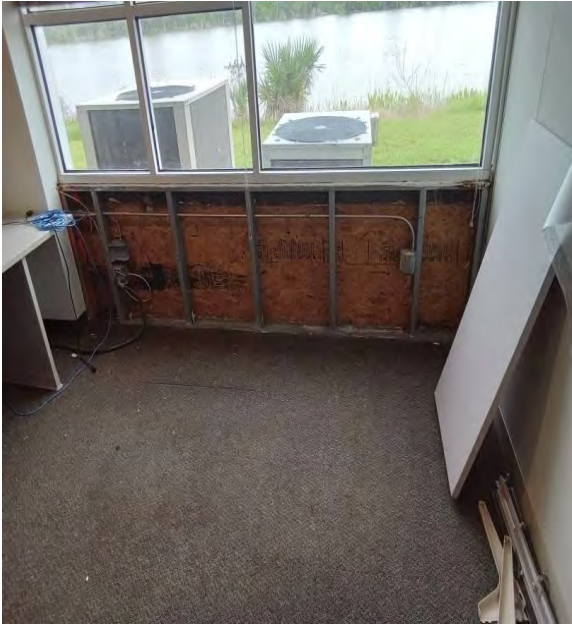
(25)

**Created:** Thu 27 Jul 08:24 2023  
**Group:** Office 3 Close to Exit  
**Cause of Damage:** Wind Driven Rain and Surface Water Flooding  
**Component Description:**

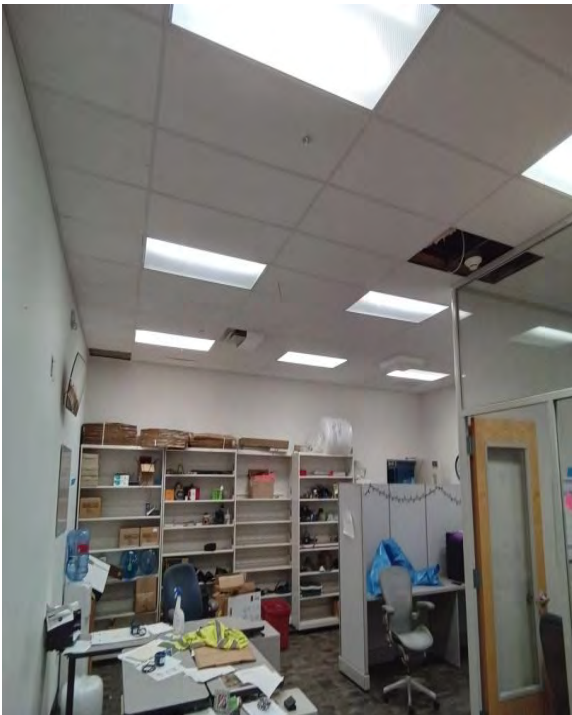
(26)

**Created:** Thu 27 Jul 08:48 2023  
**Group:** 122 Customer Records  
**Cause of Damage:** Wind Driven Rain  
**Component Description:**

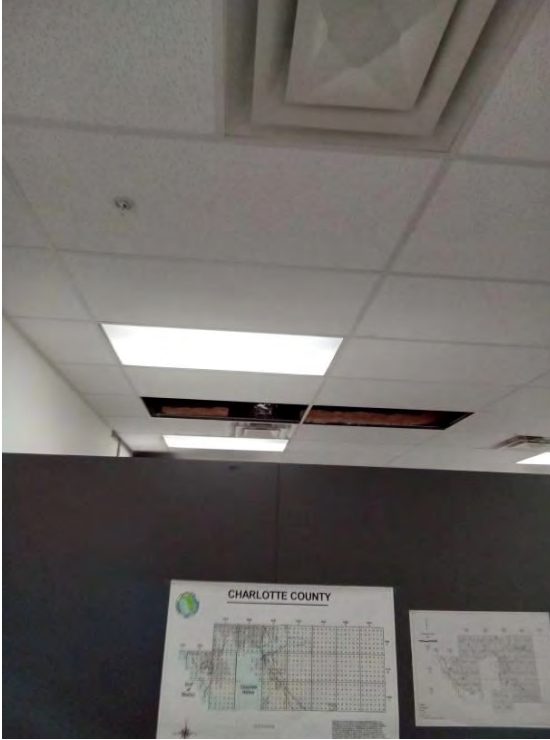
(27)

**Created:** Thu 27 Jul 08:50 2023  
**Group:** 123 Engineering  
**Cause of Damage:** Wind Driven Rain  
**Component Description:**  
 - Acoustical Ceiling Tiles  
 - Ceiling Batt Insulation

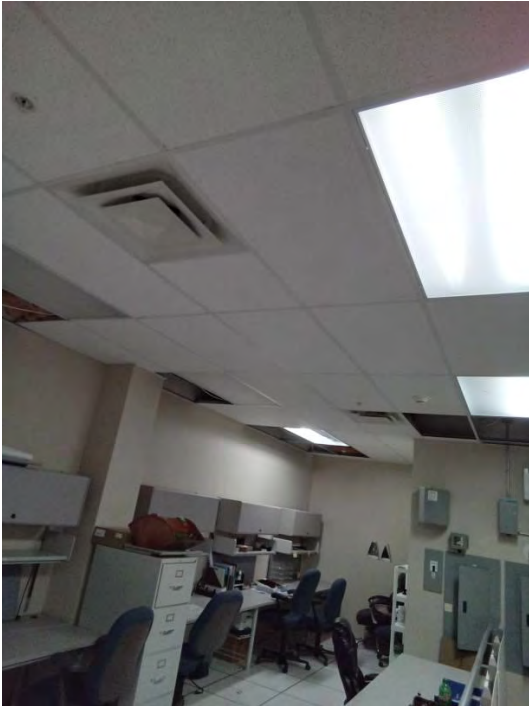
(29)

**Created:** Thu 27 Jul 08:55 2023  
**Group:** 133 Computer Room  
**Cause of Damage:** Wind Driven Rain  
**Component Description:**

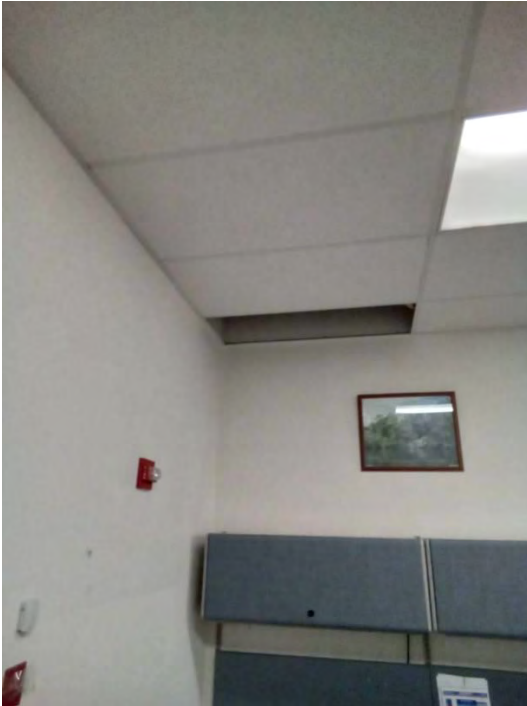
(31)

**Created:** Thu 27 Jul 08:58 2023  
**Group:** 128 Mail Room  
**Cause of Damage:** Wind Driven Rain  
**Component Description:**

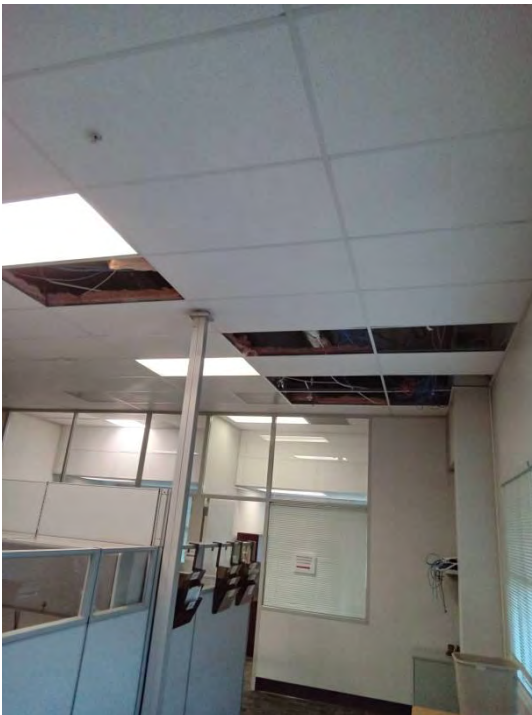
(32)

**Created:** Thu 27 Jul 08:59 2023  
**Group:** 120 Customer Service  
**Cause of damage:** Wind Driven Rain  
**Component Description:**

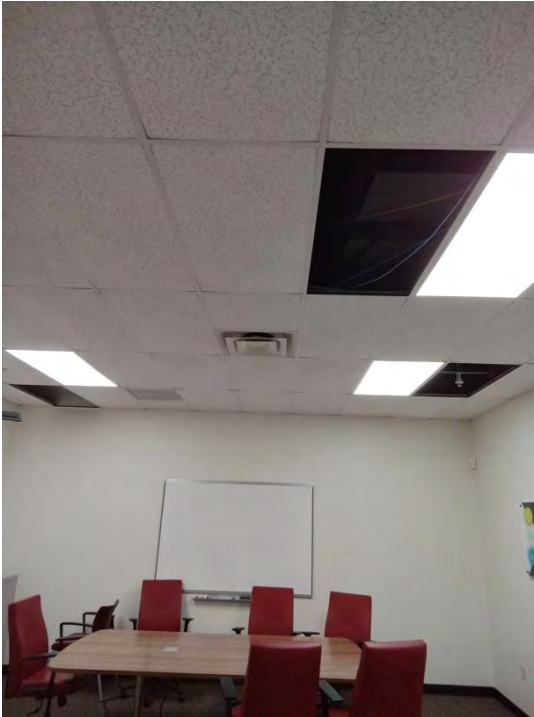
(37)

**Created:** Thu 27 Jul 09:15 2023  
**Group:** 142 Work Room 1  
**Cause of Damage:** Wind Driven Rain  
**Component Description:**

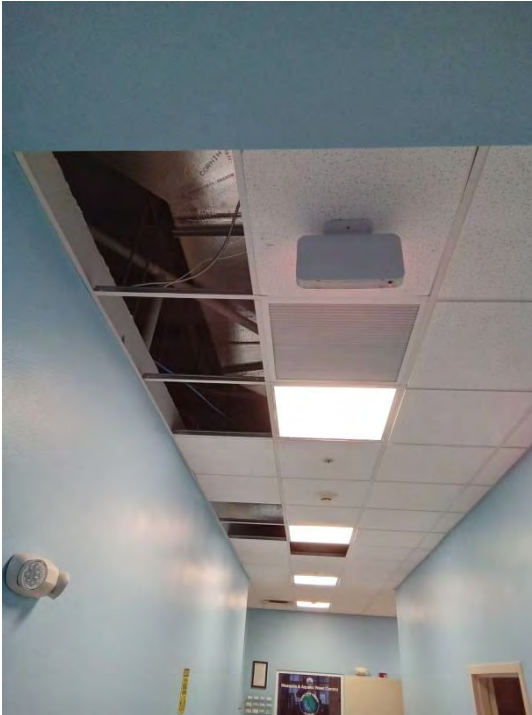
(39)

**Created:** Thu 27 Jul 09:16 2023  
**Group:** 143 Hall 2  
**Cause of Damage:** Wind Driven Rain  
**Component Description:**

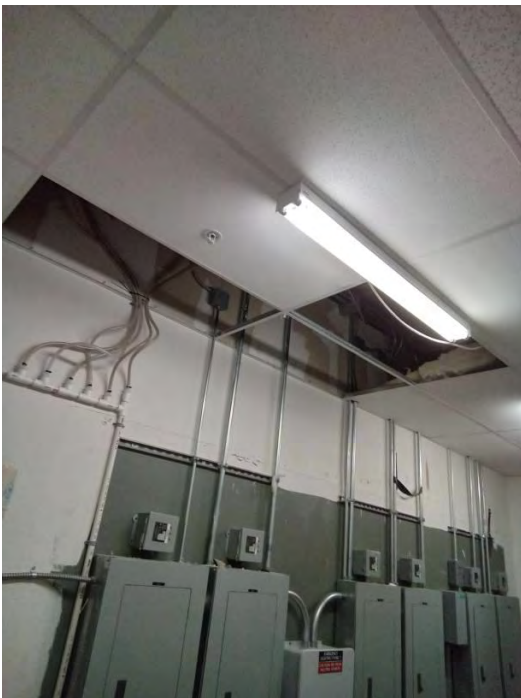
(40)

**Created:** Thu 27 Jul 09:17 2023  
**Group:** 144 Mech Elec Room  
**Cause of Damage:** Wind Driven Rain  
**Component Description:**

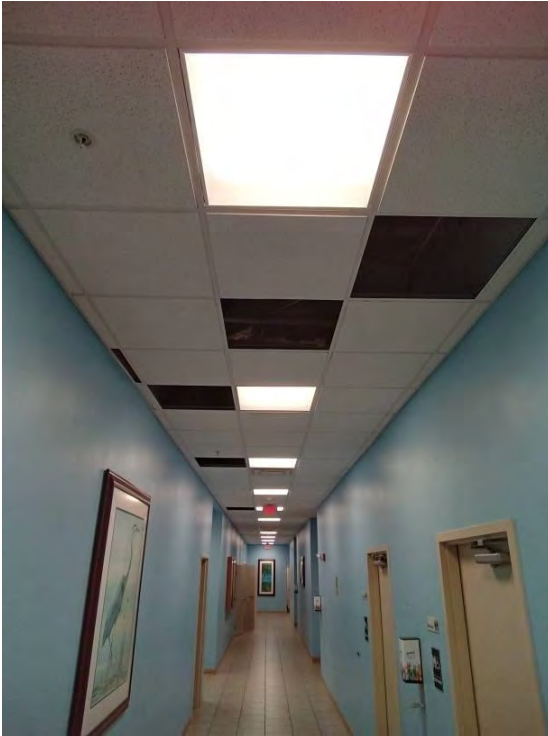
(41)

**Created:** Thu 27 Jul 09:18 2023  
**Group:** 150 Corridor 2  
**Cause of Damage:** Wind Driven Rain  
**Component Description:**

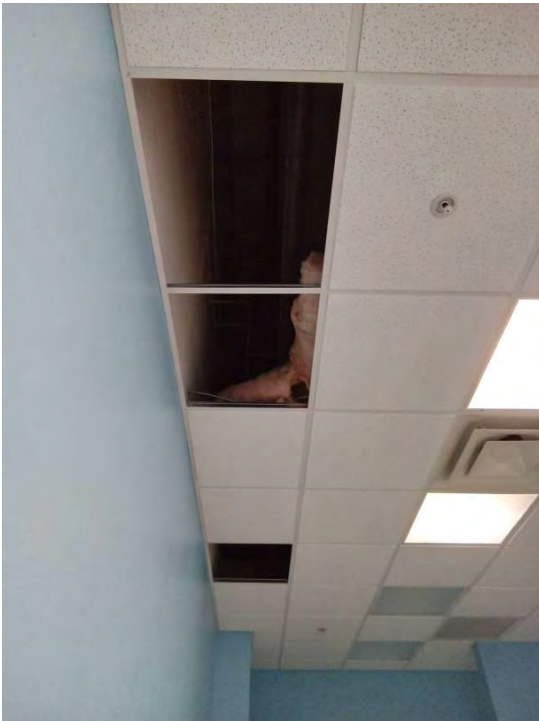
(42)

**Created:** Thu 27 Jul 09:21 2023  
**Group:** 167 Lunchroom  
**Cause of Damage:** Wind Driven Rain  
**Component Description:**

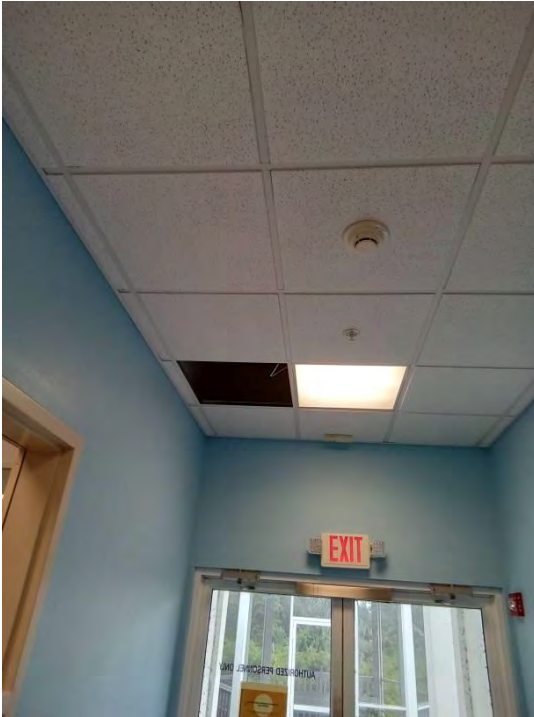
(43)

**Created:** Thu 27 Jul 09:28 2023  
**Group:** 163 Corridor 3  
**Cause of Damage:** Wind Driven Rain  
**Component Description:**

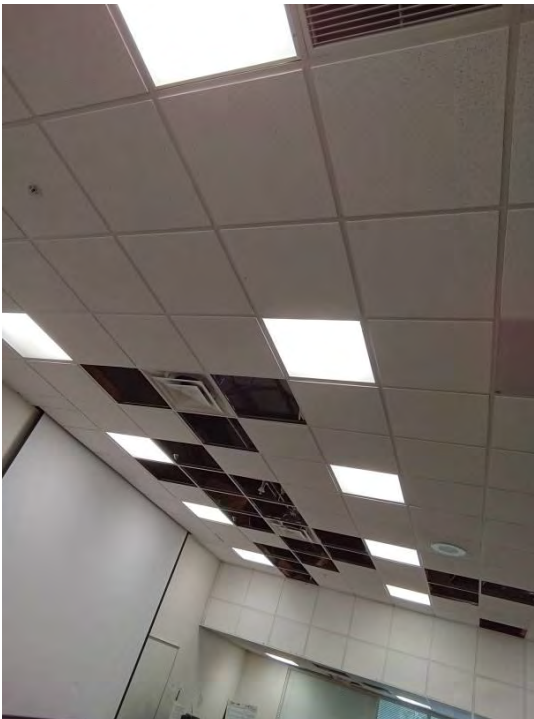
(44)

**Created:** Thu 27 Jul 09:30 2023  
**Group:** 156 Training 2  
**Cause of Damage:** Wind Driven Rain  
**Component Description:**

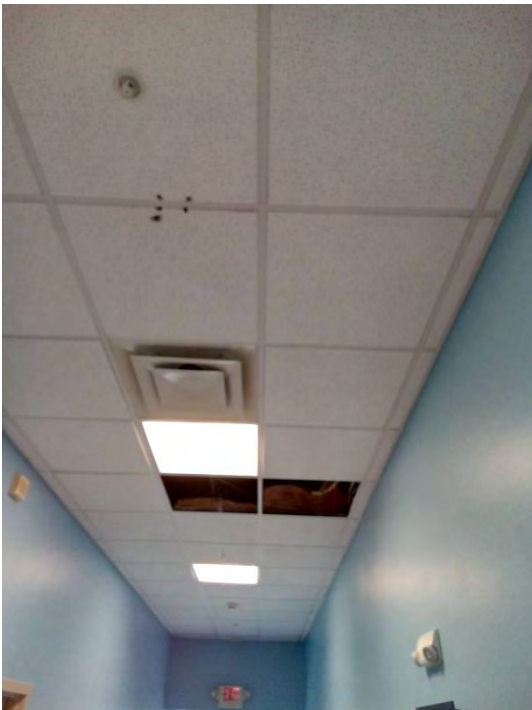
(46)

**Created:** Thu 27 Jul 09:32 2023  
**Group:** 169 Corridor 4  
**Cause of Damage:** Wind Driven Rain  
**Component Description:**  
 - Acoustical Ceiling Tiles  
 - Ceiling Batt Insulation

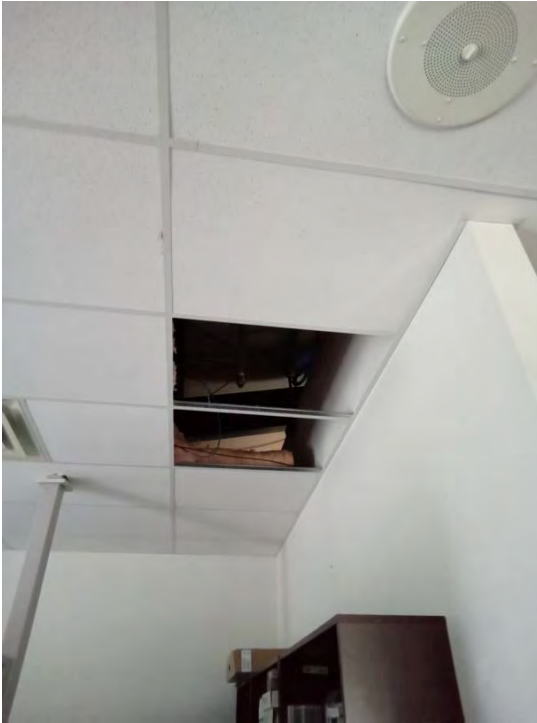
(47)

**Created:** Thu 27 Jul 09:34 2023  
**Group:** 171 Director 3  
**Cause of Damage:** Wind Driven Rain  
**Component Description:**

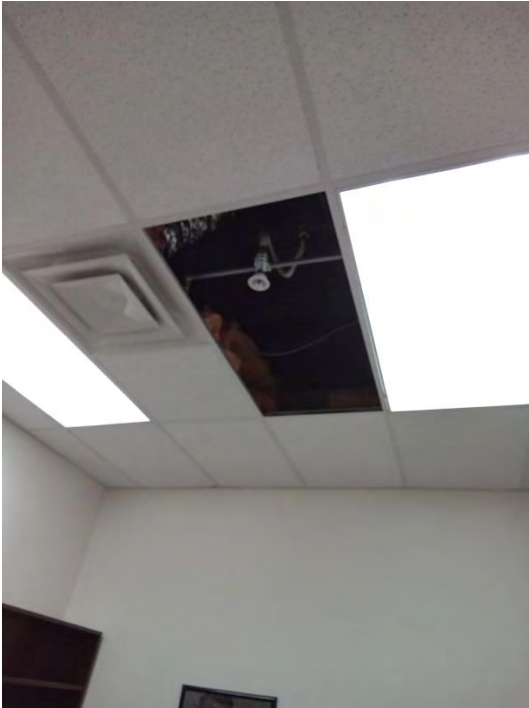
(49)

**Created:** Thu 27 Jul 09:36 2023  
**Group:** 173 Dispatch  
**Cause of Damage:** Wind Driven Rain  
**Component Description:**

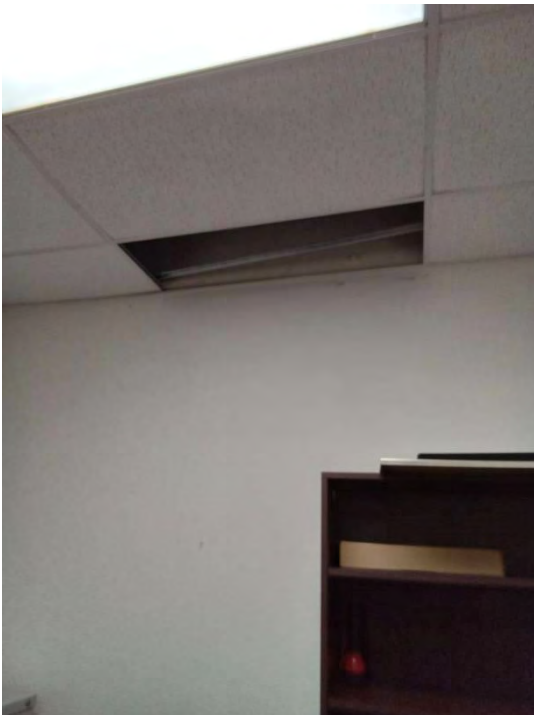
(50)

**Created:** Thu 27 Jul 09:38 2023  
**Group:** 173 Dispatch  
**Cause of Damage:** Wind Driven Rain  
**Component Description:**

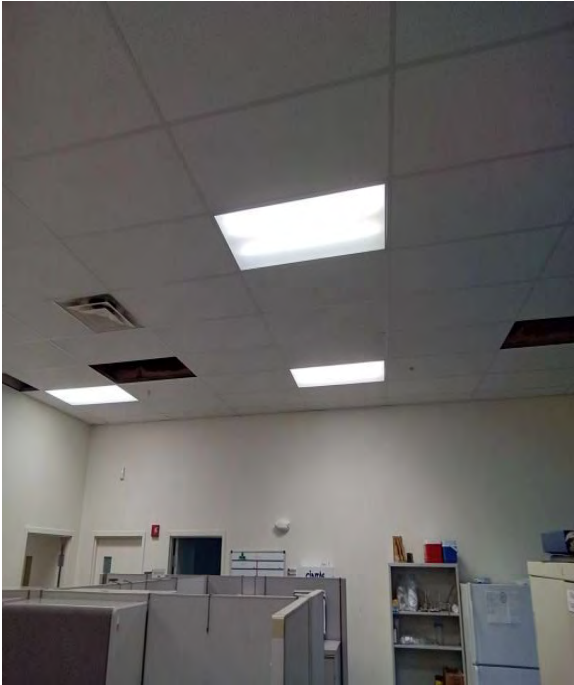
(51)

**Created:** Thu 27 Jul 09:39 2023  
**Group:** 159 Work Area 1  
**Cause of Damage:** Wind Driven Rain  
**Component Description:**

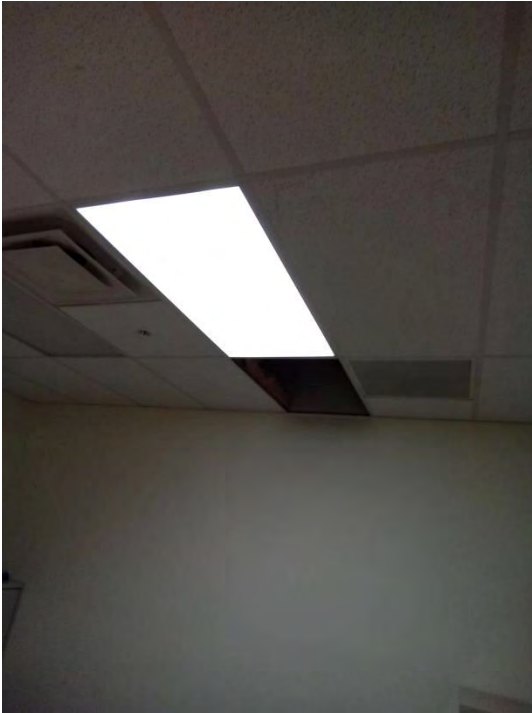
(53)

**Created:** Thu 27 Jul 09:42 2023  
**Group:** 177 System Office 4  
**Cause of Damage:** Wind Driven Rain  
**Component Description:**

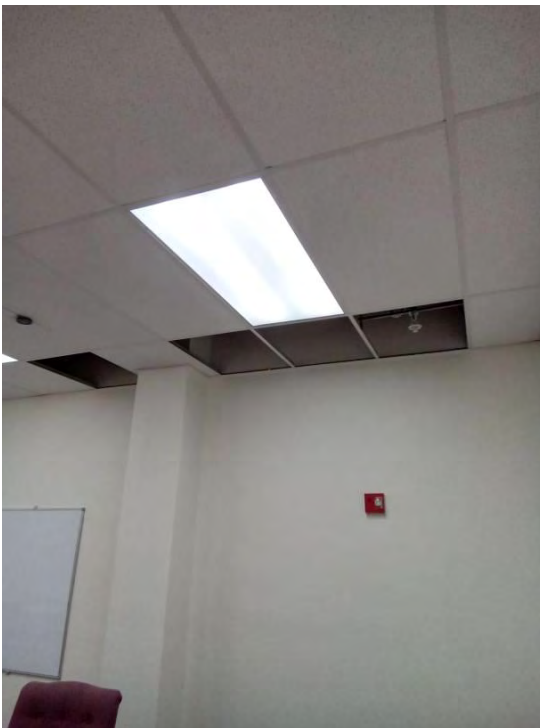
(54)

**Created:** Thu 27 Jul 09:42 2023  
**Group:** 159 Work Area 1  
**Cause of Damage:** Wind Driven Rain  
**Component Description:**

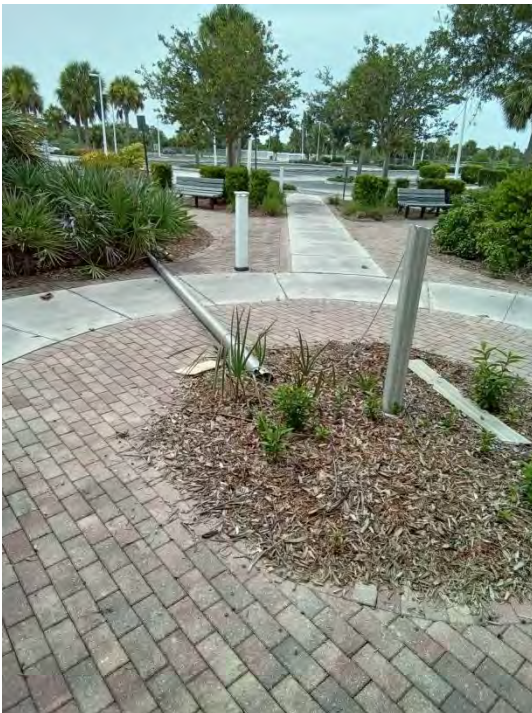
(58)

**Created:** Thu 27 Jul 10:35 2023  
**Group:** Exterior  
**Cause of** High Winds  
**Damage:**  
**Component**  
**Description:**  
 - LED light pole, round, metal, and single arm.

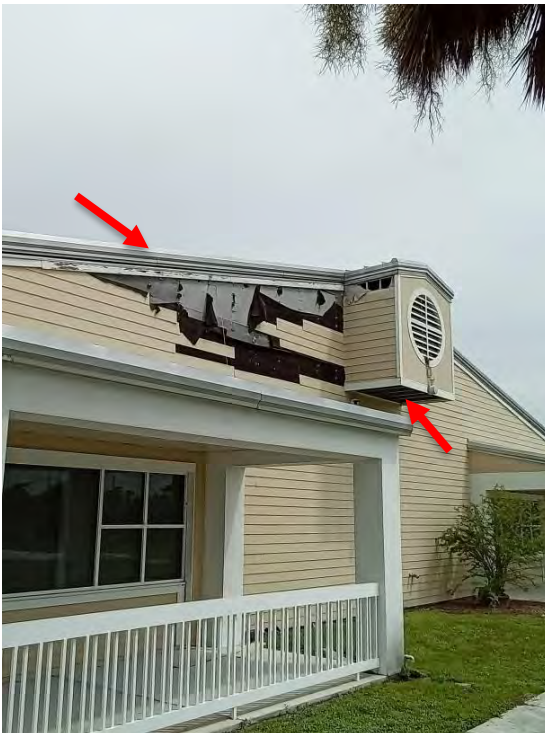
(60)

**Created:** Thu 27 Jul 10:38 2023  
**Group:** Exterior  
**Cause of Damage:** High Winds  
**Component Description:**  
 - Fiber Cement Siding panels  
 - Roof gutters  
 - Metal Soffit Panels

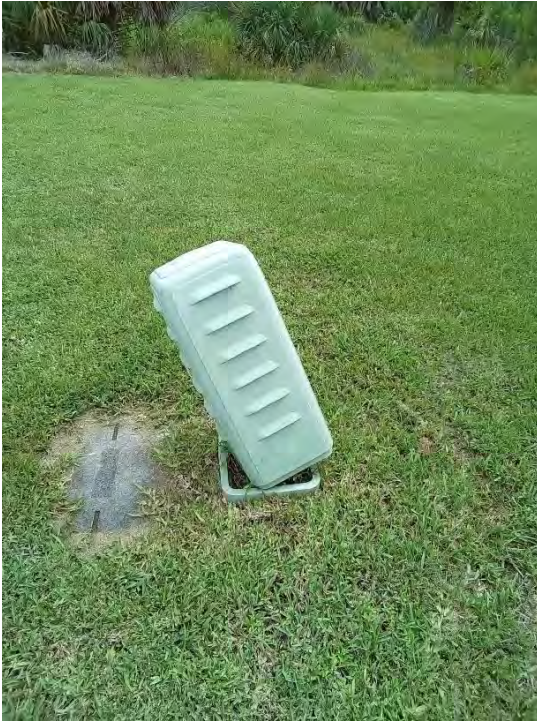
(61)

**Created:** Thu 27 Jul 10:40 2023  
**Group:** Exterior  
**Cause of Damage:** High Winds  
**Component Description:**  
 - Telecommunications box

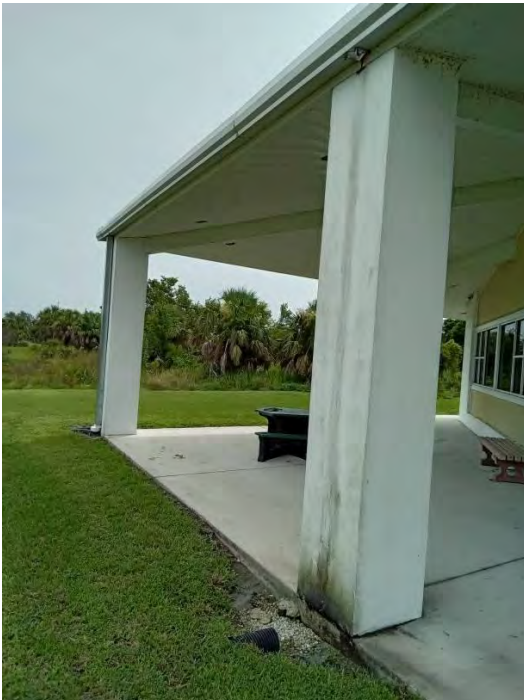
(62)

**Created:** Thu 27 Jul 10:43 2023  
**Group:** Exterior  
**Cause of Damage:** High Winds  
**Component Description:**  
 - Downspouts

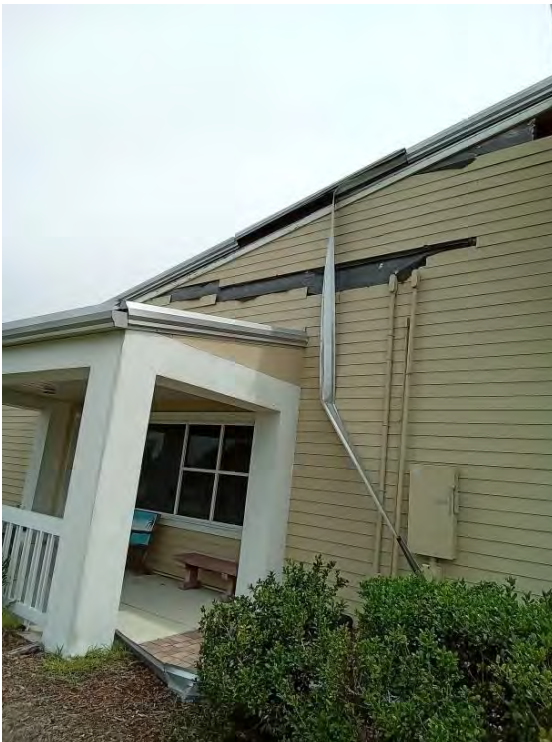
(68)

**Created:** Thu 27 Jul 10:49 2023  
**Group:** Exterior  
**Cause of Damage:** High Winds  
**Component Description:**  
 - Fiber Cement Siding panels  
 - Roof Gutters

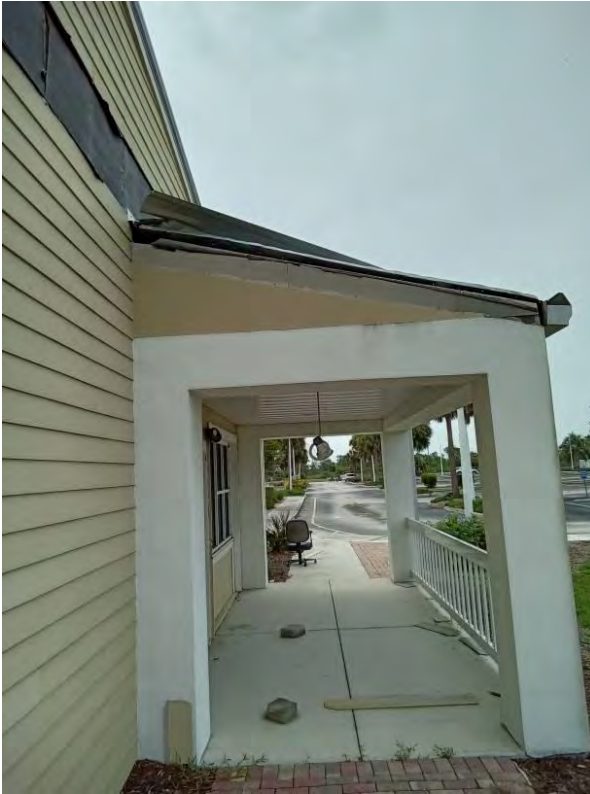
(71)

**Created:** Thu 27 Jul 10:51 2023  
**Group:** Exterior  
**Cause of Damage:** High Winds  
**Component Description:**  
 - 10 FT of 6-inch galvanized gutters

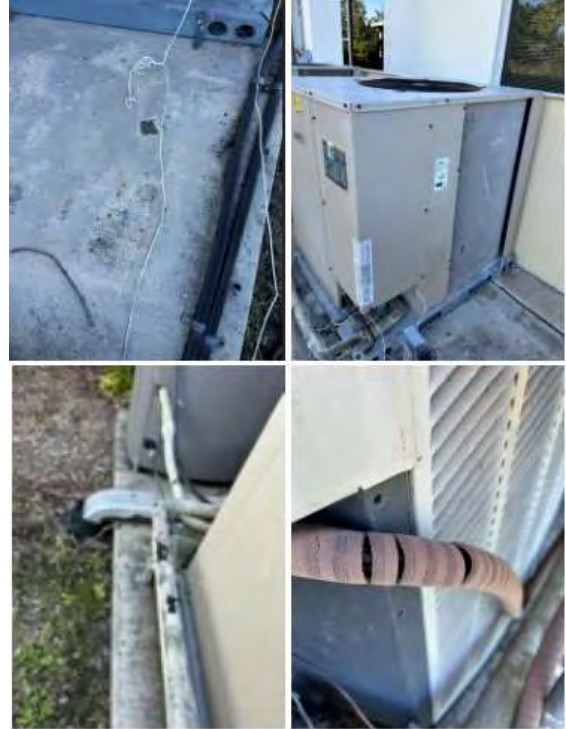
Virtually every AC condensing unit on the building's exterior showed signs of damage, likely from recent hurricanes. Many of the condenser coil fins were dented and damaged, likely from airborne debris, thus reducing the RSL and efficiency of the systems. Line set insulation showed wear and damage, and has been known to blow off in strong winds. This also lowers the system's efficiency. Low voltage control wires were observed detached and with damage, and could easily see further damage from lawn care equipment. Once damaged, these wires may not signal the condenser to run when demand is present. Lastly, several high voltage AC power supply whips were observed to be compromised with the interior wire now exposed to the elements and subject to failure. We recommend repair or replacement of the damaged condensers.

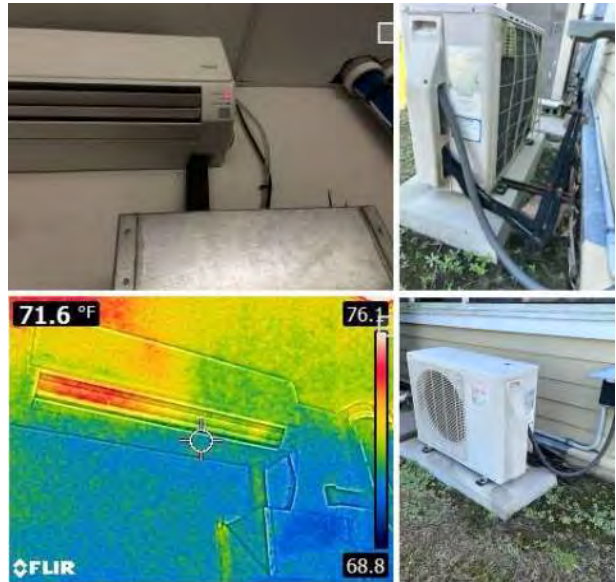
The installed Fujitsu Mini-Split system was observed in an alarm state, producing now cool air. The thermal heat signature confirms the warm air output. Despite demand from the space and thermostat, the condenser fan would not energize. Functionality of these units is extremely important, as they protect valuable and sensitive IT equipment. It is likely that the mini-split condensing unit was subject to high force winds and water intrusion, given its location at the eastern corner of the building, adjacent to the retention pond. We recommend this system is replaced with a more efficient one.

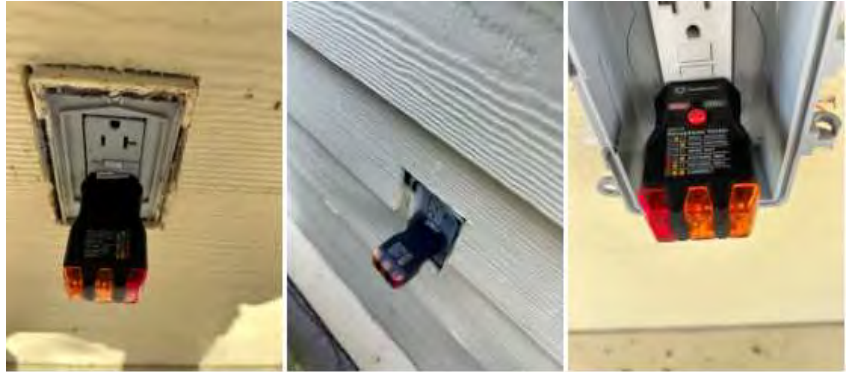
All of the exterior GFCI outlets were assessed for functionality. Most of the outlets were missing their covers and would not test and reset. They were likely exposed to winds and rain and should be replaced.

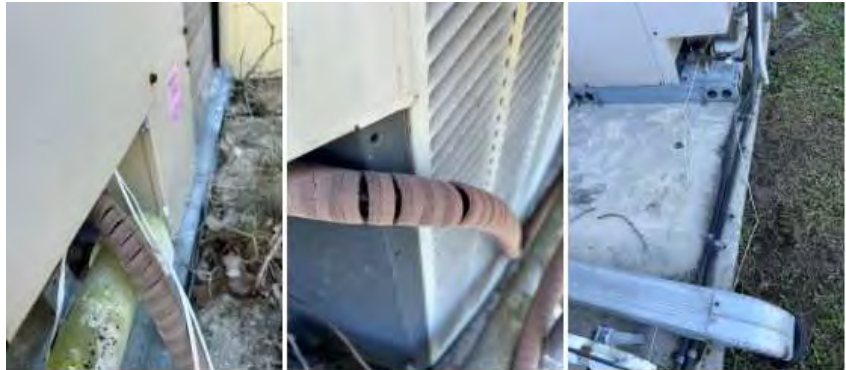
Several condensing unit AC power supply whips were observed compromised and exposing the internal wiring to the elements. Other wiring was observed unkept and looked as if high winds had blown it loose.

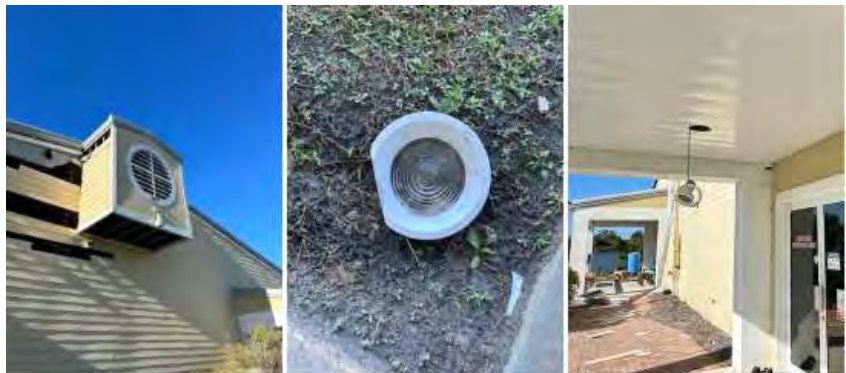
Much of the exterior lighting was damaged, with lighting fixture components scattered about the exterior. Apparent stress to connected wiring & conduit was also observed. Replacement of all exterior lighting is recommended.

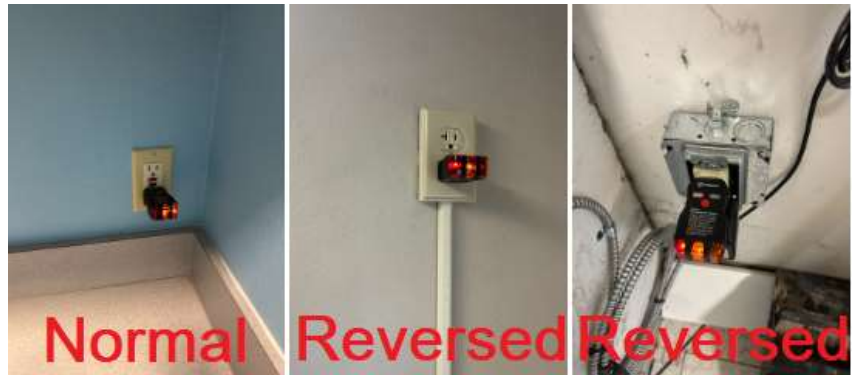
Well over 100 normal and GFCI interior outlets were tested for proper operation. Of those sampled, two were observed to have neutrals reversed. This should be corrected immediately to avoid risk of shock or fire.

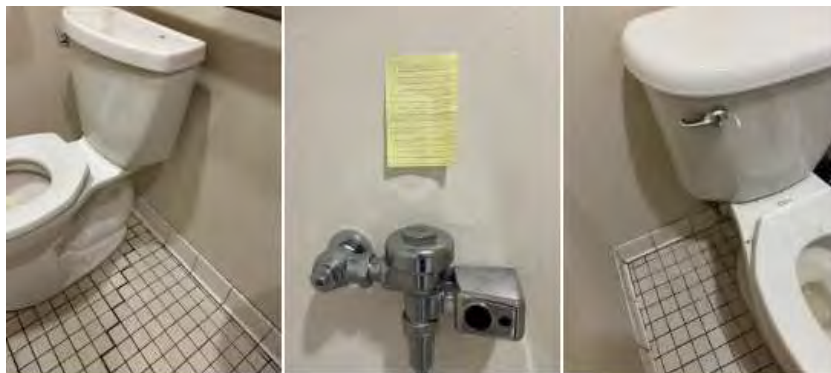
Half of the toilets and urinals assessed leaked at the flush valve or the tank-to-bowl gasket. This only occurred when flushed. Many of the fixtures had no water in them prior to assessment, so dry traps and seals were likely.

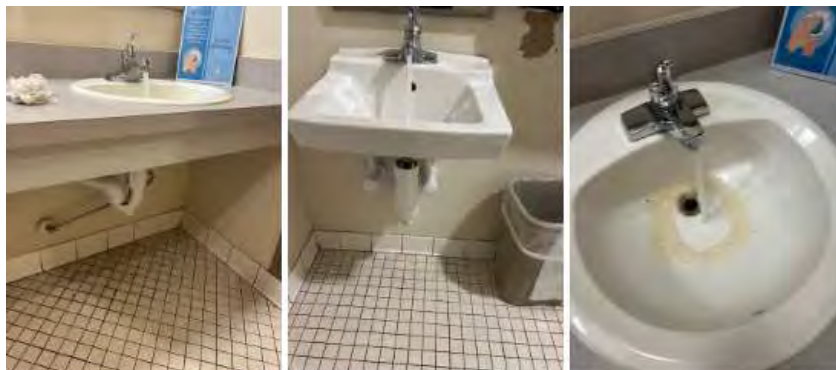
More than half of the facility sinks leaked at the faucet base or the P-trap when tested. Hurricane force winds may have helped dry out the P-traps, as high winds across vent stacks can cause water in traps to move.

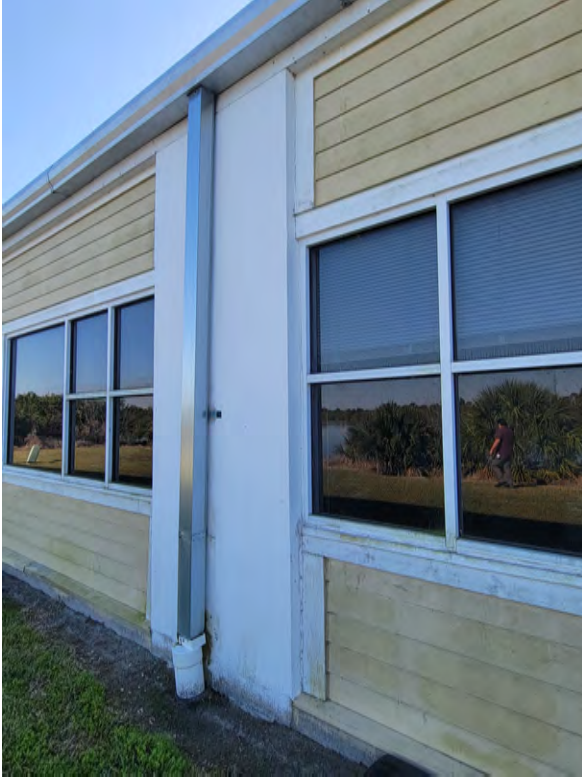
At multiple points along the perimeter of the facility, the downspouts were in disrepair. Each downspout feeds into an underground rain leader, draining into the lawn (Figure 14). In some locations, the downspouts were missing entirely, leaving the rain leader exposed (Figure 15).

**Figure 14:** Rear wall at north end of building.

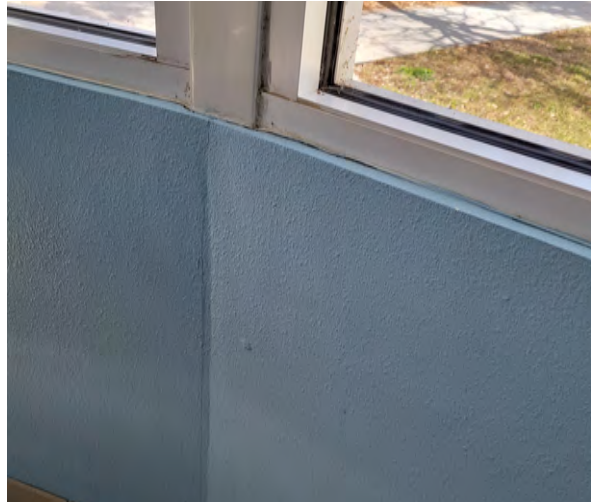
**Figure 17:** Cracks in drywall and separation of window and wall.
