**Site Inspection Report for  
Charlotte County –  
Centennial Park Campus  
Florida Hurricane Ian (DR-4673-FL)**

# Parks Mid County - Centennial Park Campus

Project# 714039 DI# 1308361

**Site Inspection Report for  
Charlotte County –  
Harold Avenue Regional Park  
Florida Hurricane Ian (DR-4673-FL)**

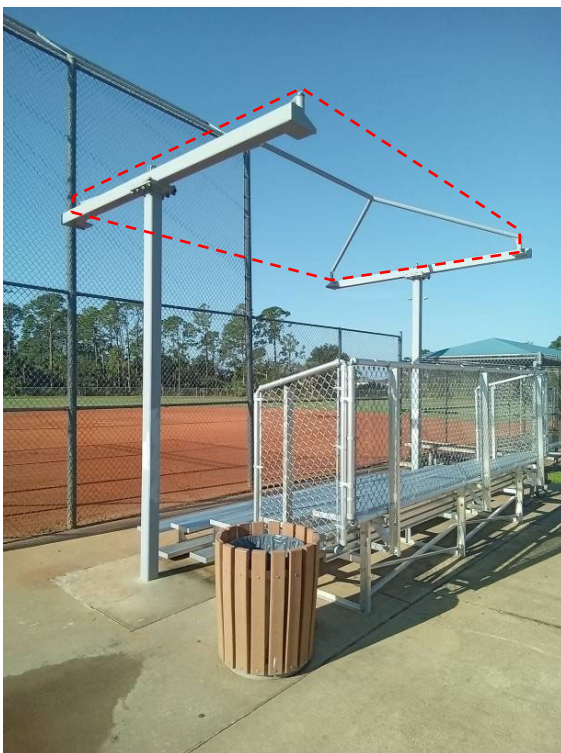
(2.)

**Created:** Wed 13 Sep 09:15 2023 Shade  
**Group:** Structure (A) (Cantilever Shade  
Fabric) Field 5  
**GPS Lat/Lon:** 27.01169, -82.17966  
**Cause of Damage:** Wind/Wind-Borne  
Debris

Baseball field 5, recommend replacement of the high tensile strength fabric. Flange experienced high volatile wind event causing stress points at the nuts and bolts of the flange.

T - Cantilever Bleacher Shade Structure

Approximate shade dimensions 20' L x 12' W

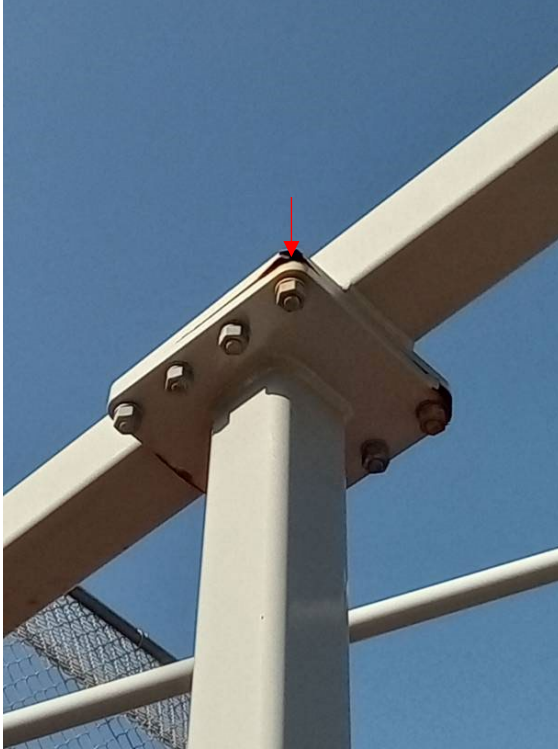
(3.)

**Created:** Wed 13 Sep 09:18 2023  
**Group:** Shade Structure (A) Field 5  
**GPS Lat/Lon:** 27.01169, -82.17966  
**Cause of Damage:** Wind/Torque  
**Component Description:**  
Close up of flange, the constant high volatile wind direction created a flange displacement as seen at the bolt observed.

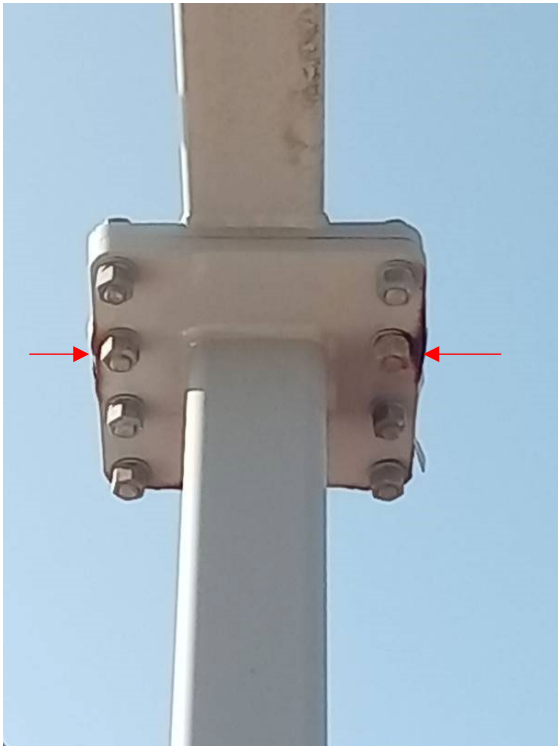
(4.)

**Created:** Wed 13 Sep 09:19 2023  
**Group:** Shade Structure (A) Field 5  
**GPS Lat/Lon:** 27.01169, -82.17966  
**Cause of Damage:** Wind  
**Component Description:**  
Close up of flange.

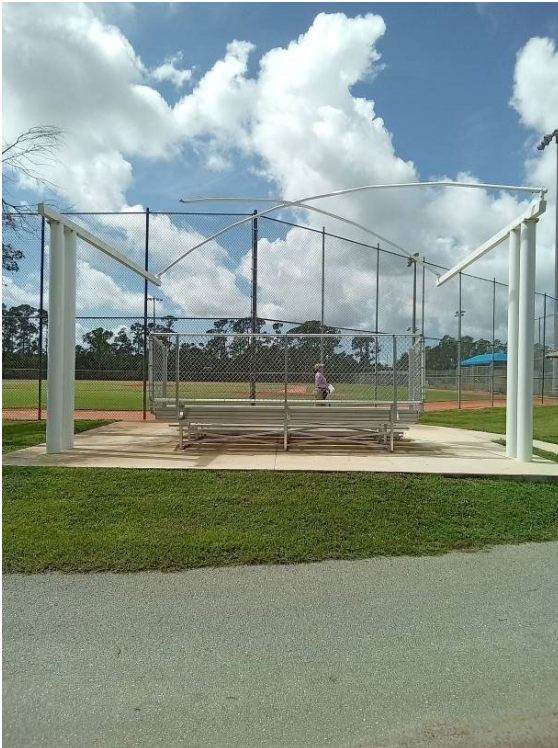
(2)

**Created:** Thu 21 Sep 11:44 2023  
**Group:** Baseball Field Shade  
Structure (A) - Field 4  
**GPS Lat/Lon:** 27.014810, -82.061795  
**Cause of Damage:** High Winds  
**Component Description:**  
(1) 2" OD pipe broken on eastern side.

Shade fabric missing.

Approximate shade dimensions 25' x 20'

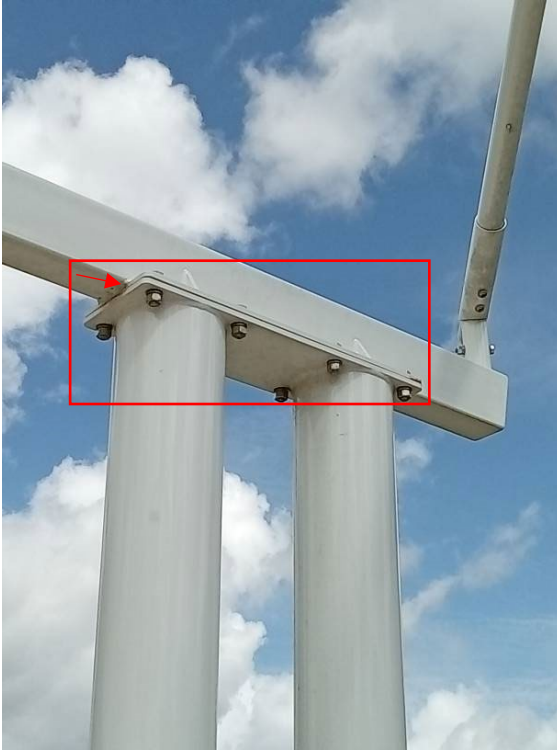
(3)

**Created:** Thu 21 Sep 11:50 2023  
**Group:** Baseball Field Shade  
Structure (A) - Field 4  
**GPS Lat/Lon:** 27.014810, -82.061795  
**Cause of Damage:** High Winds  
**Component Description:**  
Refer to Photo (2).

Stress flange shift at top of structure.

T-Cantilever Bleacher Shade.

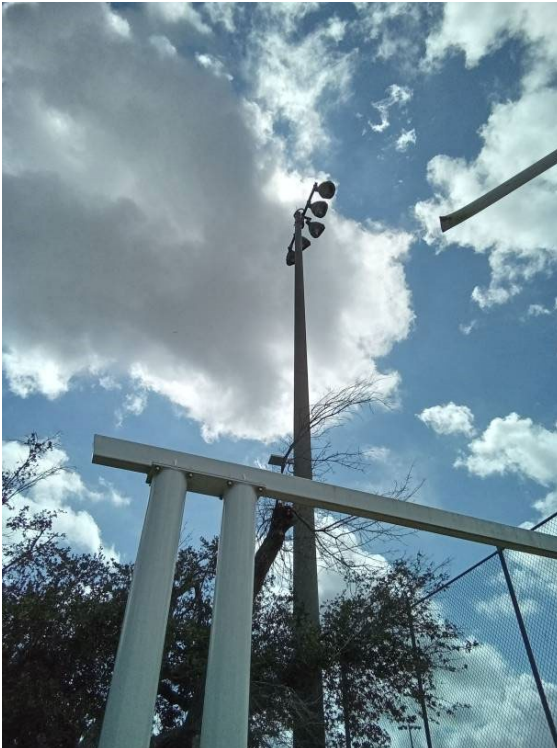
(4)

**Created:** Thu 21 Sep 11:51 2023  
**Group:** Baseball Field Shade  
Structure (A) - Field 4  
**GPS Lat/Lon:** 27.014810, -82.061795  
**Cause of Damage:** High Winds  
Refer to Photo (2).

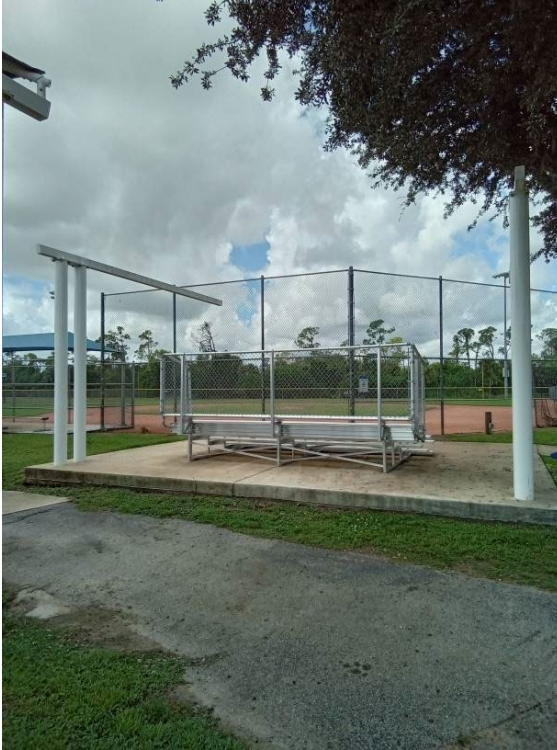
5)

**Created:** Thu 21 Sep 11:52 2023  
**Group** Baseball Field Shade  
Structure B - Field 2  
**GPS Lat/Lon:** 27.014811, -82.062222  
**Cause of Damage:** High Winds  
Structure damaged. Displacement of 2"  
pipe and multiple stress points.

Shade fabric missing.

Overall dimensions: Approximate  
shade dimension 25' x 20'

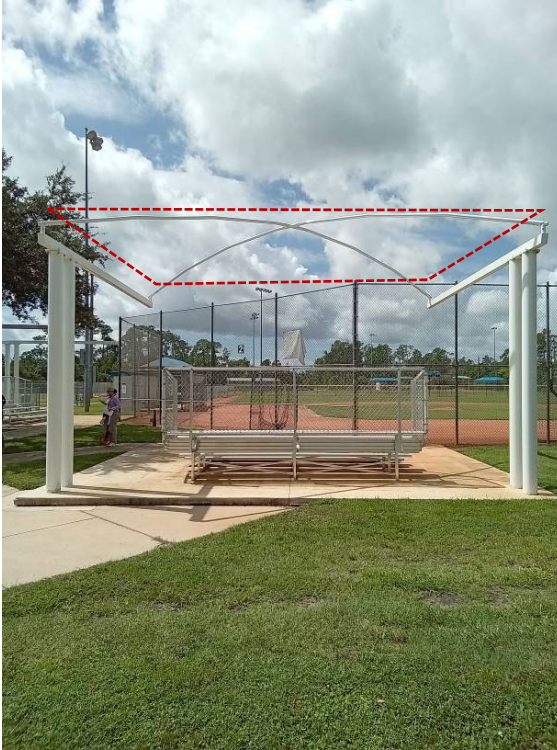
7)

**Created:** Thu 21 Sep 11:52 2023  
**Group:** Baseball Field Shade  
Structure (C) Field 2  
**GPS Lat/Lon:** 27.014974, -82.062199  
**Cause of Damage:** High Winds  
Structure damaged. Displacement of 2"  
pipe and multiple stress points.

Shade fabric missing.

Overall dimensions: Approximate  
shade dimension 25' x 20'

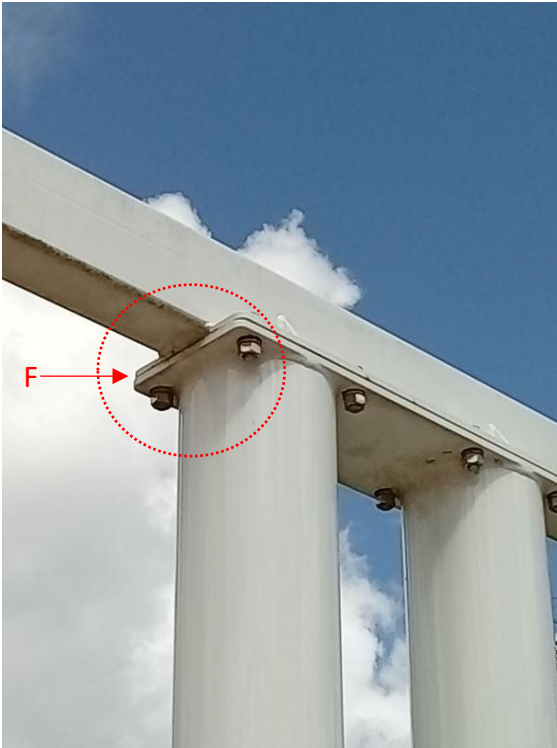
(8)

**Created:** Thu 21 Sep 11:52 2023  
**Group:** Baseball Field Shade  
Structure (C) Field 2  
**GPS Lat/Lon:** 27.014974, -82.062199  
**Cause of Damage:** High Winds  
Refer to Photo (7).

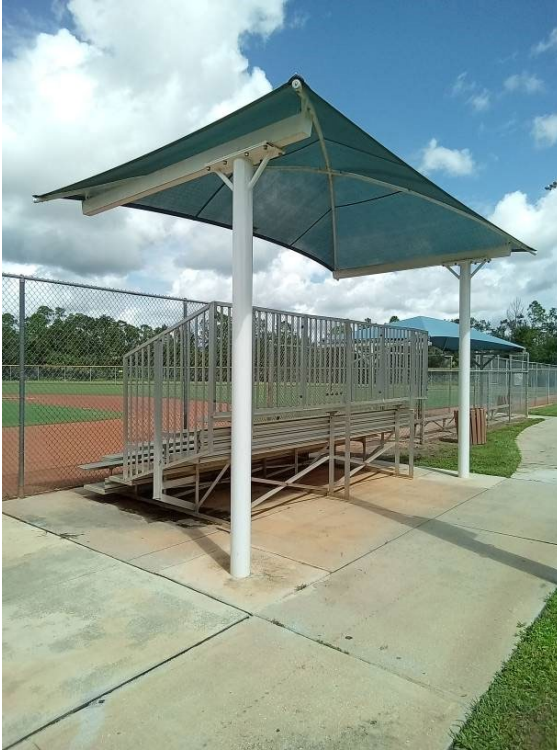
9)

**Created:** Thu 21 Sep 11:52 2023  
**Group:** Baseball Field Shade  
Structure (D) Field 3  
**GPS Lat/Lon:** 27.015221, -82.061911  
**Cause of Damage:** High Winds  
Structure damaged. Multiple  
stress points.

Overall dimensions: Approximate  
shade dimension 18' x 12'

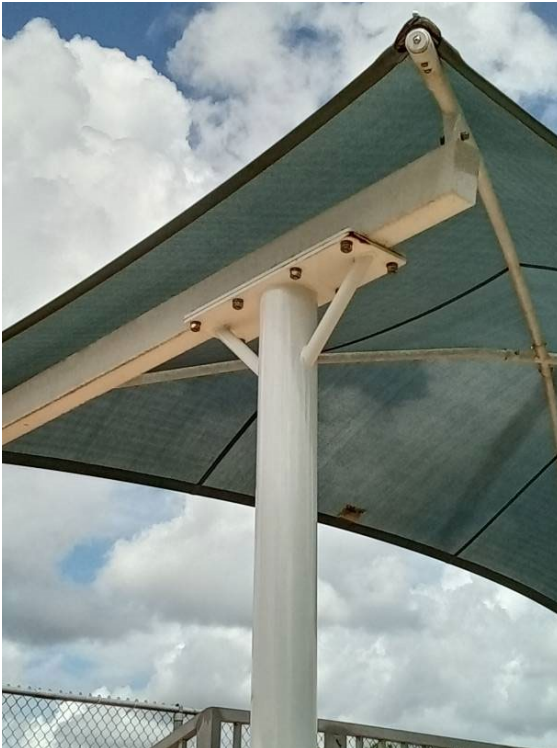
(10)

**Created:** Thu 21 Sep 12:08 2023  
**Group:** Baseball Field Shade  
Structure (D) Field 3  
**GPS Lat/Lon:** 27.015221, -82.061911  
**Cause of Damage:** High Winds  
Refer to Photo (9).

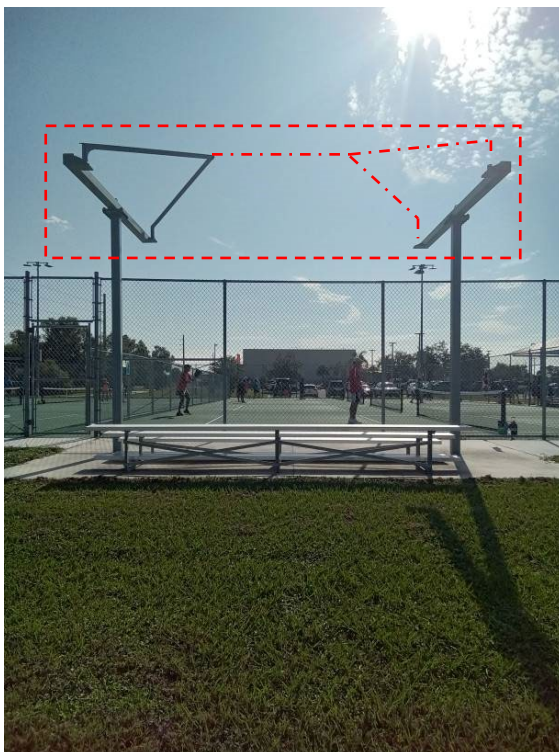
(2)

**Created:** Tue 12 Sep 09:59 2023  
**Group:** Tennis Court Shade Structure (A)  
**GPS Lat/Lon:** 26.93315, -82.03841  
**Cause of Damage:** Wind  
**Component Description:**  
West tennis court shade structure high tensile strength fabric has been blown off by apparent high volatile winds. The frame of the shade structure was also simultaneously affected during the event and a full rebuild is recommended.

Approximate shade dimensions 20' L x 10' W

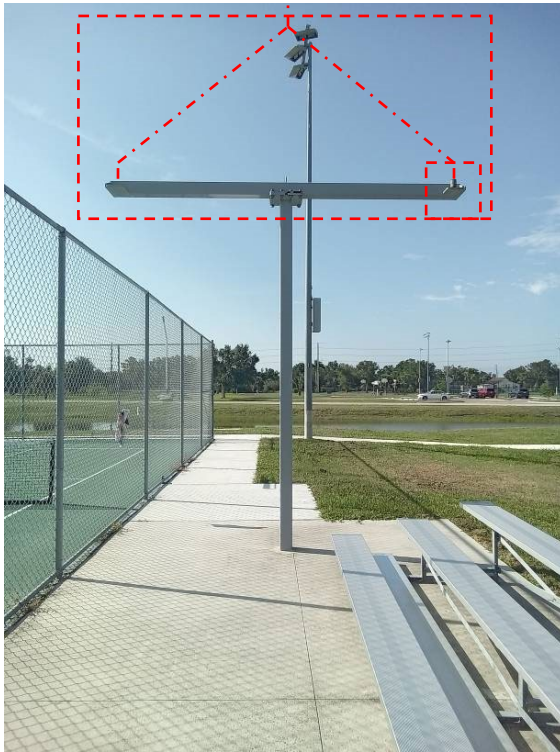
(3)

**Created:** Tue 12 Sep 10:03 2023  
**Group:** Tennis Court Shade Structure  
(A)

West tennis court shade structure high tensile strength fabric has been blown off by apparent high volatile winds. The frame of the shade structure was also simultaneously affected during the event and a full rebuild is recommended.

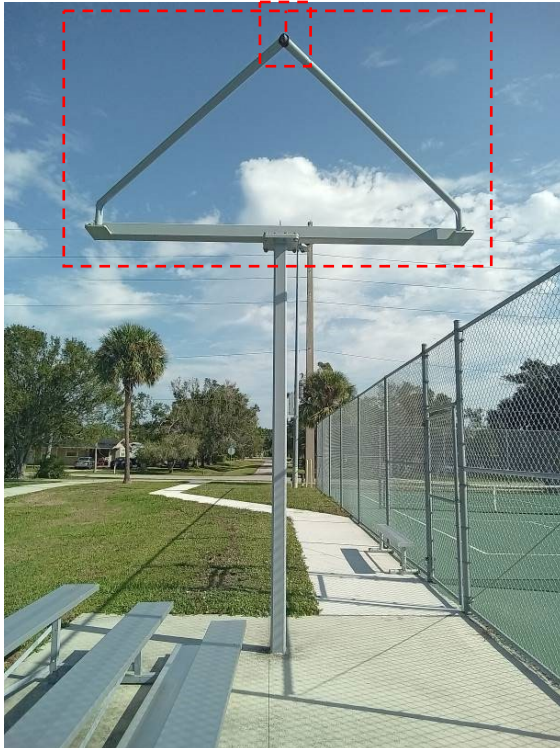
(4)

**Created:** Tue 12 Sep 10:04 2023  
**Group:** Tennis Court Shade Structure  
(A)

West tennis court shade structure high tensile strength fabric has been blown off by apparent high volatile winds. The frame of the shade structure was also simultaneously affected during the event and a full rebuild is recommended.

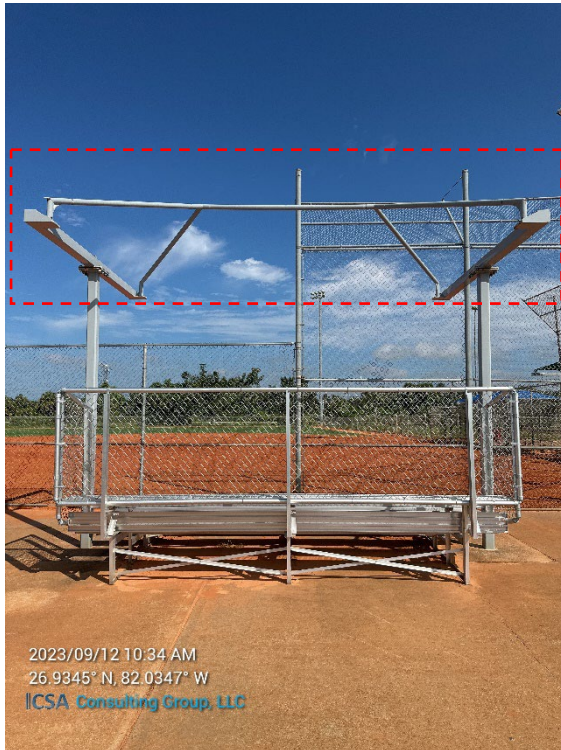
(5)

**Created:** Tue 12 Sep 10:34 2023  
**Group:** Baseball Field Shade Structure  
(A) - Baseball Field 2  
**GPS Lat/Lon:** 26.934792, -82.034551  
**Cause of Damage:** Wind  
**Component Description:**  
Facing East, Baseball Field Shade Structure (A)  
high tensile strength fabric has been blown off  
by apparent high volatile winds.

Approximate shade dimensions 16' L x 10' W

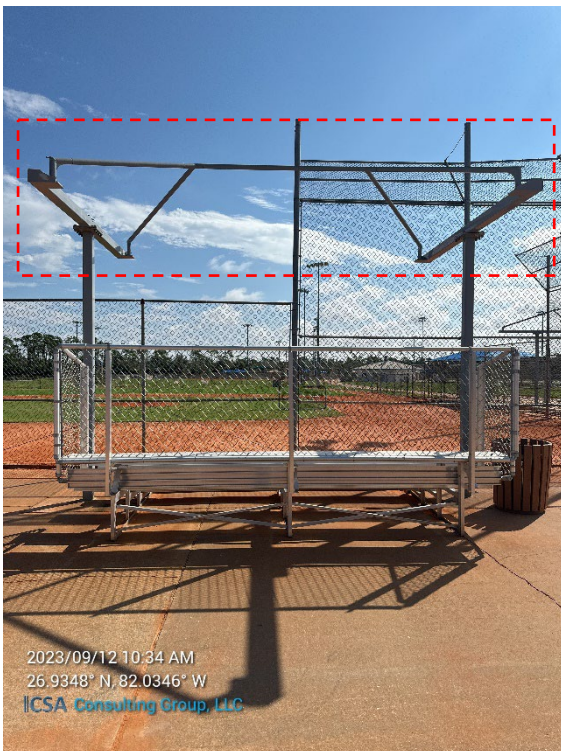
(6)

**Created:** Tue 12 Sep 10:34 2023  
**Group:** Baseball Field Shade Structure  
(B) - Baseball Field 1  
**GPS Lat/Lon:** 26.934793, -82.034584  
**Cause of Damage:** Wind  
**Component Description:**  
Baseball Field Shade Structure high tensile  
strength fabric has been blown off by  
apparent high volatile winds.

Approximate shade dimensions 16' L x 10' W

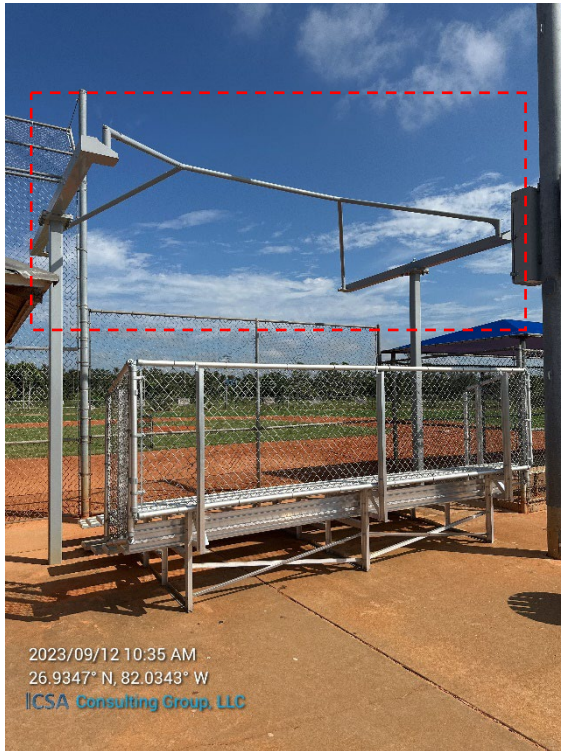
(7)

**Created:** Tue 12 Sep 10:35 2023  
**Group:** Baseball Field Shade Structure  
(C) - Baseball Field 2

Baseball Field Shade Structure high tensile strength fabric has been blown off by apparent high volatile winds.

Approximate shade dimensions 16' L x 10' W

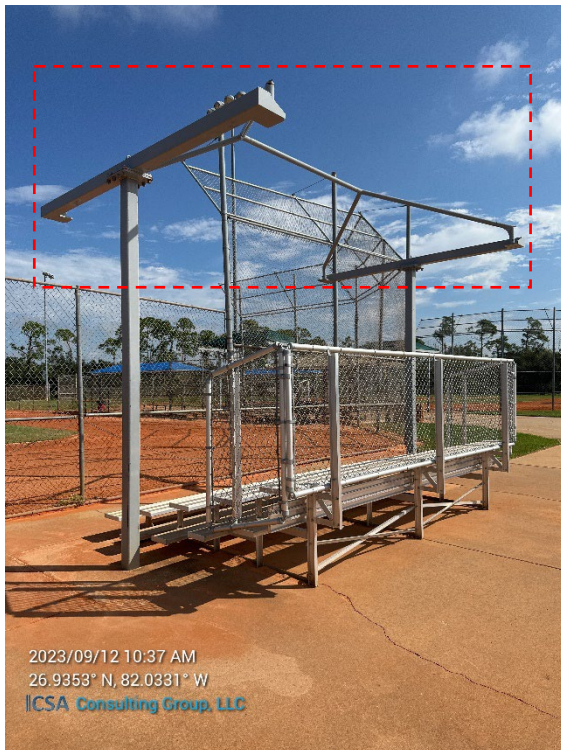
(8)

**Created:** Tue 12 Sep 10:37 2023  
**Group:** Baseball Field Shade Structure  
(D) - Baseball Field 3

Baseball Field Shade Structure high tensile strength fabric has been blown off by apparent high volatile winds.

Approximate shade dimensions 16' L x 10' W

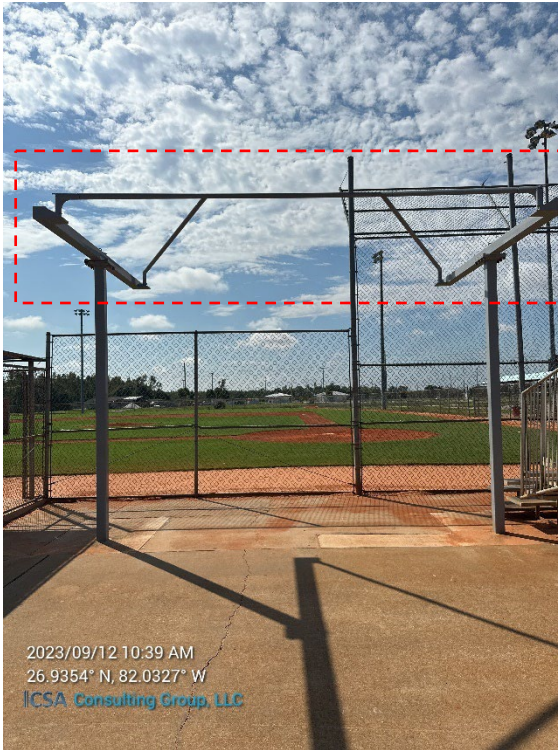
(9)

**Created:** Tue 12 Sep 10:34 2023  
**Group:** Baseball Field Shade Structure  
(E) - Baseball Field 4  
**GPS Lat/Lon:** 26.935372, -82.032663  
**Cause of Damage:** Wind  
**Component Description:**  
Baseball Field Shade Structure high tensile strength fabric has been blown off by apparent high volatile winds.

Approximate shade dimensions 16' L x 10' W

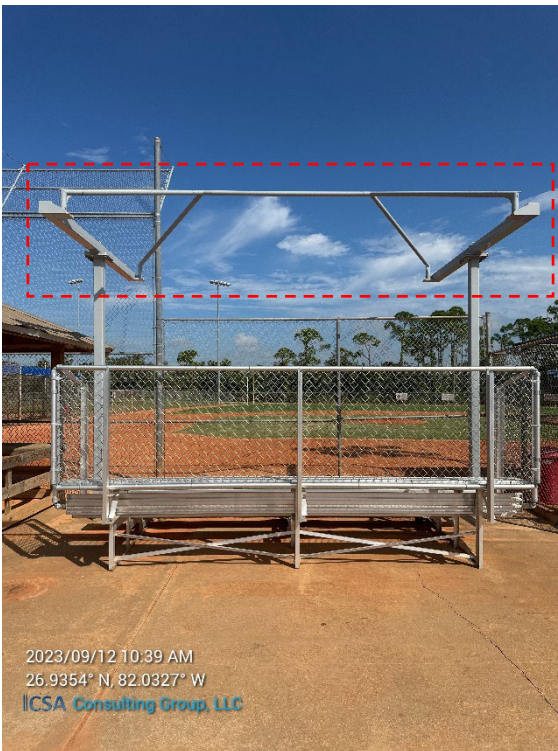
(10)

**Created:** Tue 12 Sep 10:39 2023  
**Group:** Baseball Field Shade Structure  
(F) - Baseball Field 4  
**GPS Lat/Lon:** 26.935403, -82.032697  
**Cause of Damage:** Wind  
**Component Description:**  
Baseball Field Shade Structure high tensile strength fabric has been blown off by apparent high volatile winds.

Approximate shade dimensions 16' L x 10' W

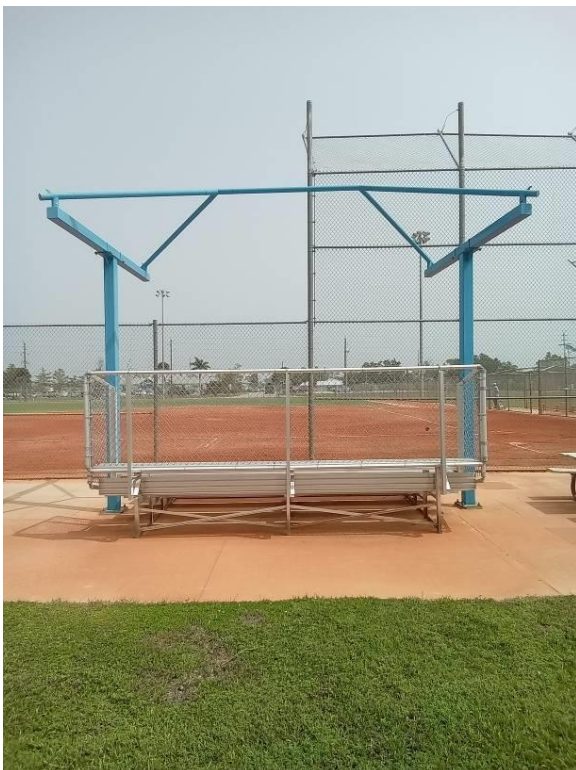
(2)

**Created:** Tue 03 Oct 13:08 2023  
**Group:** Softball (F1)  
**Cause of Damage:** Wind/Wind-Borne Debris  
**GPS Lat/Long:** 26.92828, -82.01972

**Component Description:**  
Cantilever Structure (A). Shade screen missing. Post flange shift between nuts and bolts. Top horizontal posts shifted w/bolt displacement.

Approximate shade dimensions 17' L x 11' W

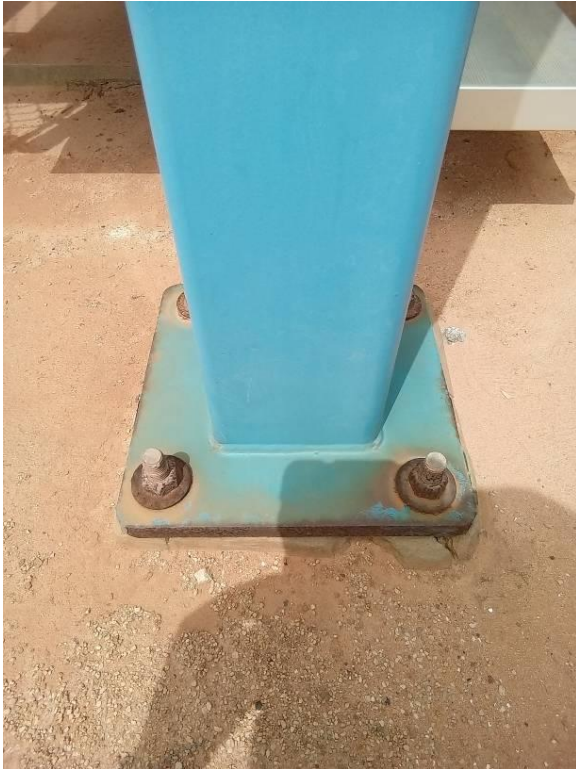
(3)

**Group:** Softball (F1)  
**Cause of Damage:** Wind/Wind-Borne Debris  
**GPS Lat/Long:** 26.92828,  
-82.01972

**Component Description:**  
Cantilever Structure (A)

Refer to Photo (4)

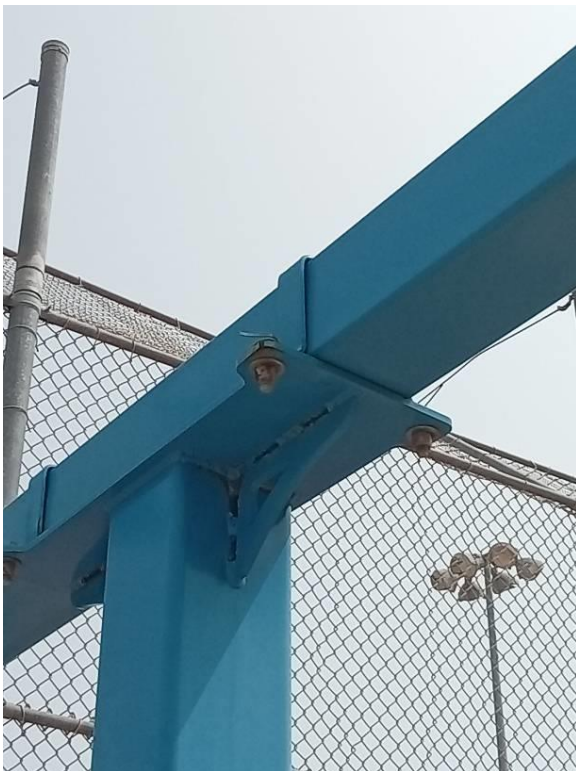
(4)

**Group:** Softball (F1)  
**Cause of Damage:** Wind/Wind-Borne Debris  
**GPS Lat/Long:** 26.92828,  
-82.01972

**Component Description:**  
Cantilever Structure (A)

Refer to Photo (4).

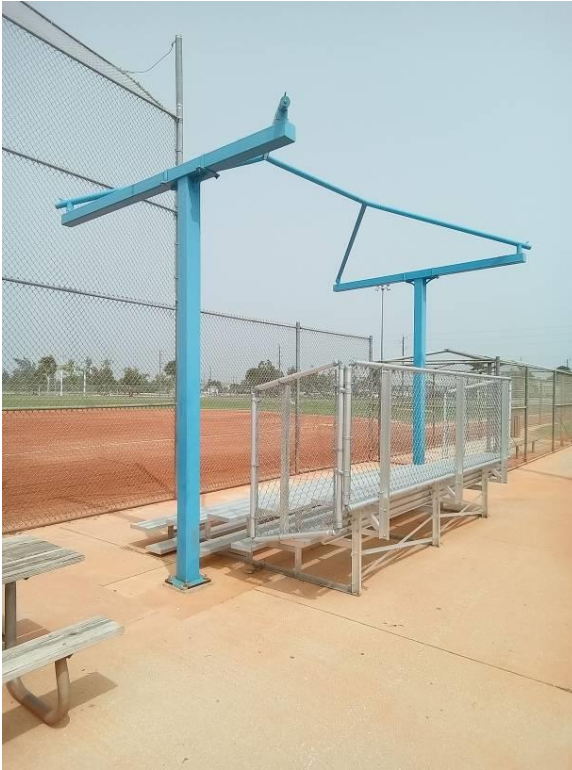
(5)

**Group:** Softball (F1)  
**Cause of Damage:** Wind/Wind-Borne Debris  
**GPS Lat/Long:** 26.92822,  
-82.01949

**Component Description:**  
Cantilever Structure (B). Shade screen missing. Post flange shift between nuts and bolts. Top horizontal posts shifted w/bolt displacement.

Approximate shade dimensions 17' L x 11' W

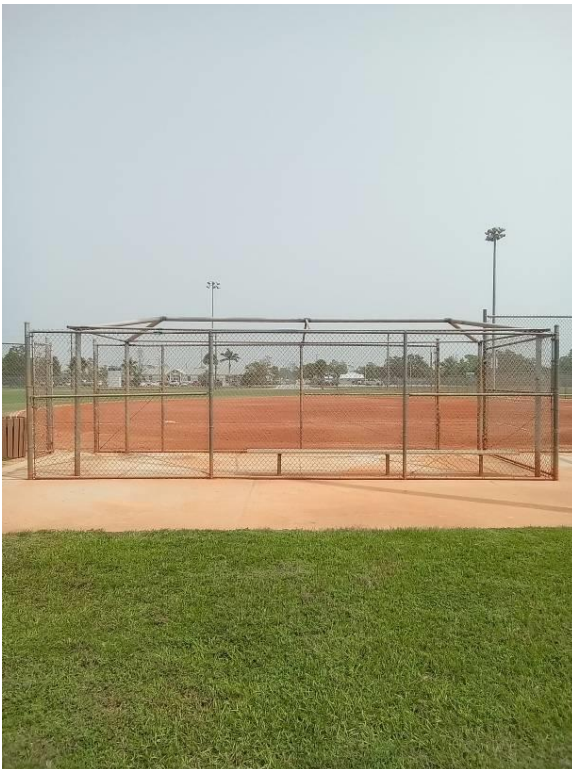
(6)

**Group:** Softball (F1)  
**Cause of Damage:** Wind/Wind-Borne Debris  
**GPS Lat/Long:** 26.92837,  
-82.01976

**Component Description:**  
Dugout Structure (A)

Missing shade.

Approximate shade dimensions 29' L x 10' W

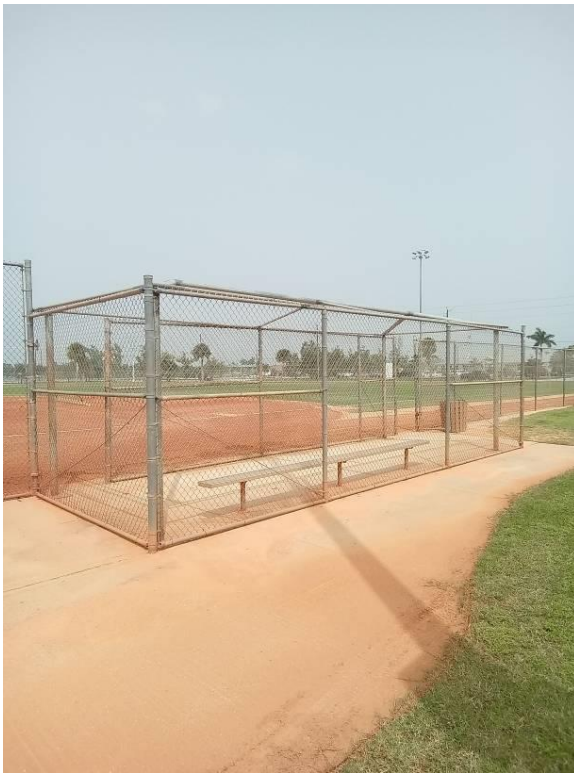
(7)

**Group:** Softball (F1)  
**Cause of Damage:** Wind/Wind-Borne Debris  
**GPS Lat/Long:** 26.92827,  
-82.01939

**Component Description:**  
Dugout Structure (B)

Missing shade.

Approximate shade dimensions 29' L x 10' W

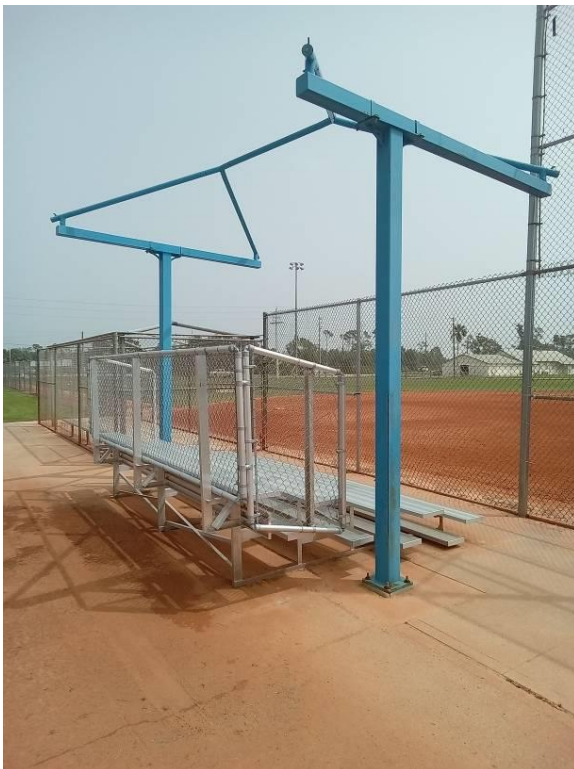
(8)

**Created:** Tue 03 Oct  
13:20 2023  
**Group:** Softball (F2)  
**Cause of Damage:** Wind/Wind-Borne Debris  
**GPS Lat/Long:** 26.92813,  
-82.01941

**Component Description:**  
Cantilever Structure (C). Shade screen missing. Post flange shift between nuts and bolts. Top horizontal posts shifted w/bolt displacement.

Approximate shade dimensions 17' L x 11' W

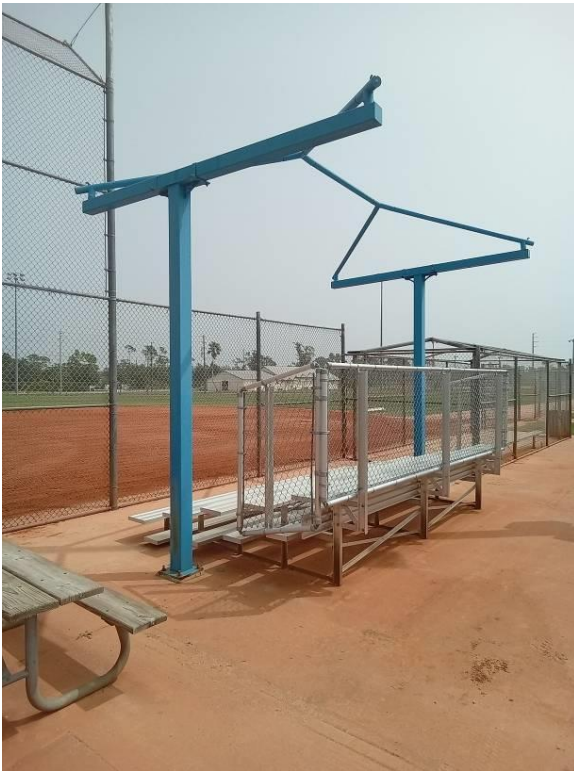
(11)

**Created:** Tue 03 Oct  
13:22 2023  
**Group:** Softball (F2)  
**Cause of Damage:** Wind/Wind-  
Borne Debris  
**GPS Lat/Long:** 26.92791,  
-82.01942

**Component Description:**  
Cantilever Structure (D). Shade  
screen missing. Post flange shift  
between nuts and bolts. Top  
horizontal posts shifted w/bolt  
displacement.

Approximate shade dimensions 17' L x 11' W

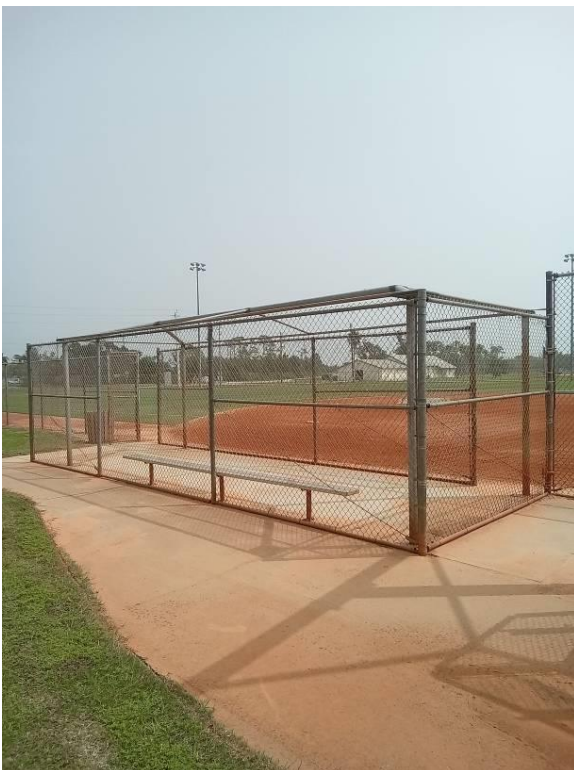
(12)

**Created:** Tue 03 Oct  
13:31 2023  
**Group:** Softball (F2)  
**Cause of Damage:** Wind/Wind-  
Borne Debris  
**GPS Lat/Long:** 26.92818,  
-82.01932

**Component Description:**  
Dugout Structure (C)

Missing shade.

Approximate shade dimensions 29' L x 10' W

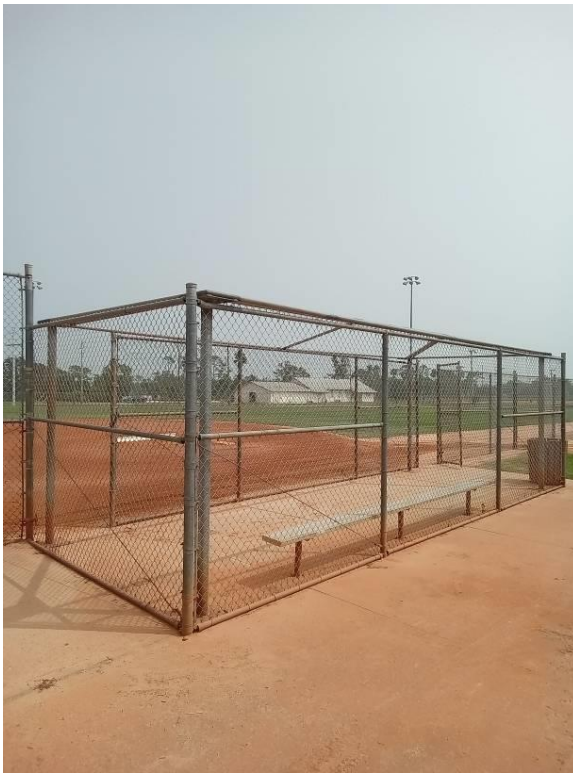
(9)

**Group:** Softball (F2)  
**Cause of Damage:** Wind/Wind-Borne Debris  
**GPS Lat/Long:** 26.92784,  
-82.01933

**Component Description:**  
Dugout Structure (D)

Missing shade.

Approximate shade dimensions 29' L x 10' W

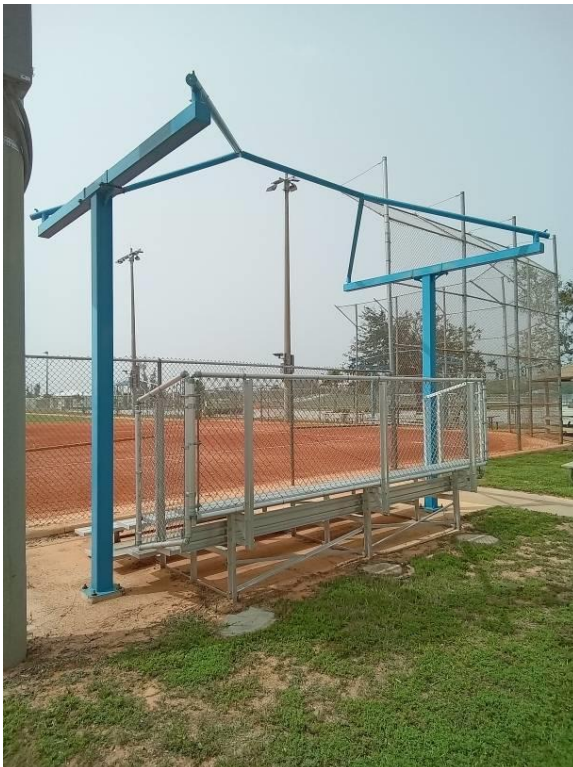
(10)

**Created:** Tue 03 Oct  
13:29 2023  
**Group:** Softball (F3)  
**Cause of Damage:** Wind/Wind-Borne Debris  
**GPS Lat/Long:** 26.92835,  
-82.01994

**Component Description:**  
Cantilever Structure (E). Shade screen missing. Post flange shift between nuts and bolts. Top horizontal posts shifted w/bolt displacement.

Approximate shade dimensions 17' L x 11' W

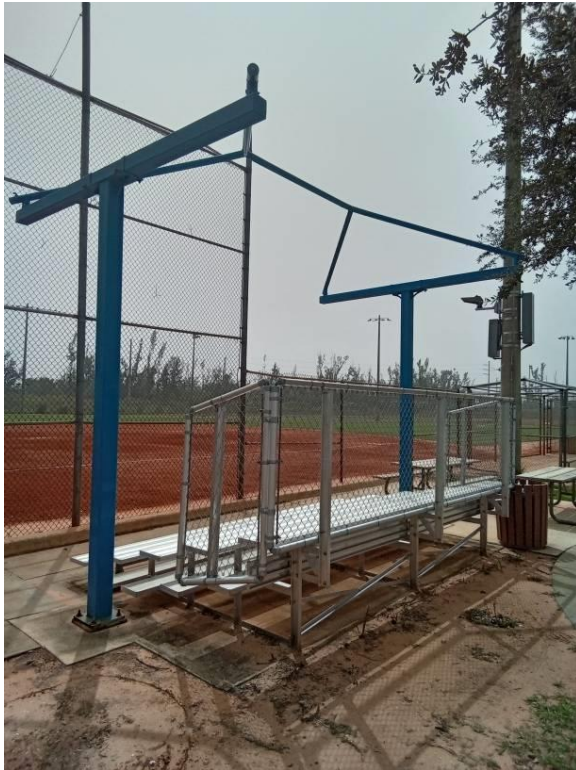
(11)

**Group:** Softball (F3)  
**Cause of Damage:** Wind/Wind-Borne Debris  
**GPS Lat/Long:** 26.92847,  
-82.02015

**Component Description:**  
Cantilever Structure (F). Shade screen missing. Post flange shift between nuts and bolts. Top horizontal posts shifted w/bolt displacement.

Approximate shade dimensions 17' L x 11' W

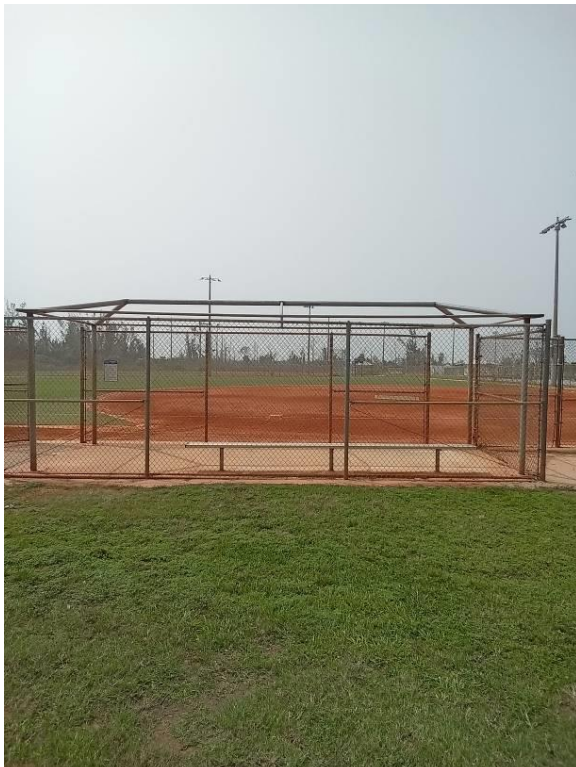
(12)

**Created:** Tue 03 Oct  
13:28 2023  
**Group:** Softball (F3)  
**Cause of Damage:** Wind/Wind-Borne Debris  
**GPS Lat/Long:** 26.92827,  
-82.01991

**Component Description:**  
Dugout Structure (E)

Missing shade.

Approximate shade dimensions 29' L x 10' W

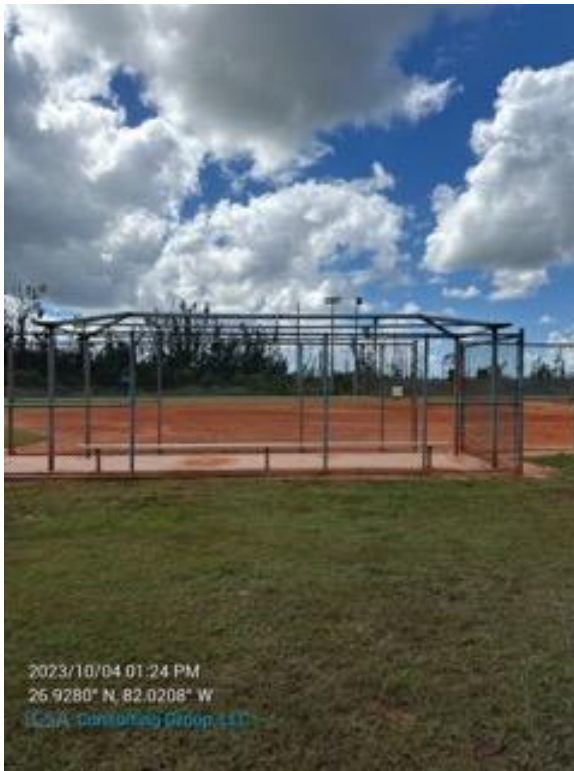
(13)

**Group:** Softball (F4)  
**Cause of Damage:** Wind/Wind-Borne Debris  
**GPS Lat/Long:** 26.92770,  
-82.02094

**Component Description:**  
Dugout Structure (G)

Missing shade.

Approximate shade dimensions 29' L x 10' W

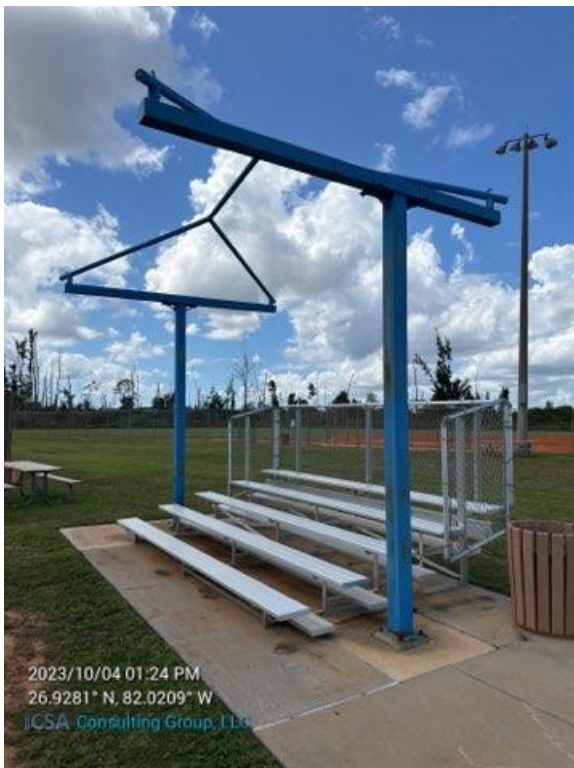
(14)

**Created:** Tue 03 Oct  
13:33 2023  
**Group:** Softball (F4)  
**Cause of Damage:** Wind/Wind-Borne Debris  
**GPS Lat/Long:** 26.92782,  
-82.02137

**Component Description:**  
Cantilever Structure (H). Shade screen missing. Post flange shift between nuts and bolts. Top horizontal posts shifted w/bolt displacement.

Approximate shade dimensions 17' L x 11' W

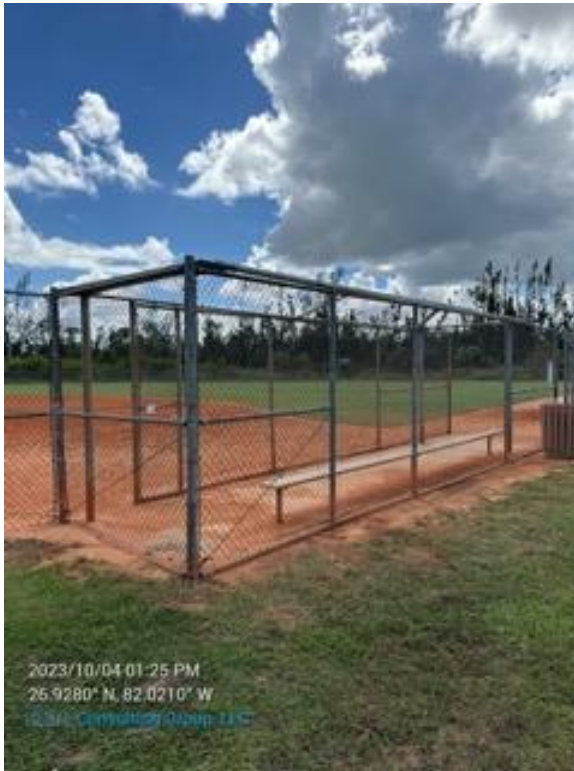
(15)

**Group:** Softball (F4)  
**Cause of Damage:** Wind/Wind-Borne Debris  
**GPS Lat/Long:** 26.92773,  
-82.02144

**Component Description:**  
Dugout Structure (H)

Missing shade.

Approximate shade dimensions 29' L x 10' W

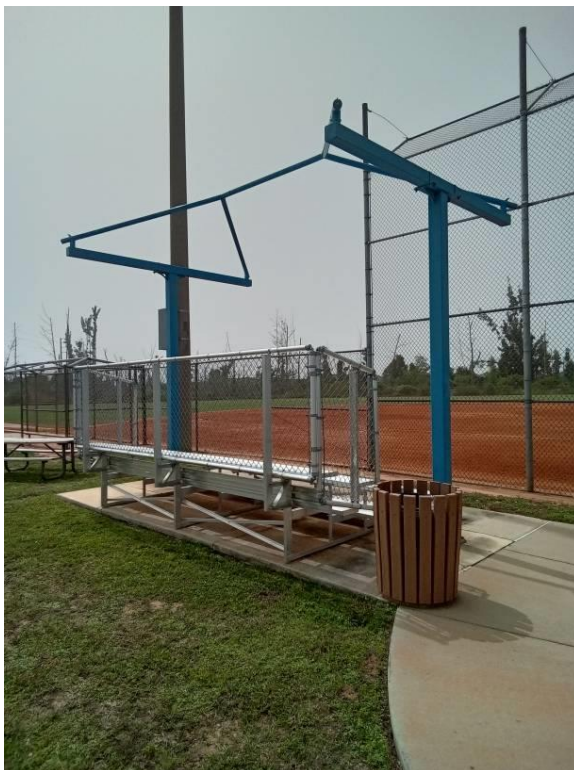
(16)

**Created:** Tue 03 Oct 14:06 2023  
**Group:** Softball (F5)  
**Cause of Damage:** Wind/Wind-Borne Debris  
**GPS Lat/Long:** 26.92802,  
-82.02161

**Component Description:**  
Cantilever Structure (I). Shade screen missing. Post flange shift between nuts and bolts. Top horizontal posts shifted w/bolt displacement.

Approximate shade dimensions 17' L x 11' W

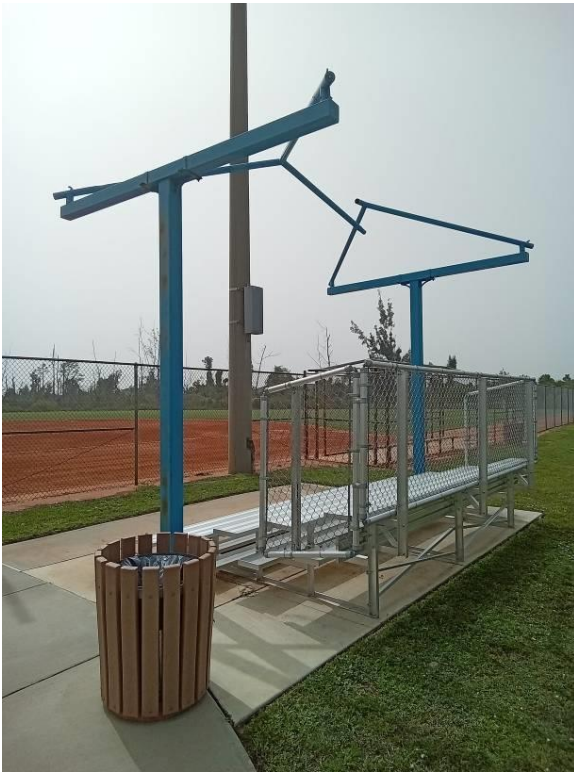
(17)

**Group:** Softball (F5)  
**Cause of Damage:** Wind/Wind-Borne Debris  
**GPS Lat/Long:** 26.92819,  
-82.02174

Cantilever Structure (J). Shade screen missing. Post flange shift between nuts and bolts. Top horizontal posts shifted w/bolt displacement. Center Beam damaged and dislodged.

Approximate shade dimensions 17' L x 11' W

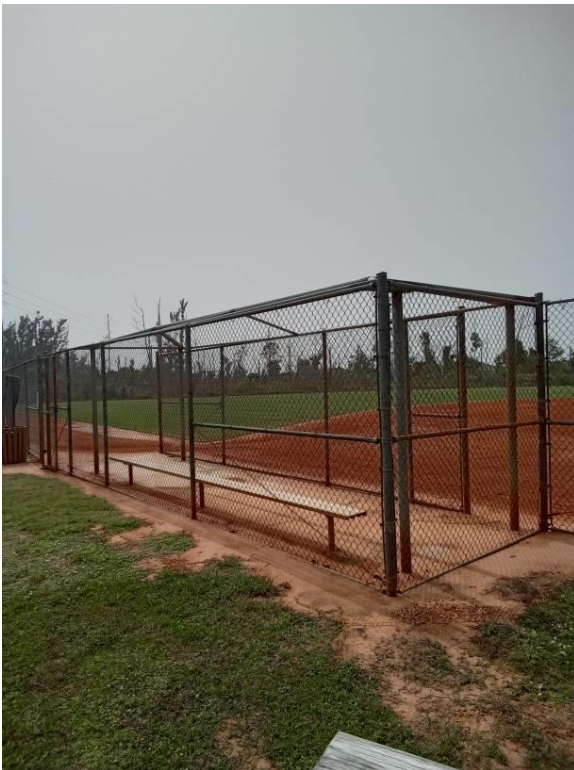
(18)

**Created:** Tue 03 Oct 14:07 2023  
**Group:** Softball (F5)  
**Cause of Damage:** Wind/Wind-Borne Debris  
**GPS Lat/Long:** 26.92791,  
-82.02165

Dugout Structure (I)

Missing shade.

Approximate shade dimensions 29' L x 10' W

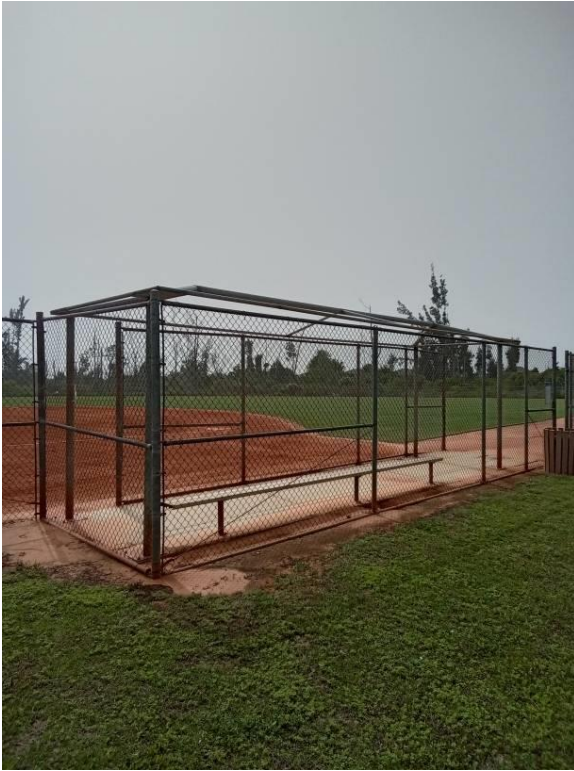
(19)

**Group:** Softball (F5)  
**Cause of Damage:** Wind/Wind-Borne Debris  
**GPS Lat/Long:** 26.92819,  
-82.02186

**Component Description:**  
Dugout Structure (J)

Missing shade.

Approximate shade dimensions 29' L x 10' W

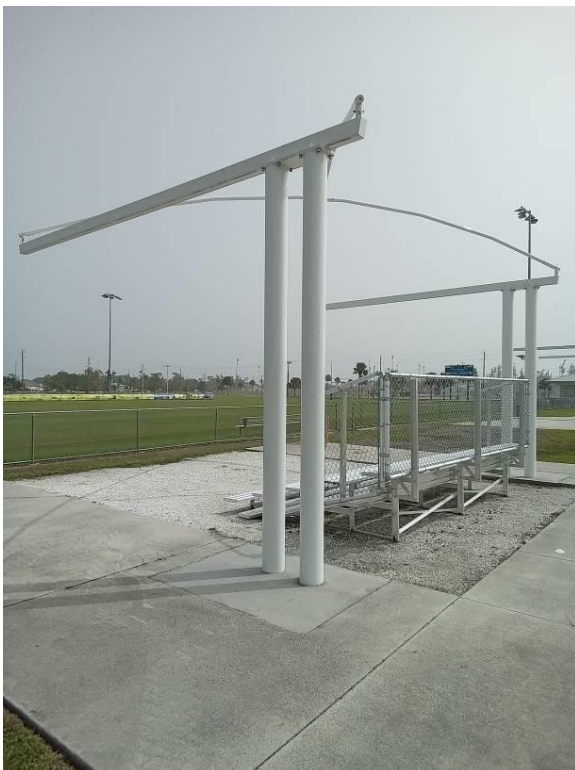
(20)

**Created:** Tue 03 Oct  
14:48 2023  
**Group:** Football Fields  
**Cause of Damage:** Wind/Wind-Borne Debris  
**GPS Lat/Long:** 26.93101,  
-82.02120

**Component Description:**  
Offset Cantilever Shade Structure  
(A).

Missing shade fabric

Approximate shade dimensions 25' L x 20' W

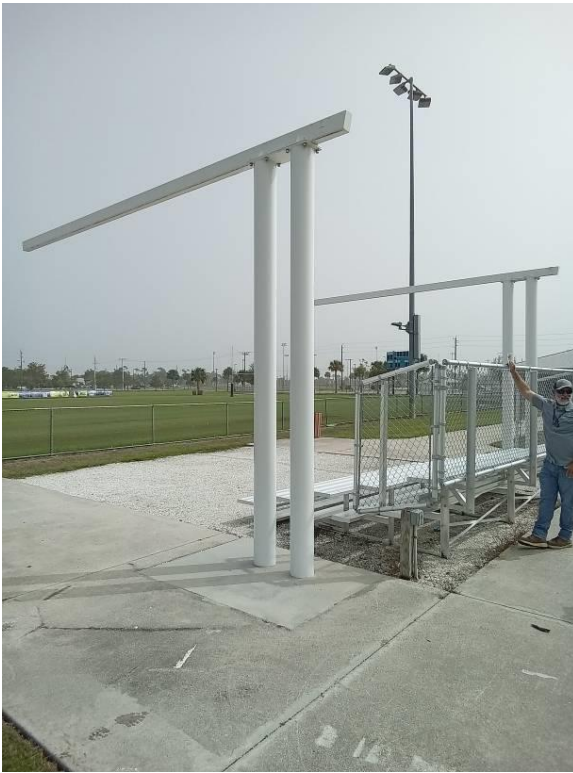
(21)

**Group:** Football Fields  
**Cause of Damage:** Wind/Wind-Borne Debris  
**GPS Lat/Long:** 26.93079,  
-82.02121

**Component Description:**  
Offset Cantilever Shade Structure  
(B).

Missing shade fabric

Approximate shade dimensions 25' L x 20' W
