**Site Inspection Report for  
Charlotte County –  
Ann & Chuck Dever Regional Park &  
Community Pool Splash Pad  
Florida Hurricane Ian (DR-4673-FL)**

**Site Inspection Report for  
Charlotte County –  
Carmalita Park  
Florida Hurricane Ian (DR-4673-FL)**

**Site Inspection Report for  
Charlotte County –  
Centennial Park Campus  
Florida Hurricane Ian (DR-4673-FL)**

**Site Inspection Report for  
Charlotte County –  
Rotonda Park  
Florida Hurricane Ian (DR-4673-FL)**

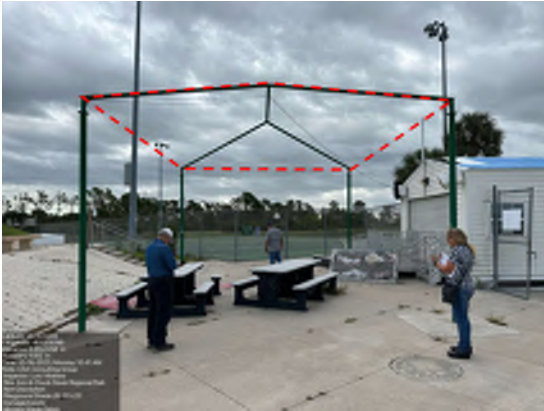
(1)

**Group:** Skateboard Park Shade & Structure A

**Cause of Damage:** High Winds

Overview Photo of Shade Structure

- Shade Structure (20' x 25')
- (4) 12' Posts (above grade)
- (4) Rail Beams
- (2) Sleeve(s)
- Approximate shade dimensions 25' L x 20' W

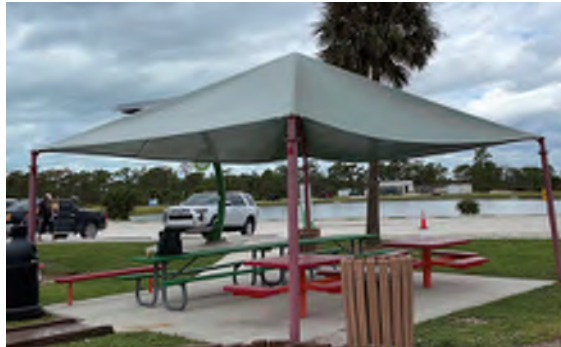
(2)

**Group:** Playground Picnic Shade & Structure B

**Cause of Damage:** High Winds

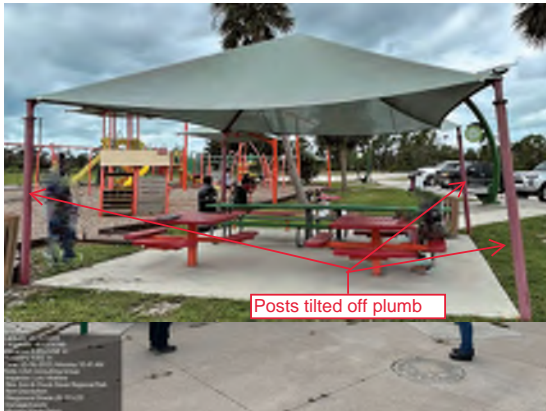
(3)

**Created:** Mon 16 Oct 10:41 2023  
**Group:** Playground Picnic Shade & Structure B  
**GPS Lat/Lon:** 26.91977, -82.31475  
**Cause of Damage:** High Winds  
**Component Description:**

Approximately 400 SF of BCI Burke® ShadePlay  
Canopy Square shaped fabric,

Approximate shade dimensions 20' L x 20' W

4 each of BCI Burke® Play Systems  
Galvanized steel tube posts and  
associated footings, Approximately 14 FT long x 8  
IN in diameter

4 each of BCI Burke® Play Systems  
Galvanized steel tube top shade  
connector arms, Approximately 13 FT long x 5 IN in  
diameter

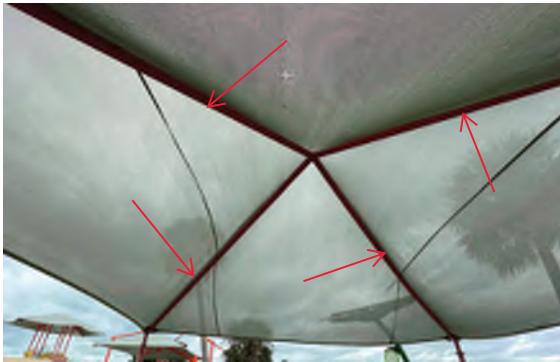
(4)

**Created:** Mon 16 Oct 10:41 2023  
**Group:** Playground Picnic Shade & Structure B  
**GPS Lat/Lon:** 26.91977, -82.31475  
**Cause of Damage:** High Winds  
**Component Description:**

Approximately 400 SF of BCI Burke® ShadePlay  
Canopy Square shaped fabric,

Approximate shade dimensions 20' L x 20' W

4 each of BCI Burke® Play Systems  
Galvanized steel tube posts and  
associated footings, Approximately 14 FT long x 8  
IN in diameter

4 each of BCI Burke® Play Systems  
Galvanized steel tube top shade  
connector arms, Approximately 13 FT long x 5 IN in  
diameter

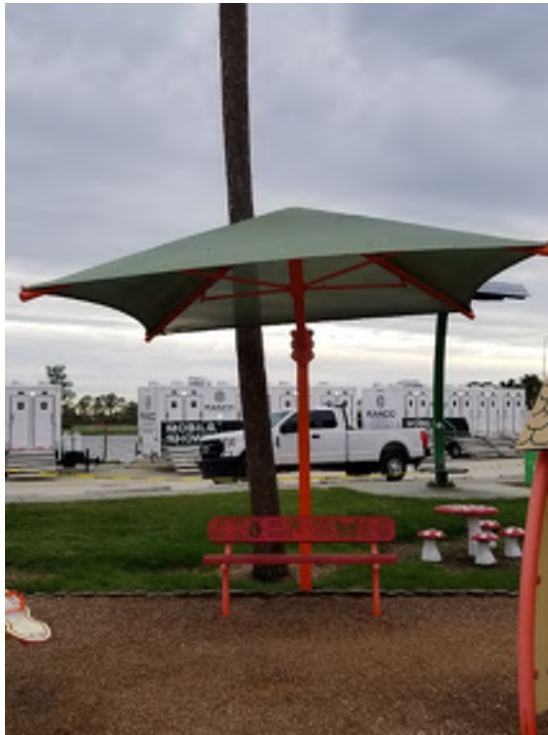
(5)

**Group:** Umbrella Shade and Structure C

**Cause of Damage:** High Winds

approximate shade dimension 15 FT long x 15 FT wide

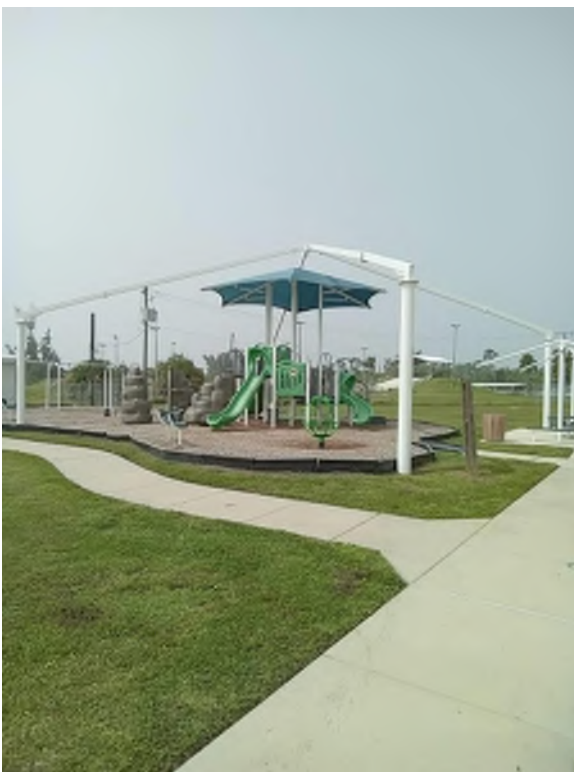
(2)

**Group:** Playground Mega Shade  
and Structure A  
**Cause of Damage:** Wind/Wind-  
Borne Debris  
**GPS Lat/Long:** 26.92834, -82.02115

**Component Description:**  
MegaSpan shade structure missing.

10" Diameter Posts - Center post  
22' to top

Approximate shade dimensions 50' L x 50' W

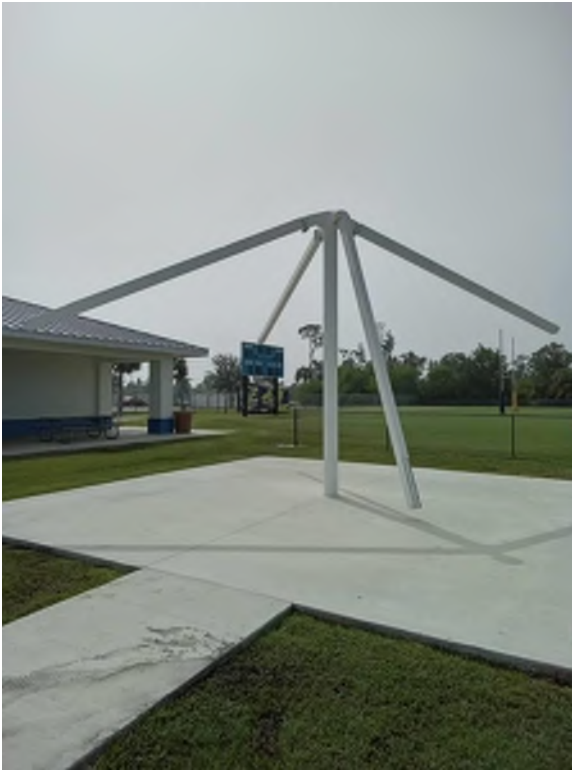
(3)

**Group:** Football Field Umbrella Shade and Structure A  
**Cause of Damage:** Wind/Wind-Borne Debris  
**GPS Lat/Long:** 26.93039, -82.02129

**Component Description:**  
Umbrella Shade(10). Structural damage at the arm. Shade missing. Bolts and nuts have stress bends.

Approximate shade dimensions 20' L x 20' W

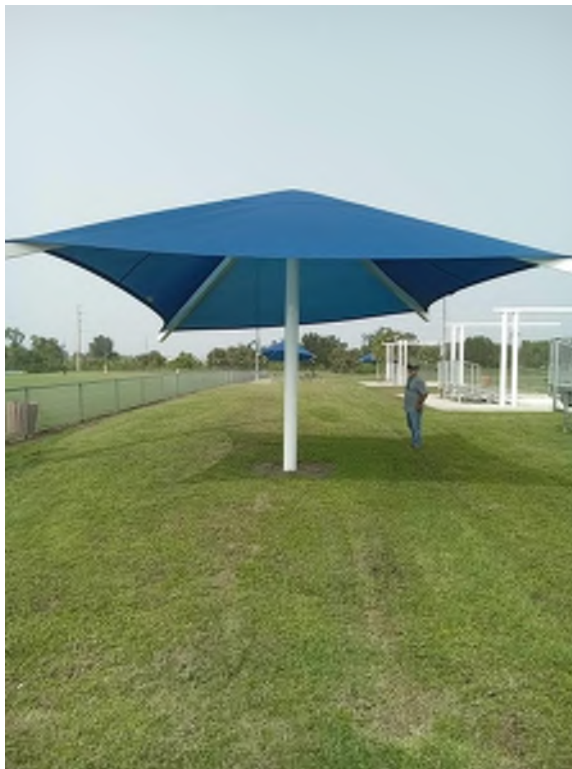
(4)

**Created:** Tue 03 Oct  
**Group:** Football Field Umbrella Shade and Structure B  
**Cause of Damage:** Wind/Wind-Borne Debris  
**GPS Lat/Long:** 26.93065, -82.02134

**Component Description:**  
Sustain tensional bends at one arm.

Approximate shade dimensions 20' L x 20' W

5' x 5' x 5' concrete foundation under grade.

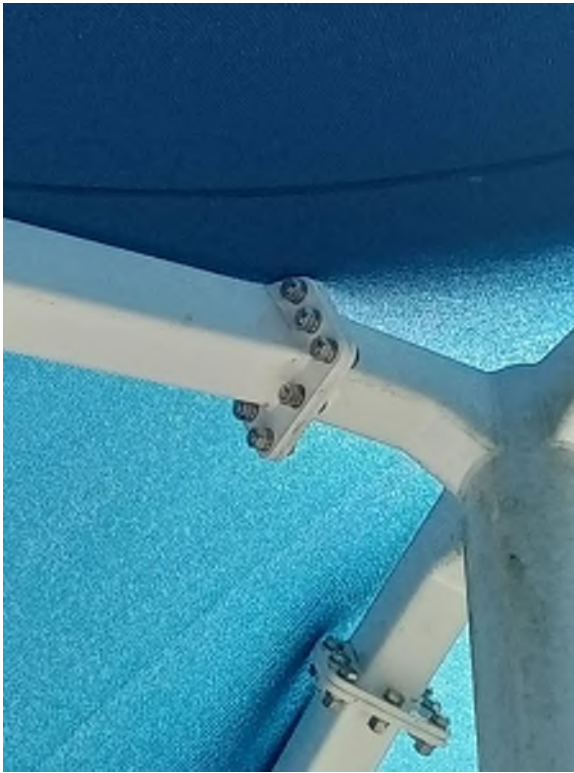
**Group:** Football Field Umbrella Shade and Structure C  
**Cause of Damage:** Wind/Wind-Borne Debris  
**GPS Lat/Long:** 26.93129, -82.02122

**Component Description:**  
Stress bend at East Arm. (5) bent bolts.

Approximate shade dimensions 20' L x 20' W

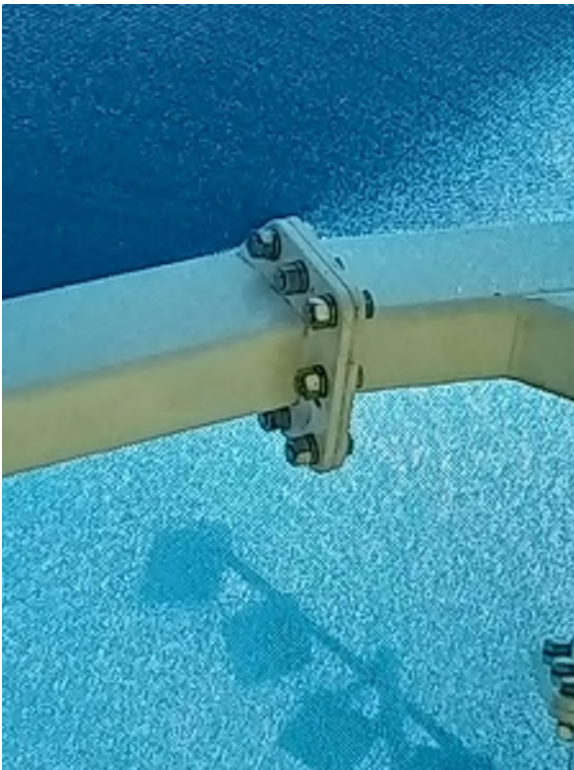
(6)

**Created:** Tue 03 Oct  
**Group:** Football Field Umbrella Shade and Structure D  
**Cause of Damage:** Wind/Wind-Borne Debris  
**GPS Lat/Long:** 26.93107, -82.021342

**Component Description:**  
Bent arm.

Approximate shade dimensions 20' L x 20' W

5' x 5' x 5' concrete foundation under grade.

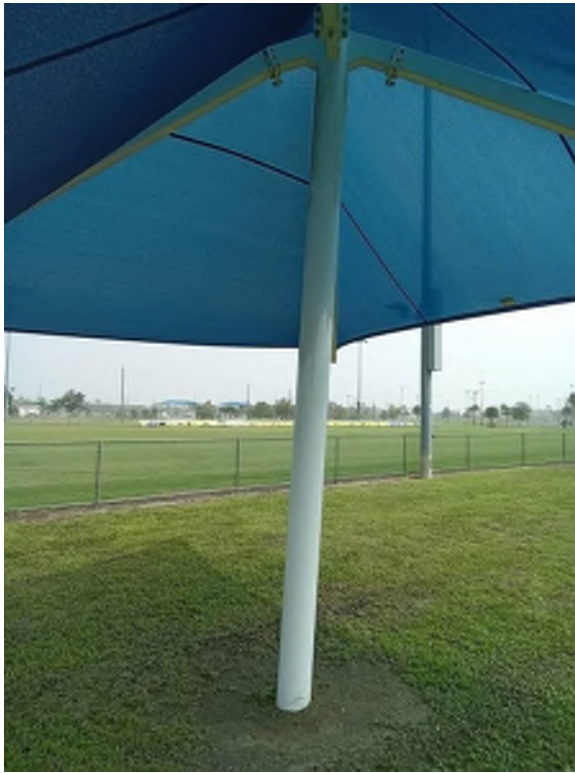
(7)

**Group:** Football Field Umbrella Shade and Structure D  
**Cause of Damage:** Wind/Wind-Borne Debris  
**GPS Lat/Long:** 26.93107, -82.021342

Main support post bent.

Approximate shade dimensions 20' L x 20' W

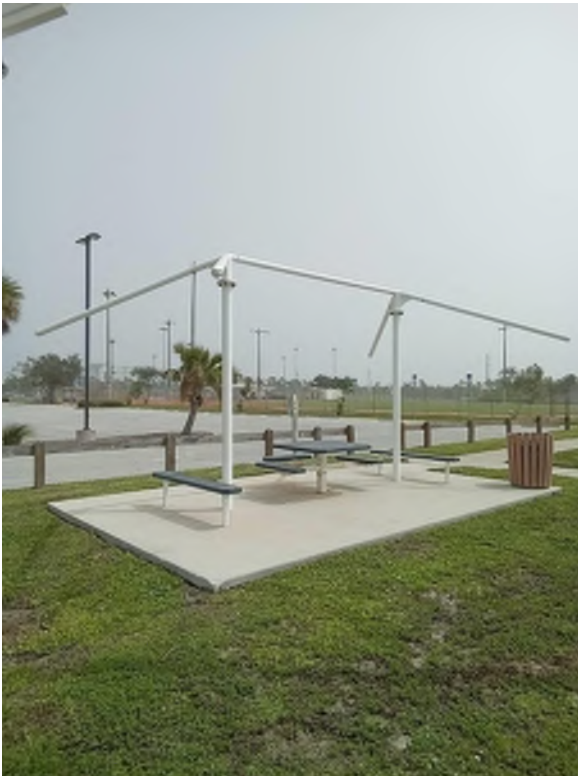
(8)

**Created:** Tue 03 Oct 13:55 2023  
**Group:** Playground Picnic Area Shade and Structure A  
**Cause of Damage:** Wind/Wind-Borne Debris  
**GPS Lat/Long:** 26.92834, -82.02115

Rectangular Shade

Approximate shade dimensions 22' L x 15' W

Angle sleeve  
4" pipe from sleeve

Missing shade.

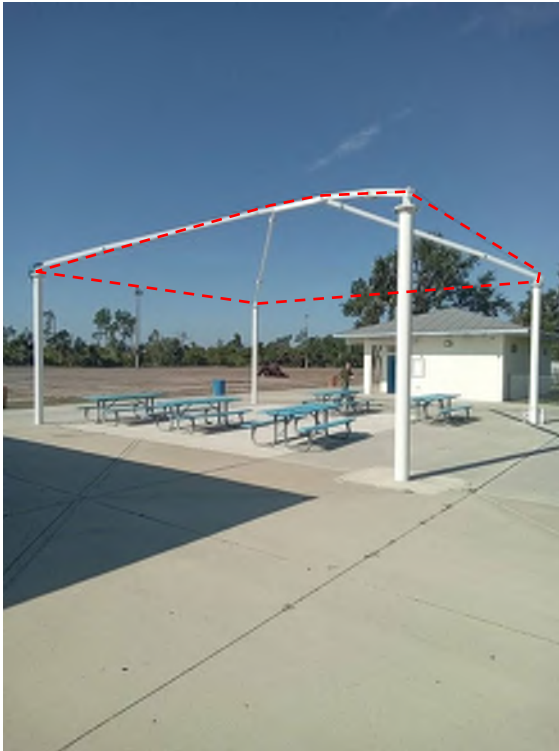
(1.)

**Created:** Wed 13 Sep 09:57 2023  
**Group:** Soccer Field Mega Span Shade & Structure A  
 (Super Dome Hip Shade)  
**GPS Lat/Lon:** 27.00855, -82.17830  
**Cause of Damage:** Wind/Wind-Borne  
 Debris

Approximate shade dimensions 35.5' L x 30' W

8" diameter steel pipe apparently did not experience any win driven damage or bends.

Missing (2) steel tensile cables, and the fabric was blue in colour.

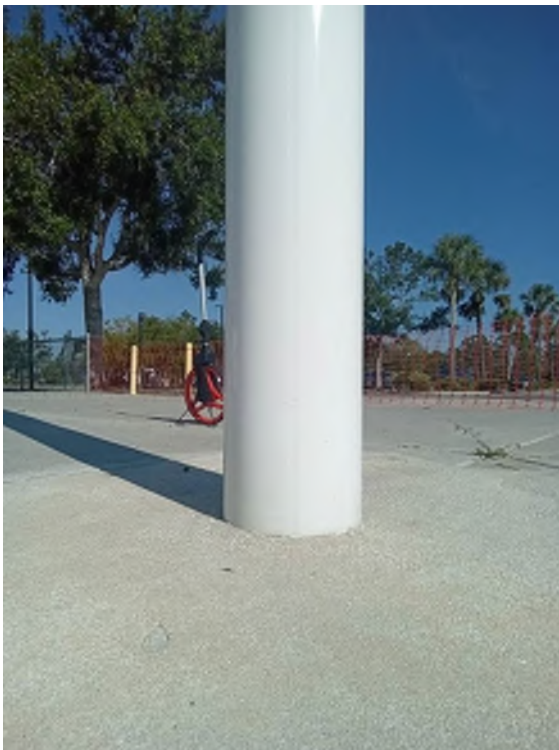
(2.)

**Created:** Wed 13 Sep 10:01 2023  
**Group:** Soccer Field Mega Span Shade & Structure A  
**GPS Lat/Lon:** 27.00855, -82.17830  
**Cause of Damage:** N/A  
**Component Description:**

Approximate shade dimensions 35.5' L x 30' W

8" diameter steel pipe apparently did not experience any win driven damage or bends.

Missing (2) steel tensile cables, and the fabric was blue in colour.

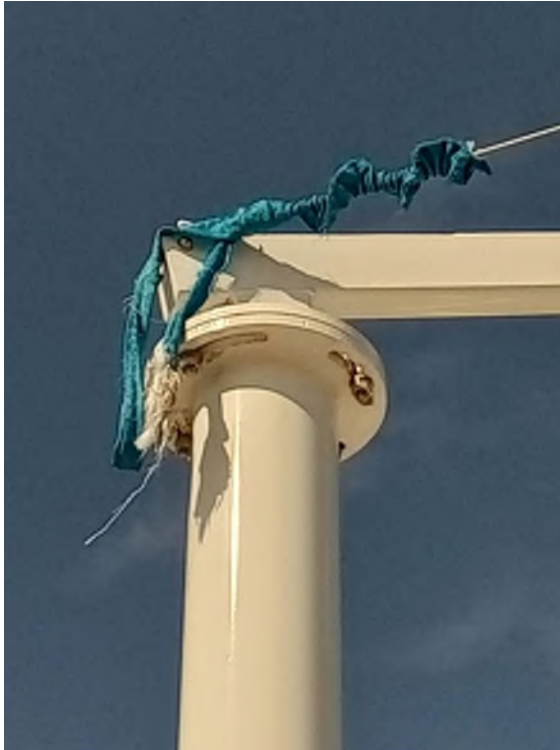
(3.)

**Created:** Wed 13 Sep 10:02 2023  
**Group:** Soccer Field Mega Span Shade & Structure A  
**GPS Lat/Lon:** 27.00855, -82.17830  
**Cause of Damage:** Wind/Wind-Borne  
 Debris  
**Component Description:**

8" diameter steel pipe apparently did not experience any win driven damage or bends.

Missing (2) steel tensile cables, and the fabric was blue in colour.

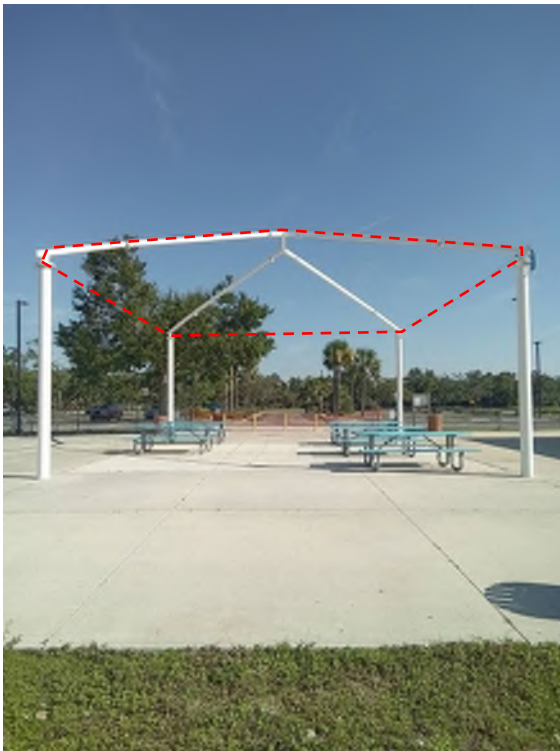
(4.)

**Created:** Wed 13 Sep 10:05 2023  
**Group:** Soccer Field Mega Span Shade & Structure A  
**GPS Lat/Lon:** 27.00855, -82.17830  
**Cause of Damage:** Wind/Wind-Borne  
 Debris  
**Component Description:**

8" diameter steel pipe apparently did not experience any win driven damage or bends.

Missing (2) steel tensile cables, and the fabric was blue in colour.

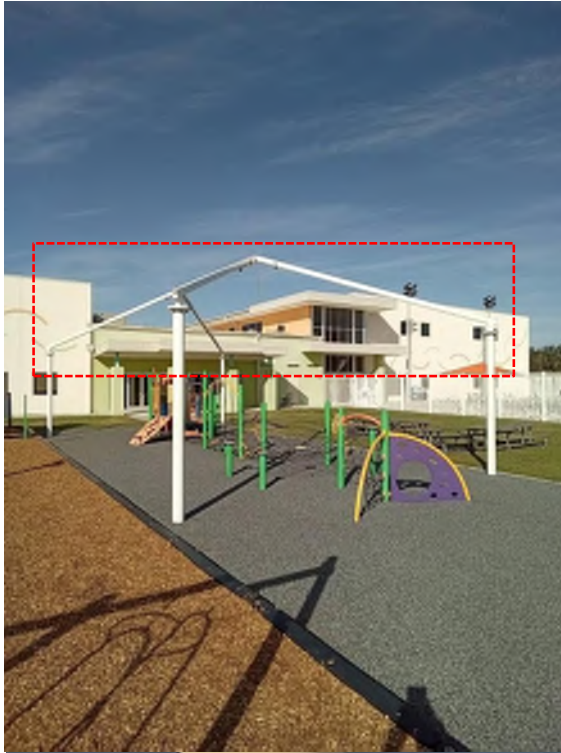
(5.)

**Created:** Wed 13 Sep 10:02 2023  
**Group:** Playground Mega Shade & Structure D  
**GPS Lat/Lon:** 27.01396, -82.17404  
**Cause of Damage:** Wind/Wind-Borne  
Debris

CoolNet Aquatic Blue fabric and cables  
for an R2345 Playground Shade, includes  
hardware

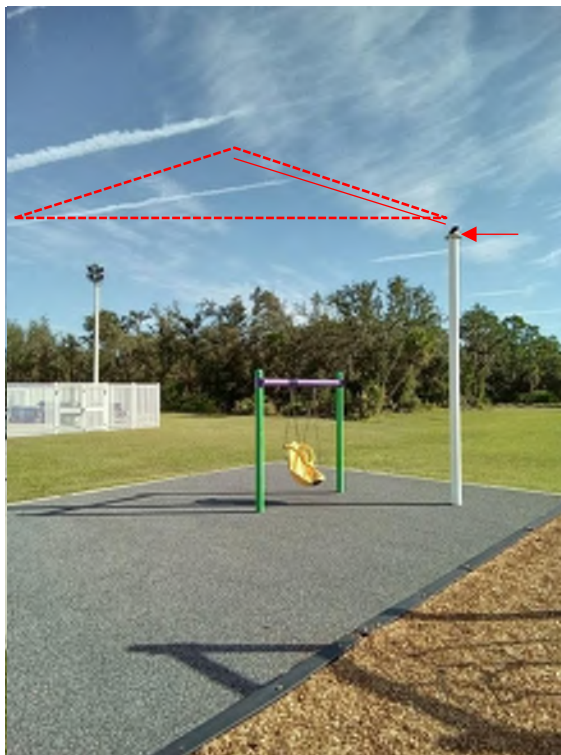
(6.)

**Created:** Wed 13 Sep 10:05 2023  
**Group:** Playground Single Post Shade & Structure A  
**GPS Lat/Lon:** 27.01393, -82.17388  
**Cause of Damage:** Wind/Wind-Borne  
Debris

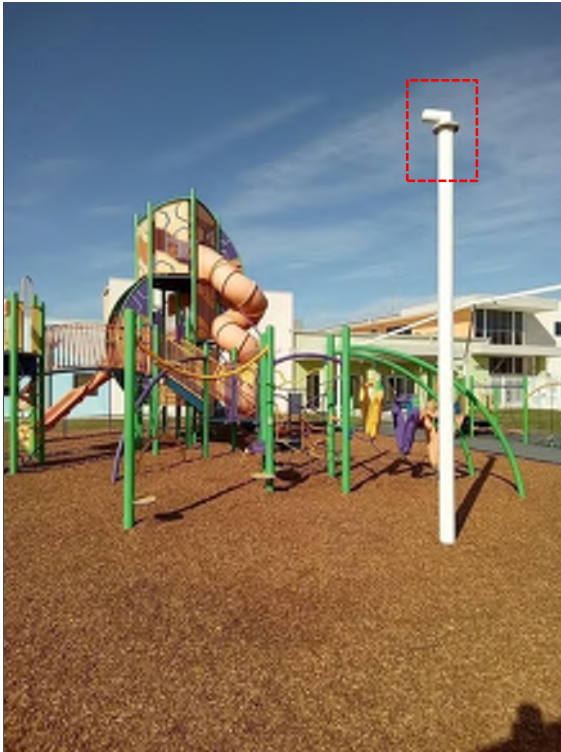
(7.)

**Created:** Wed 13 Sep 10:02 2023  
**Group:** Playground Offset Shade & Structure B  
**GPS Lat/Lon:** 27.01378, -82.17403  
**Cause of Damage:** Wind/Wind-Borne  
 Debris

Offset single post pyramid with shade and hardware.

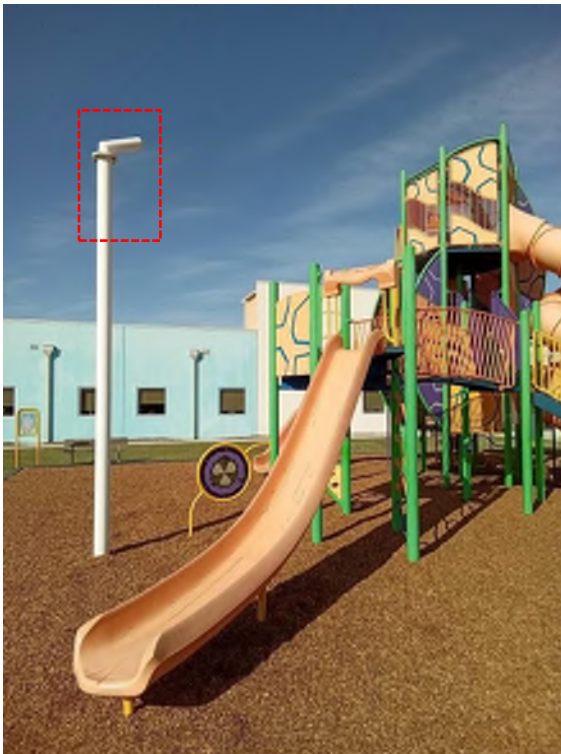
(8.)

**Created:** Wed 13 Sep 10:05 2023  
**Group:** Playground Offset Shade & Structure C  
**GPS Lat/Lon:** 27.01378, -82.17403  
**Cause of Damage:** Wind/Wind-Borne  
 Debris

Offset single post pyramid with shade and hardware.

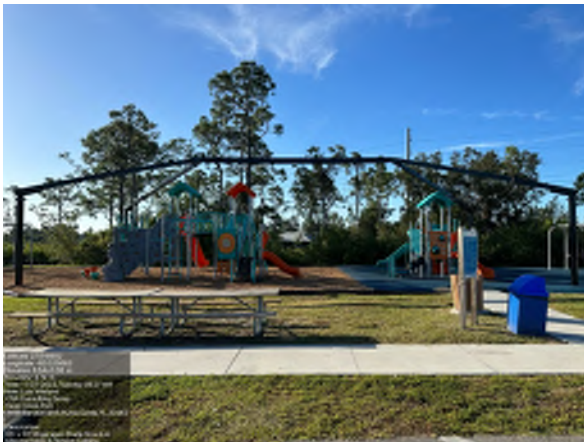
**Created:** Tue 07 Nov 08:27 2023  
**Group:** Playground Mega Shade & Structure (A)  
**GPS Lat/Lon:** 27.01669, -82.02577  
**Cause of Damage:** High Winds  
**Component Description:**  
Mega Span Shade Structure suffered a large wind event which separated its fabric shade during the high wind event of hurricane Ian.

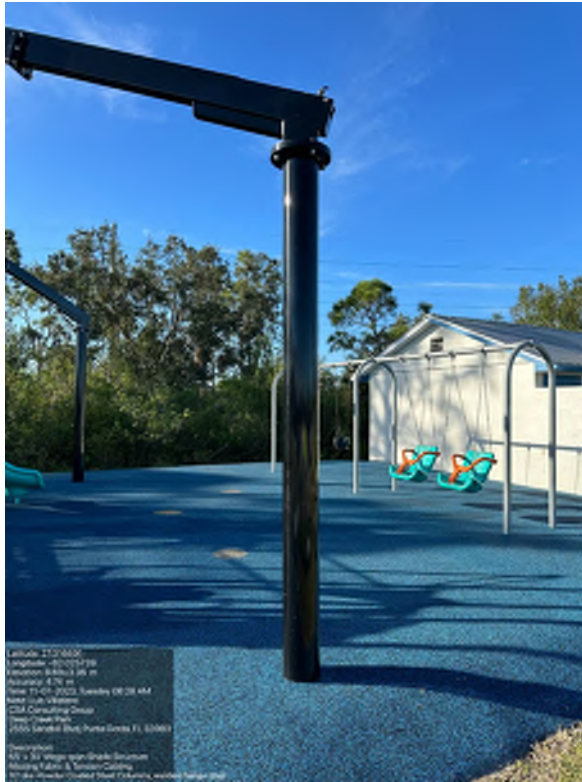
**Created:** Tue 07 Nov 08:28 2023  
**Group:** Playground Mega Shade & Structure (A)  
**GPS Lat/Lon:** 27.01669, -82.02577  
**Cause of Damage:** High Winds  
**Component Description:**  
Dimensions: (4) 10' Dia. Powder Coated Steel Column, High Quality Finish, Welded flange (top), (4) 4' x 4' x 3' CIP Footer(s), #5 Rebar, (16) 1-inch Bolt, Nut, Washer(s)

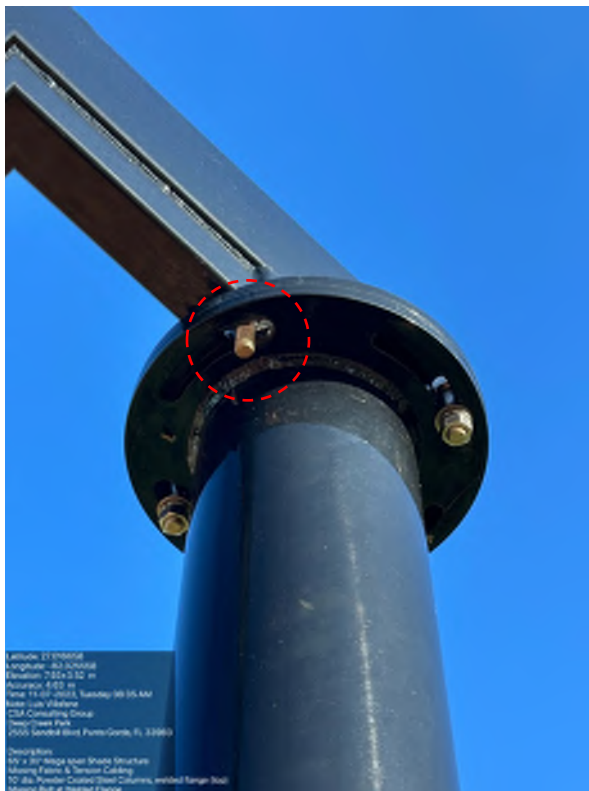
**Created:** Tue 07 Nov 08:35 2023  
**Group:** Playground Mega Shade & Structure (A)  
**GPS Lat/Lon:** 27.01669, -82.02577  
**Cause of Damage:** High Winds  
**Component Description:**  
Photo depicts (1) nut & washer missing from high tension vibrational stresses during the event.

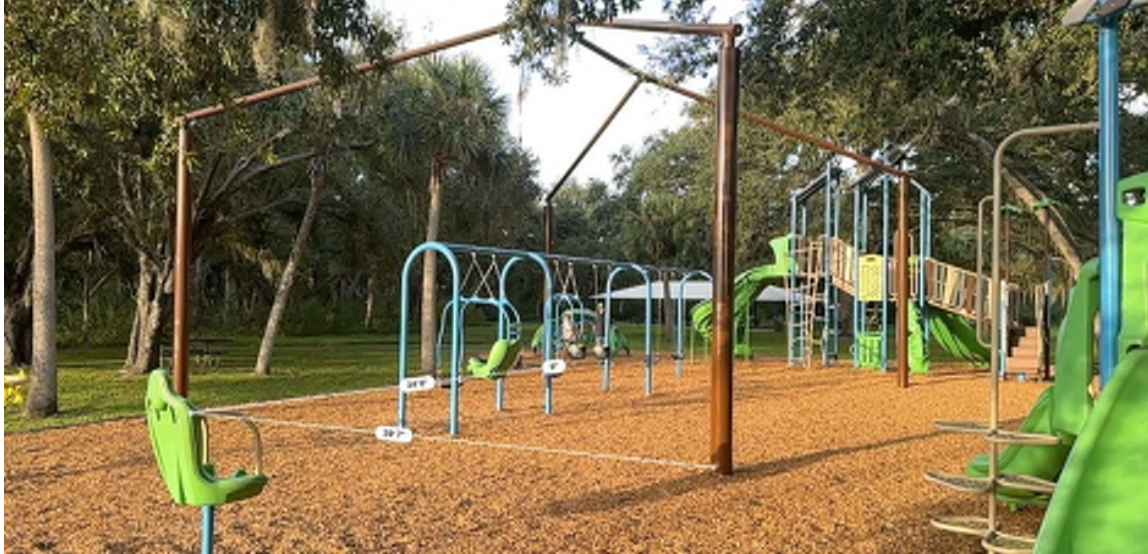
**Created:** Tue 24 Oct 08:24 2023  
**Group:** Playground Shade Structure (A)  
**GPS Lat/Lon:** 27.00878, -82.12923  
**Cause of Damage:** Wind  
**Component Description:**  
 Playground Mega Shade and Structure A. Approximate shade dimensions 35' L x 30' W  
 9" diameter columns. Missing shade fabric.

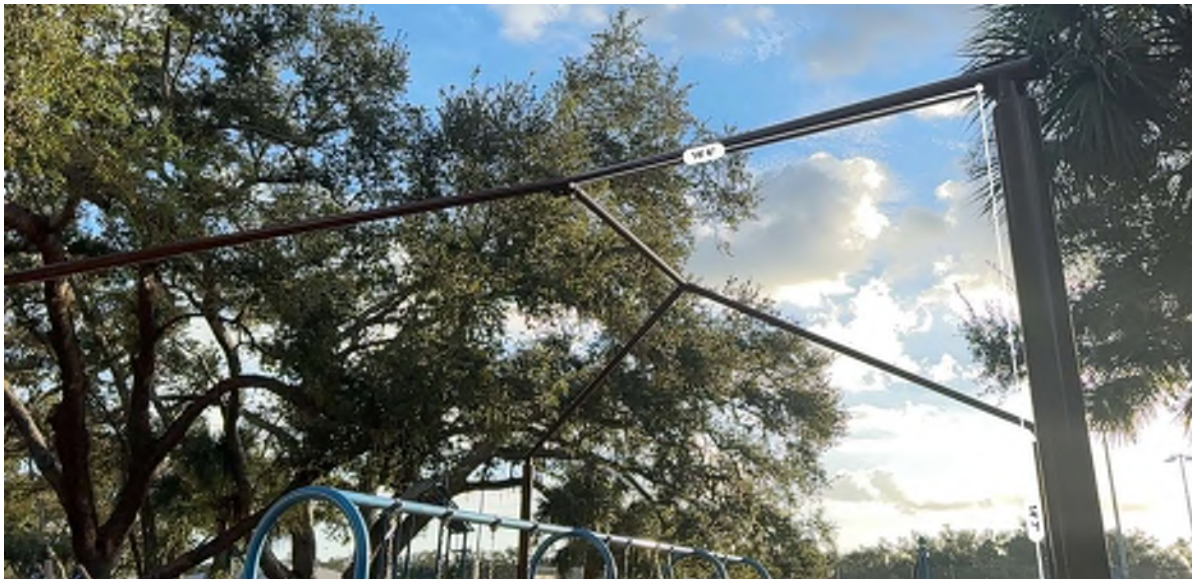
(2)

**Created:** Tue 24 Oct 08:26 2023  
**Group:** Playground Mega Shade and Structure A  
**GPS Lat/Lon:** 27.00878, -82.12923  
**Cause of Damage:** Wind  
**Component Description:** Refer to Photo (1).

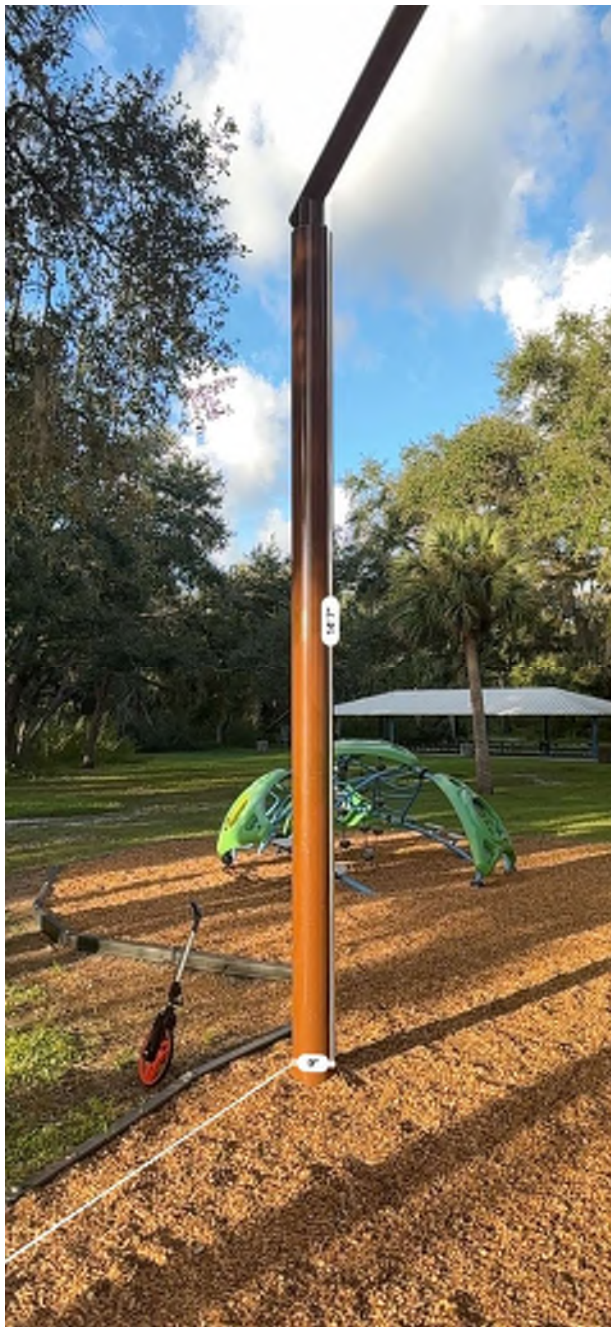
(3)

**Created:** Tue 24 Oct 08:28 2023  
**Group:** Playground Mega Shade and Structure A  
**GPS Lat/Lon:** 27.00875, -82.12923  
**Cause of Damage:** Wind  
**Component Description:**  
Refer to Photo (1).

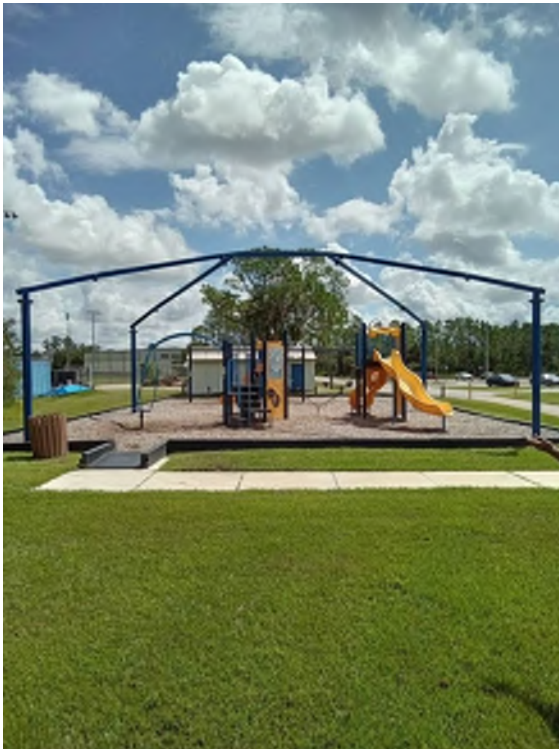
**Created:** Thu 21 Sep 12:14 2023  
**Group:** Baseball Field 4  
Shade & Structure A  
**GPS Lat/Lon:** 27.01454, -82.06127  
**Cause of Damage:** High Winds  
**Component Description:**  
4-column mega span shade structure  
fabric missing.

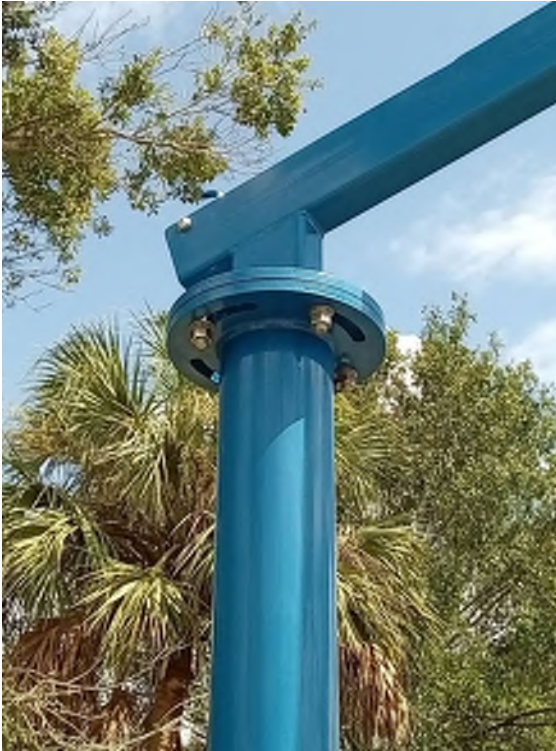
**Created:** Thu 21 Sep 12:19 2023  
**Group:** Baseball Field 4  
 Shade & Structure A  
**GPS Lat/Lon:** 27.01454, -82.06127  
**Cause of Damage:** High Winds  
**Component Description:**  
 4-column mega span shade structure  
 fabric missing.  
 5" wide columns.

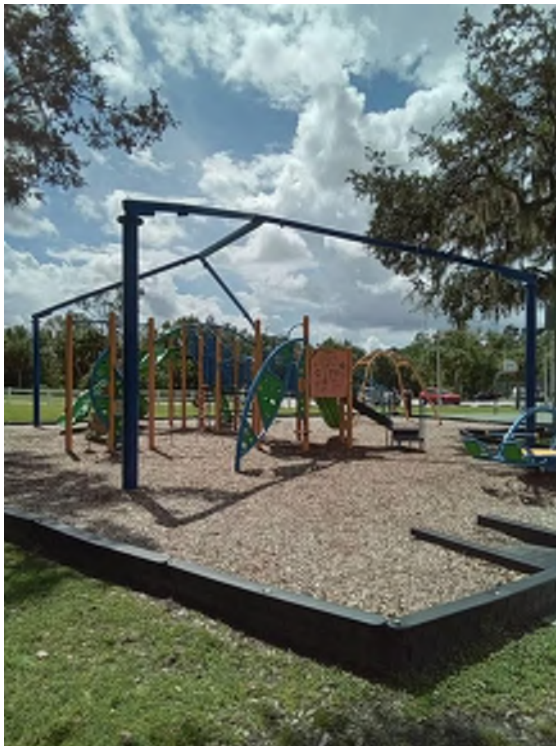
**Created:** Thu 21 Sep 12:19 2023  
**Group:** Tennis Court Playground Shade  
 and Structure A  
**GPS Lat/Lon:** 27.01436, -85.05825  
**Cause of Damage:** High Winds  
**Component Description:**  
 Shade Structure Missing Fabric.

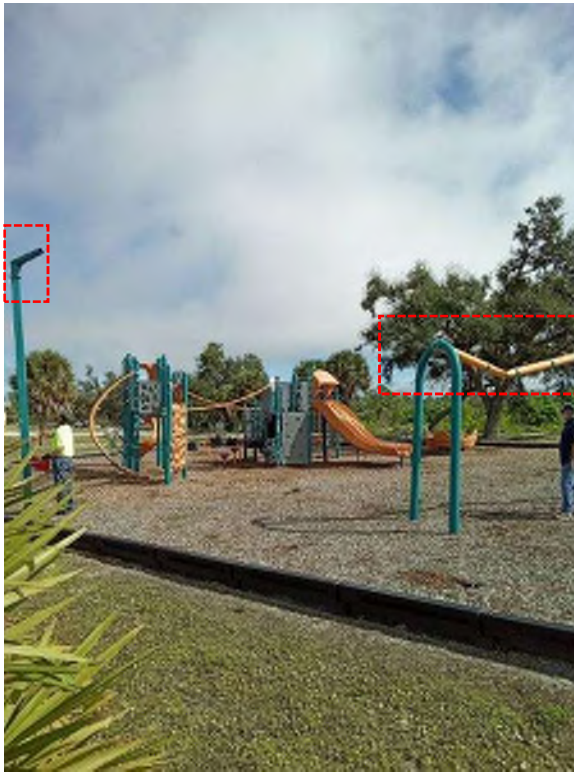
**Created:** Fri 17 Nov 11:40 2023  
**Group:** Playground Shade and Structure (A)  
**GPS Lat/Lon:** 26.89140, -82.26998  
**Cause of Damage:** High Winds  
and Windborne Debris

Overview of damaged rectangular Shade Structure (A) and Swing Set (A) from fallen tree/windborne debris. Complete displacement of Shade Structure, only (1) column remains.

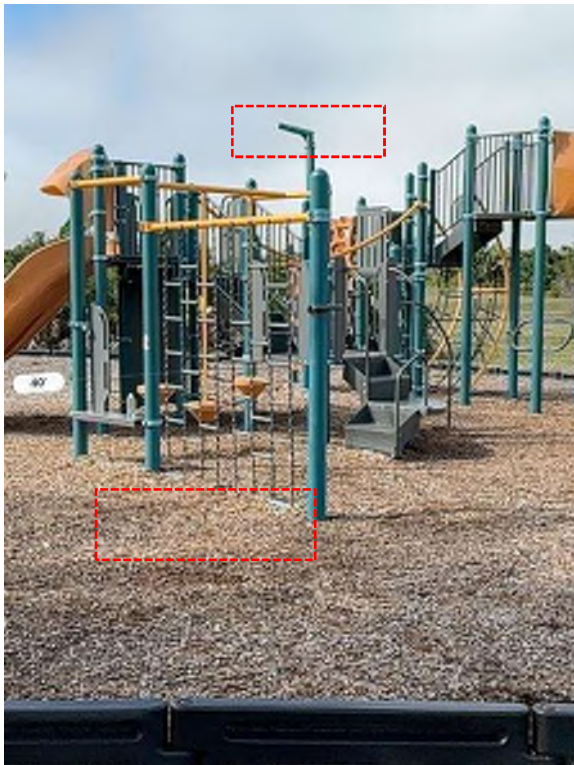
**Created:** Fri 17 Nov 11:44 2023  
**Group:** Playground Shade and Structure (A)  
**GPS Lat/Lon:** 26.89140, -82.26998  
**Cause of Damage:** High Winds

Overview of Playground (A), counter angle depicts missing structure and shade fabric.

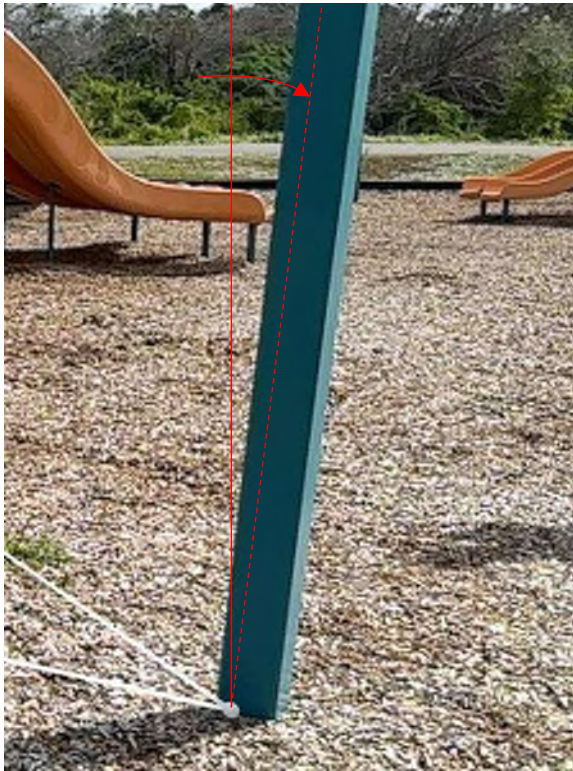
**Created:** Fri 17 Nov 11:47 2023  
**Group:** Playground Shade and Structure A  
**GPS Lat/Lon:** 26.89140, -82.26998  
**Cause of Damage:** High Winds  
**Component Description:**  
Close-up of Playground (A) remaining column, photo depicts the column to be Off Center as seen.

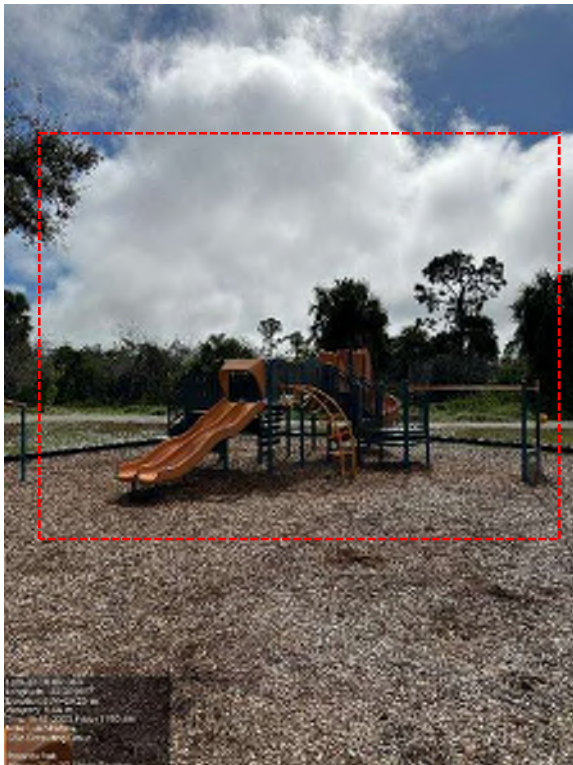
(4)

**Created:** Fri 17 Nov 11:50 2023  
**Group:** Playground Shade and Structure B  
**GPS Lat/Lon:** 26.89125, -82.26994  
**Cause of Damage:** High Winds  
**Component Description:**  
Overview of Playground (B), counter angle depicts missing structure and shade fabric.  
Approximate shade dimensions 24' L x 24' W  
4 each of Tubular Galvanized Steel Posts - 5IN diameter, 12 FT high  
4 each of Galvanized Steel Tubular Rail Arms, 12 FT long x 5 IN in diameter

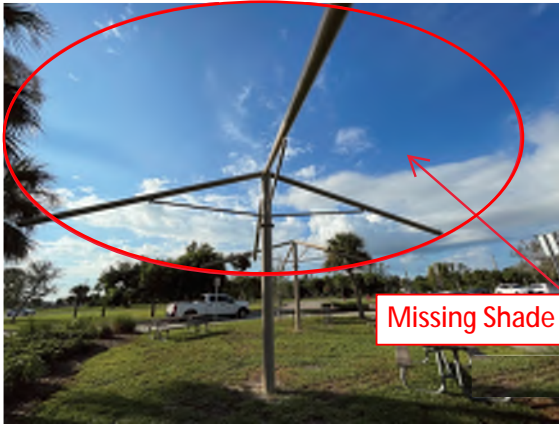
(1)

**Created:** Mon 18 Sep 2023  
**Group:** Picnic Area Shade and Structure A  
**GPS Lat/Lon:** 26.93264, -82.03697  
**Cause of Damage:** Wind/Windborne  
Debris

**Component Description:**  
High density polyethylene with  
ultraviolet (U.V.) Shade Canopies for  
Umbrella Shade Structure.

Approximate shade dimensions 20' L x 20' W

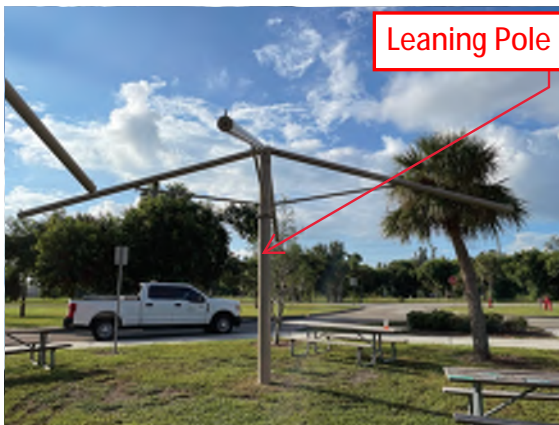
(2)

**Created:** Mon 18 Sep 2023  
**Group:** Picnic Area Shade and Structure B  
**GPS Lat/Lon:** 26.93264, -82.03697  
**Cause of Damage:** Wind/Windborne  
Debris

**Component Description:**  
High density polyethylene with  
ultraviolet (U.V.) Shade Canopies for  
Umbrella Shade Structure.

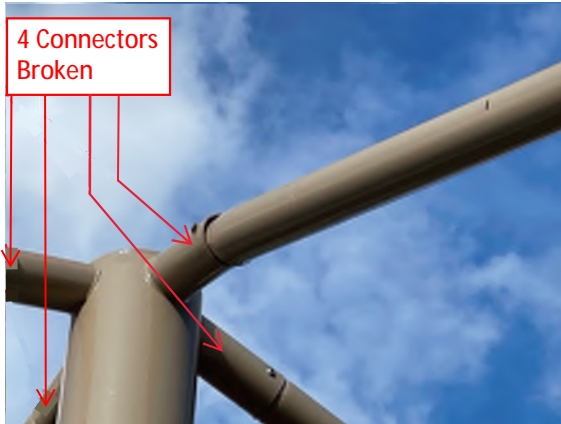
(3)

**Created:** Mon 18 Sep 2023  
**Group:** Picnic Area Shade and Structure C  
**GPS Lat/Lon:** 26.93264, -82.03697  
**Cause of Damage:** Wind/Windborne  
Debris

**Component Description:**  
High density polyethylene with  
ultraviolet (U.V.) Shade Canopies for  
Umbrella Shade Structure. Umbrella Metal  
Pole Cap (4 Connectors).

Approximate shade dimensions 20' L x 20' W

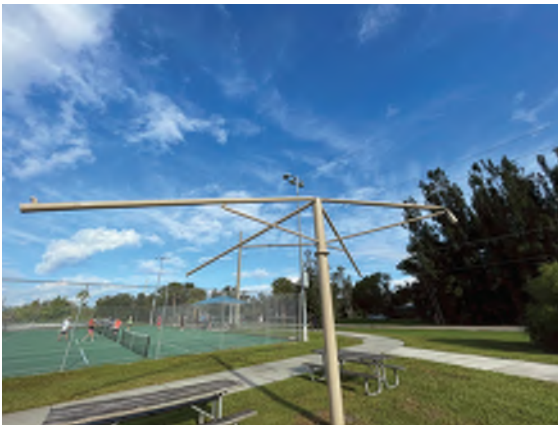
(4)

**Created:** Mon 18 Sep 2023  
**Group:** Picnic Area Shade and Structure C  
**GPS Lat/Lon:** 26.93264, -82.03697  
**Cause of Damage:** Wind/Windborne  
Debris

**Component Description:**  
High density polyethylene with  
ultraviolet (U.V.) Shade Canopies for  
Umbrella Shade Structure.

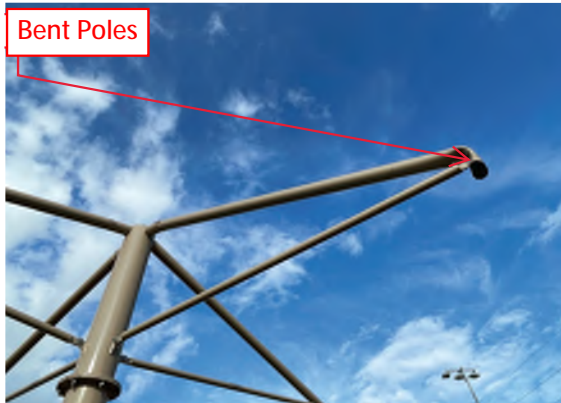
(5)

**Created:** Mon 18 Sep 2023  
**Group:** Picnic Area Shade and Structure D  
**GPS Lat/Lon:** 26.93264, -82.03697  
**Cause of Damage:** Wind/Windborne  
Debris

**Component Description:**  
High density polyethylene with  
ultraviolet (U.V.) Shade Canopies for  
Umbrella Shade Structure. Umbrella Metal  
Pole Supports.

Approximate shade dimensions 20' L x 20' W

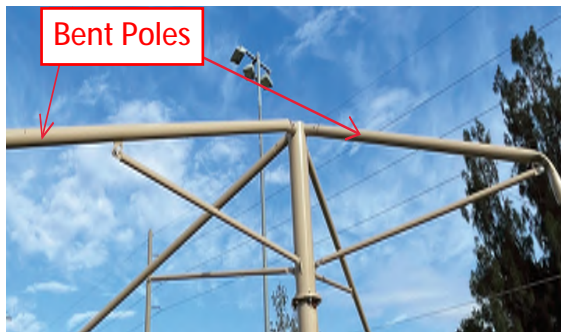
(6)

**Created:** Mon 18 Sep 2023  
**Group:** Picnic Area Shade and Structure D  
**GPS Lat/Lon:** 26.93264, -82.03697  
**Cause of Damage:** Wind/Windborne  
Debris

**Component Description:**  
High density polyethylene with  
ultraviolet (U.V.) Shade Canopies for  
Umbrella Shade Structure. Umbrella Metal  
Pole Supports.

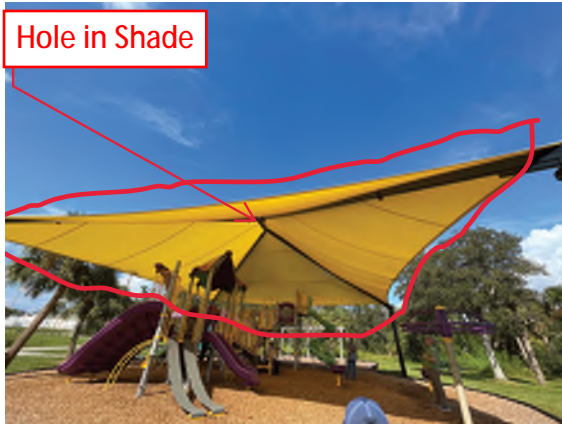
(7)

**Created:** Mon 18 Sep 2023  
**Group:** Playground Shade & Structure A  
**GPS Lat/Lon:** 26.93406, -82.03550  
**Cause of Damage:** Wind/Windborne  
Debris

**Component Description:**  
High density polyethylene with ultra  
violet (U.V) shade canopy.

Approximate shade dimensions 50' L x 45' W

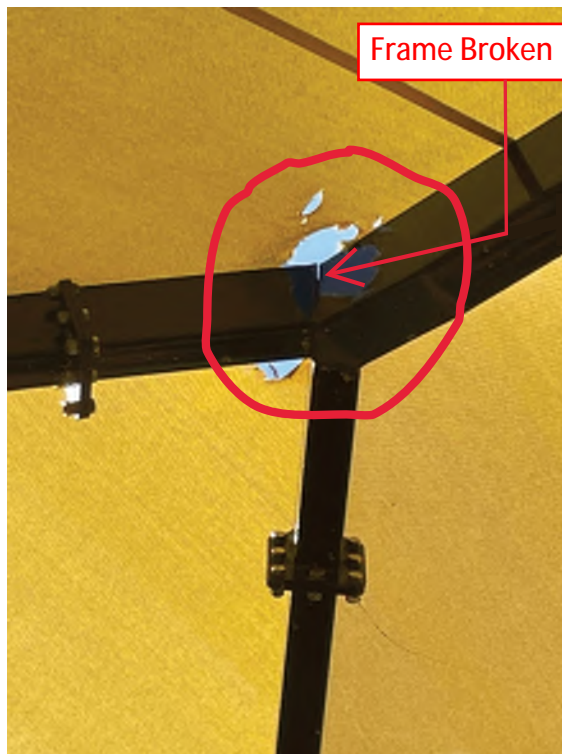
(8)

**Created:** Mon 18 Sep 2023  
**Group:** Playground Shade & Structure A  
**GPS Lat/Lon:** 26.93406, -82.03550  
**Cause of Damage:** Wind/Windborne  
Debris

**Component Description:**  
High density polyethylene with ultra  
violet (U.V) shade canopy.

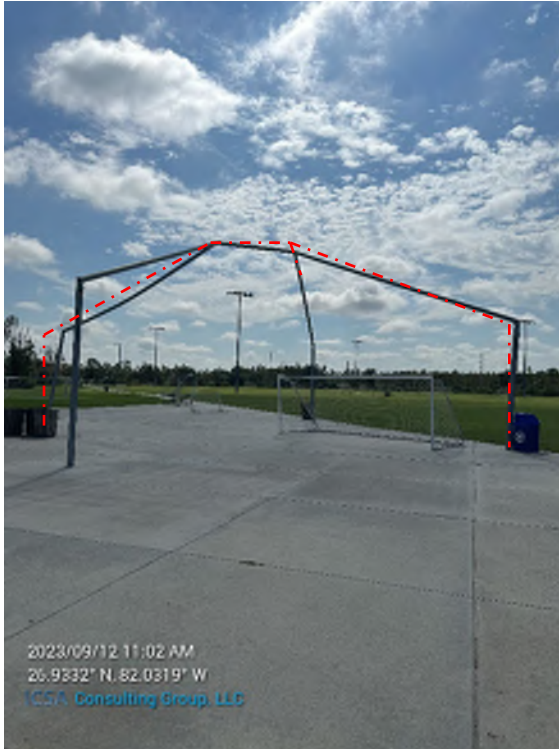
**Created:** Tue 12 Sep 11:02 2023  
**Group:** Soccer Field Shade & Structure A  
**GPS Lat/Lon:** 26.933314, -82.031727  
**Cause of Damage:** Wind/Windborne  
Debris

Soccer Field Shade Structure (A) has experienced a series of damages, as the shade structure appeared to be warped out of its original shape.

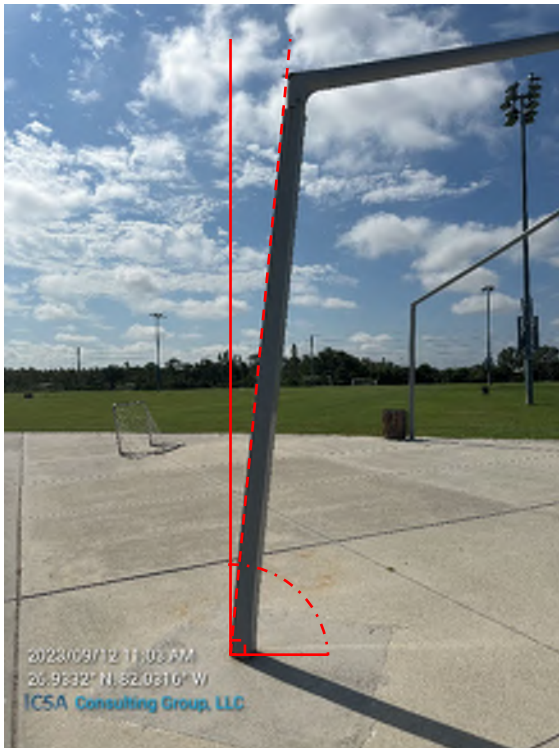
**Created:** Tue 12 Sep 11:03 2023  
**Group:** Soccer Field Shade & Structure A  
**GPS Lat/Lon:** 26.933150, -82.031572  
**Cause of Damage:** Wind/Windborne  
Debris

Soccer Field Shade Structure (A) has experienced a series of damages, as the shade structure appeared to be warped out of its original shape.

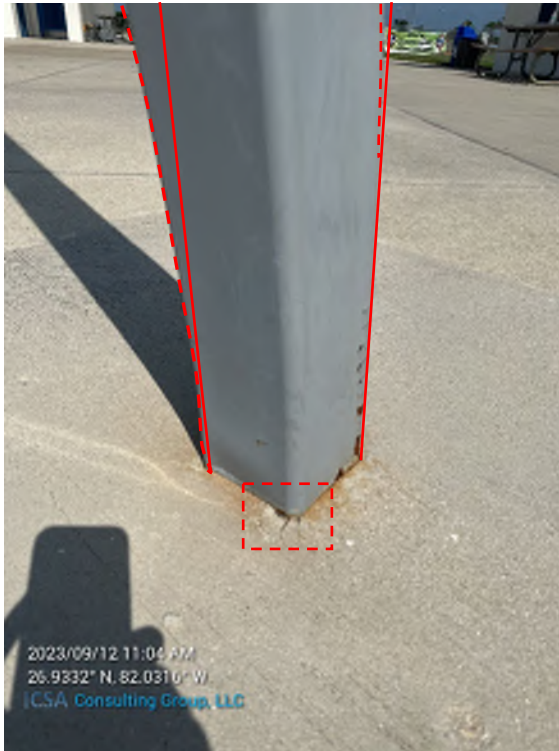
**Created:** Tue 12 Sep 11:04 2023  
**Group:** Soccer Field Shade & Structure A  
**GPS Lat/Lon:** 26.933150, -82.031572  
**Cause of Damage:** Wind/Windborne  
Debris

Soccer Field Shade Structure (A) has experienced a series of damages, as the shade structure appeared to be warped out of its original shape. In this depiction, stress points are visually observable.

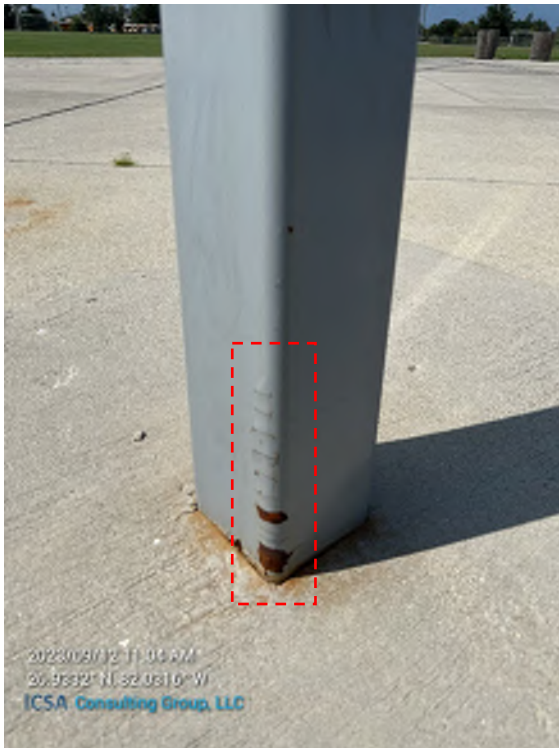
**Created:** Tue 12 Sep 11:04 2023  
**Group:** Soccer Field Shade & Structure A  
**GPS Lat/Lon:** 26.933150, -82.031572  
**Cause of Damage:** Wind/Windborne  
Debris

Soccer Field Shade Structure (A) has experienced a series of damages, as the shade structure appeared to be warped out of its original shape. In this depiction, stress points are visually observable.

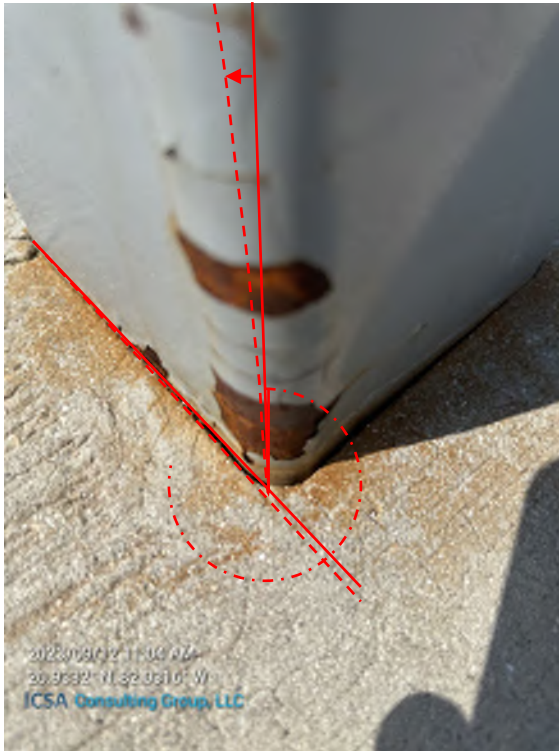
**Created:** Tue 12 Sep 11:04 2023  
**Group:** Soccer Field Shade & Structure A  
**GPS Lat/Lon:** 26.933150, -82.031572  
**Cause of Damage:** Wind/Windborne  
Debris

Soccer Field Shade Structure (A) has experienced a series of damages, as the shade structure appeared to be warped out of its original shape. In this depiction, stress points are visually observable.

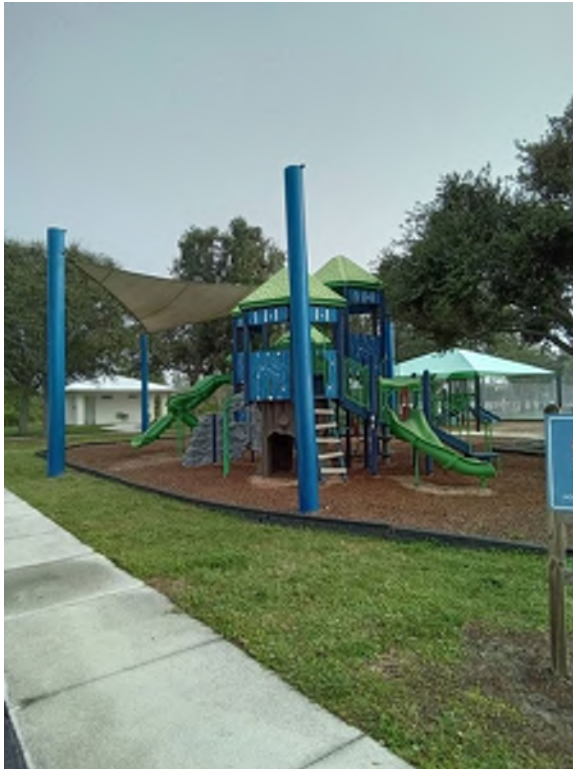
**Created:** Thu 16 Nov 08:51 2023  
**Group:** Playground Sail  
Shade & Structure A  
**GPS Lat/Lon:** 26.93505, -82.29203  
**Cause of Damage:** High Winds  
**Component Description:**  
Overview Photo.

List of Damaged/Missing Components:

- (1) damaged North Sail Shade Fabric
- (1) missing South Sail Shade Fabric
- (2) Fasteners & Couplings
- (1) 12" Column Off Center
- (1) 20" Column Off Center
- (1) 10" Column Off Center
- Playground Structure (Reset) refer to Photo 10 for details.
