**Site Inspection Report for  
Charlotte County –  
Ann & Chuck Dever Regional Park &  
Community Pool Splash Pad  
Florida Hurricane Ian (DR-4673-FL)**

**Site Inspection Report for  
Charlotte County –  
Carmalita Park  
Florida Hurricane Ian (DR-4673-FL)**

**Site Inspection Report for  
Charlotte County –  
Centennial Park Campus  
Florida Hurricane Ian (DR-4673-FL)**

**Site Inspection Report for  
Charlotte County –  
Rotonda Park  
Florida Hurricane Ian (DR-4673-FL)**

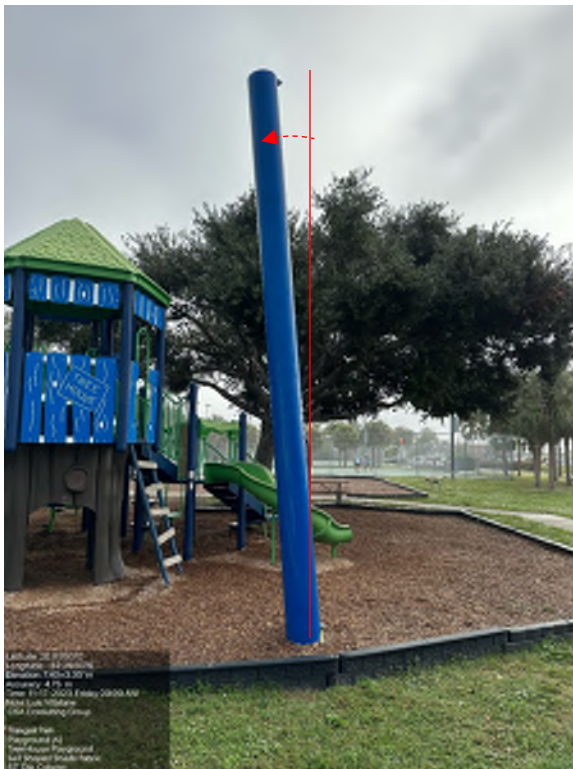
**Created:** Thu 16 Nov 09:09 2023  
**Group:** Playground Sail  
Shade & Structure A  
**GPS Lat/Lon:** 26.93505, -82.29203  
**Cause of Damage:** High Winds  
**Component Description:**  
Deflection of the 12" dia. Column in question.  
Damaged fasteners and missing coupling.

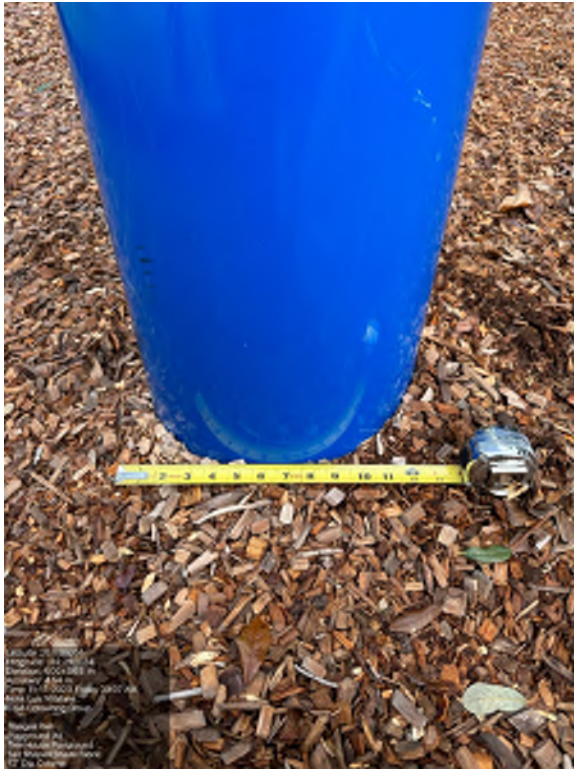
(3.)

**Created:** Thu 16 Nov 09:13 2023  
**Group:** Playground Sail  
Shade & Structure A  
**GPS Lat/Lon:** 26.93505, -82.29203  
**Cause of Damage:** High Winds  
**Component Description:**  
Refer to Photo (2).

Diameter measurement.

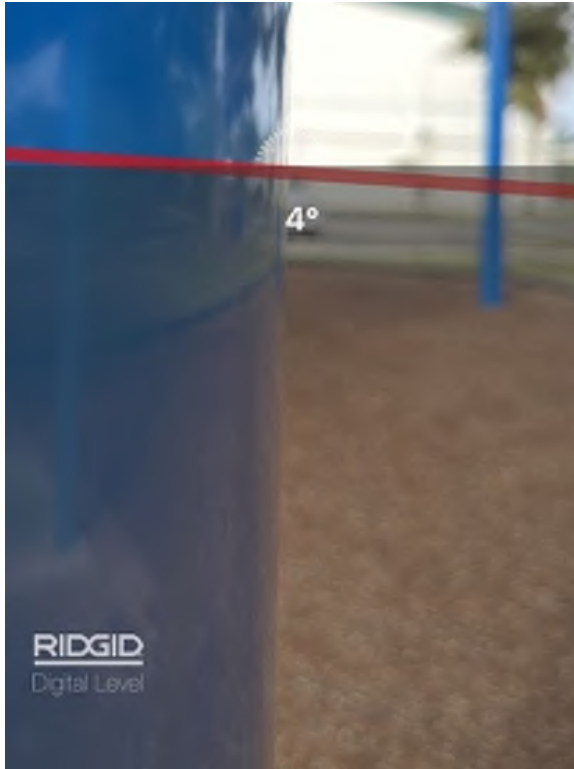
(7.)

**Created:** Thu 16 Nov 09:14 2023  
**Group:** Playground Sail  
 Shade & Structure A  
**GPS Lat/Lon:** 26.93505, -82.29203  
**Cause of Damage:** High Winds  
**Component Description:**  
 Refer to Photo (1).

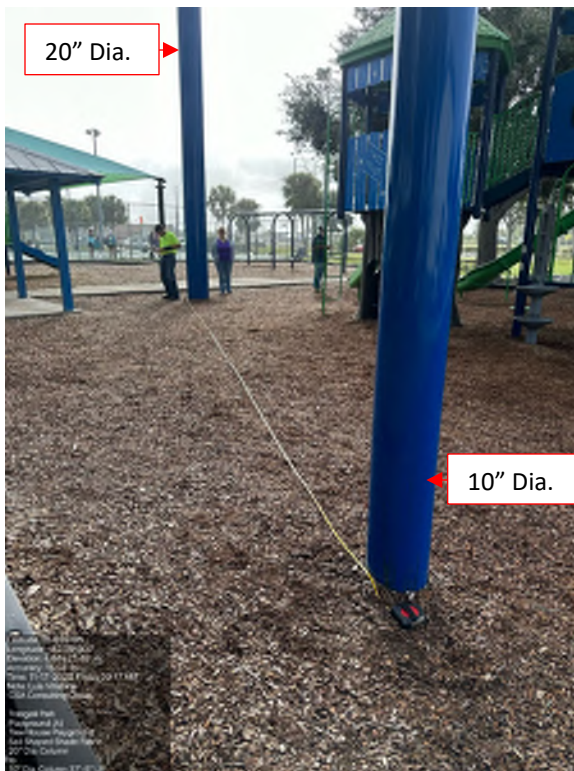
(8.)

**Created:** Thu 16 Nov 09:09 2023  
**Group:** Playground Sail  
 Shade & Structure A  
**GPS Lat/Lon:** 26.93505, -82.29203  
**Cause of Damage:** High Winds  
**Component Description:**  
 Refer to Photo (1).

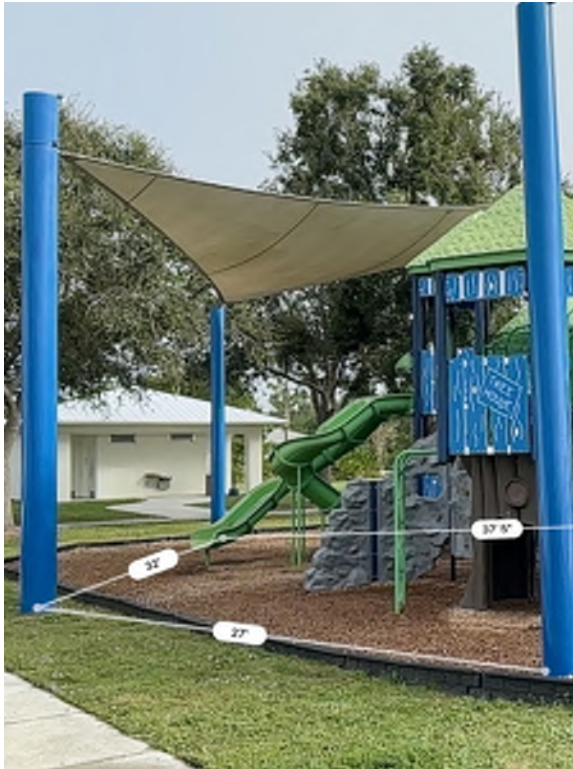
(9.)

**Created:** Thu 16 Nov 09:17 2023  
**Group:** Playground Sail  
 Shade & Structure A  
**GPS Lat/Lon:** 26.93505, -82.29203  
**Cause of Damage:** High Winds  
**Component Description:**  
 Refer to Photo (1).

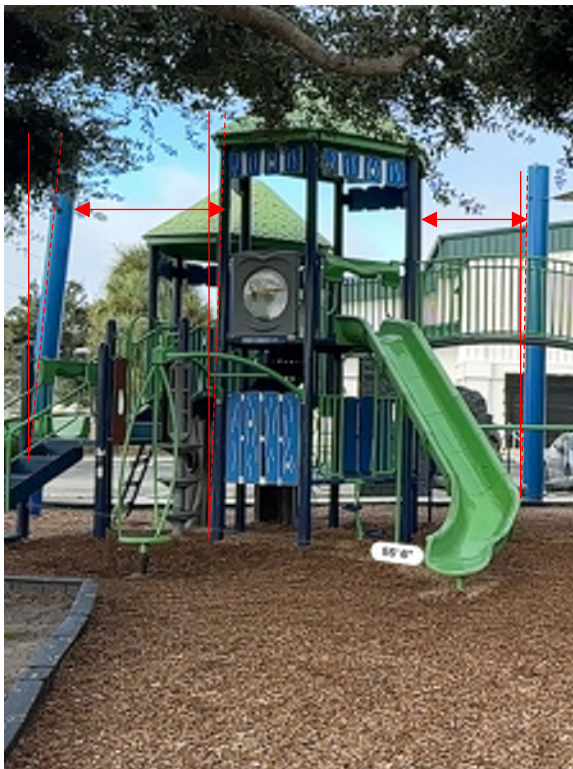
(10.)

**Created:** Thu 16 Nov 09:21 2023  
**Group:** Playground Sail  
 Shade & Structure A  
**GPS Lat/Lon:** 26.93505, -82.29203  
**Cause of Damage:** High Winds  
**Component Description:**  
 Refer to Photo (1).

Measurement detail.

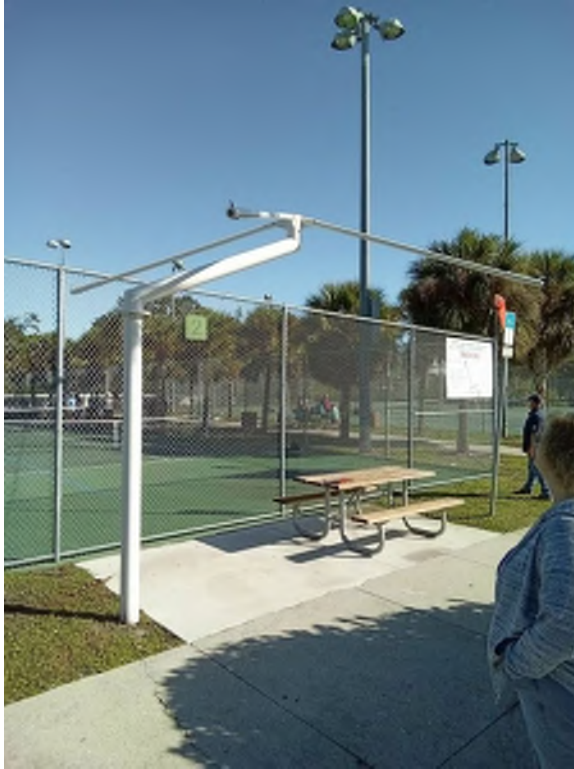
**Created:** Thu 16 Nov 09:39 2023  
**Group:** Tennis Court 2  
Offset Umbrella  
Shade & Structure A  
**GPS Lat/Lon:** 26.93490, -82.29145  
**Cause of Damage:** High Winds  
**Component Description:**  
Shade structure damaged. Hip rail detached.

Damaged Components:

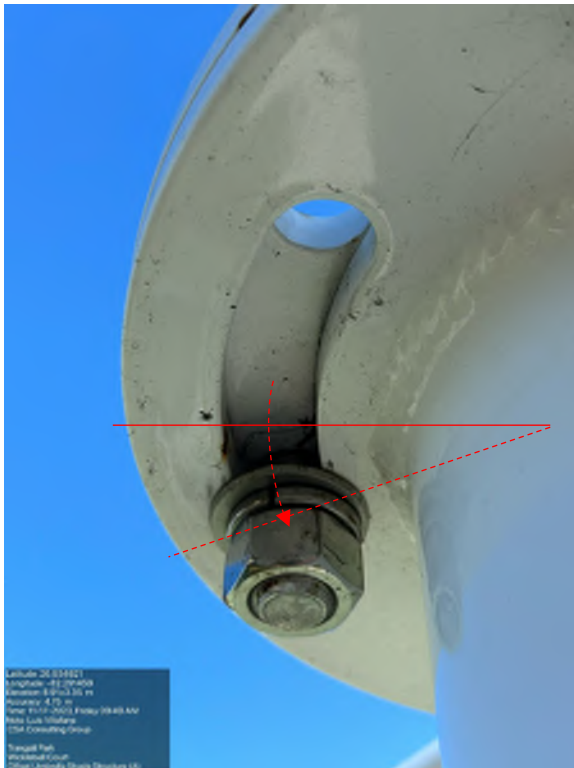
**Created:** Thu 16 Nov 09:39 2023  
**Group:** Tennis Court 2  
Offset Umbrella  
Shade & Structure A  
**GPS Lat/Lon:** 26.93490, -82.29145  
**Cause of Damage:** High Winds  
**Component Description:**  
Refer to Photo (11). Displacement detail photo.

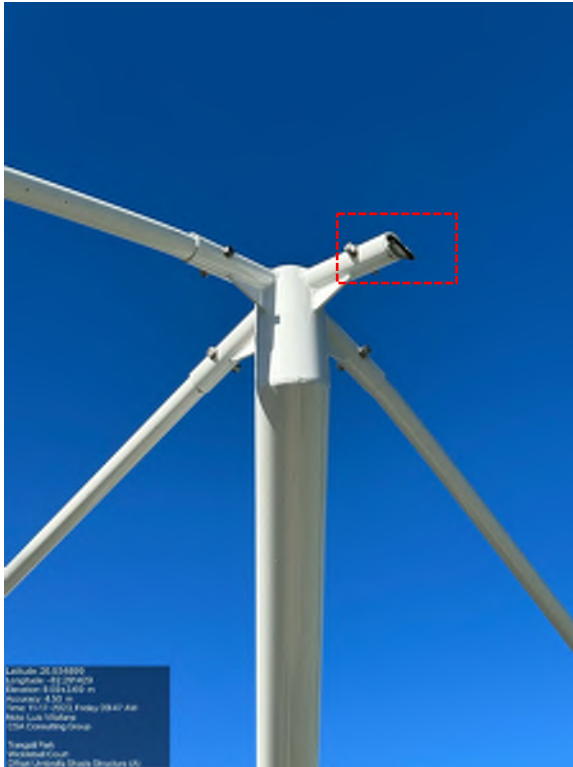
**Created:** Thu 16 Nov 09:47 2023  
**Group:** Tennis Court 2  
 Offset Umbrella  
 Shade & Structure A  
**GPS Lat/Lon:** 26.93490, -82.29145  
**Cause of Damage:** High Winds  
**Component Description:**  
 Refer to Photo (11).

Detail of missing hip rail arm and damaged sleeve.

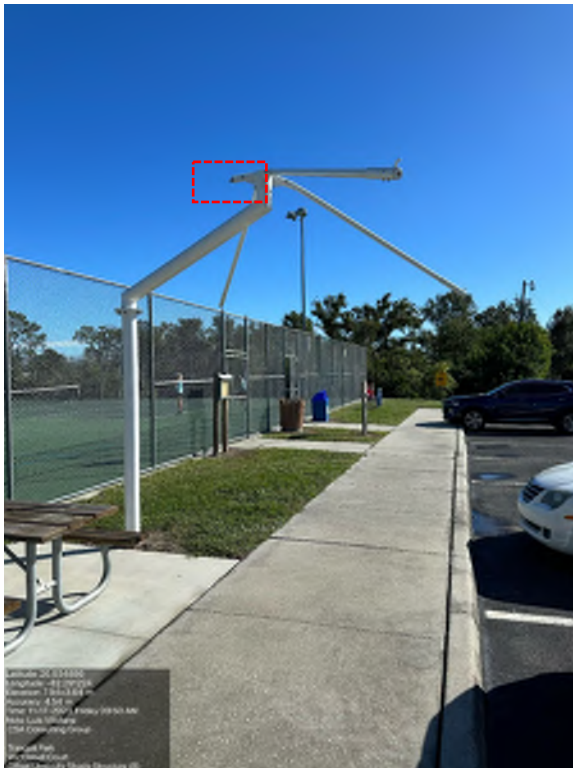
**Created:** Thu 16 Nov 09:50 2023  
**Group:** Tennis Court 3  
 Offset Umbrella  
 Shade & Structure B  
**GPS Lat/Lon:** 26.93489, -82.29121  
**Cause of Damage:** High Winds  
**Component Description:**

Shade structure damaged. Missing hip rail arm with damage sleeve.

Damaged Components:

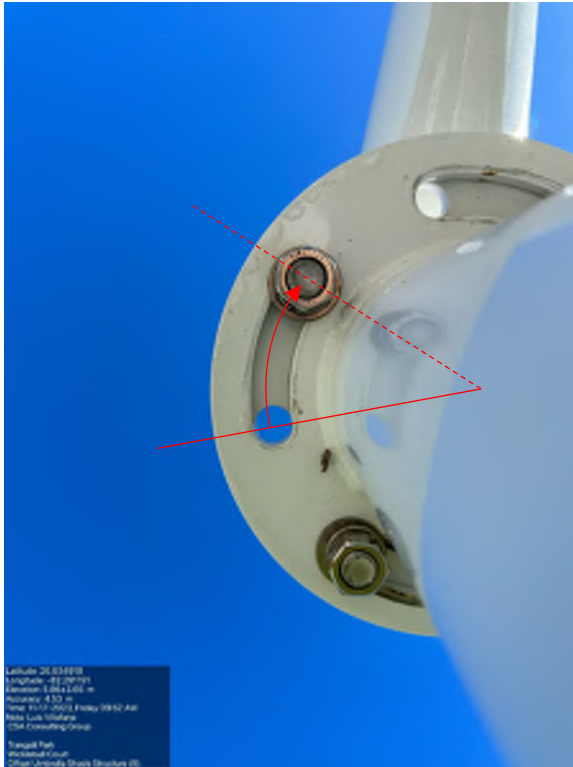
**Created:** Thu 16 Nov 09:52 2023  
**Group:** Tennis Court 3  
Offset Umbrella  
Shade & Structure B  
**GPS Lat/Lon:** 26.93489, -82.29121  
**Cause of Damage:** High Winds  
**Component Description:**  
Refer to Photo (14). Displacement detail photo.
