Placida Bunkhouse

November 12, 2024

CHARLOTTE COUNTY
FLORIDA

2024 Preservation Plan

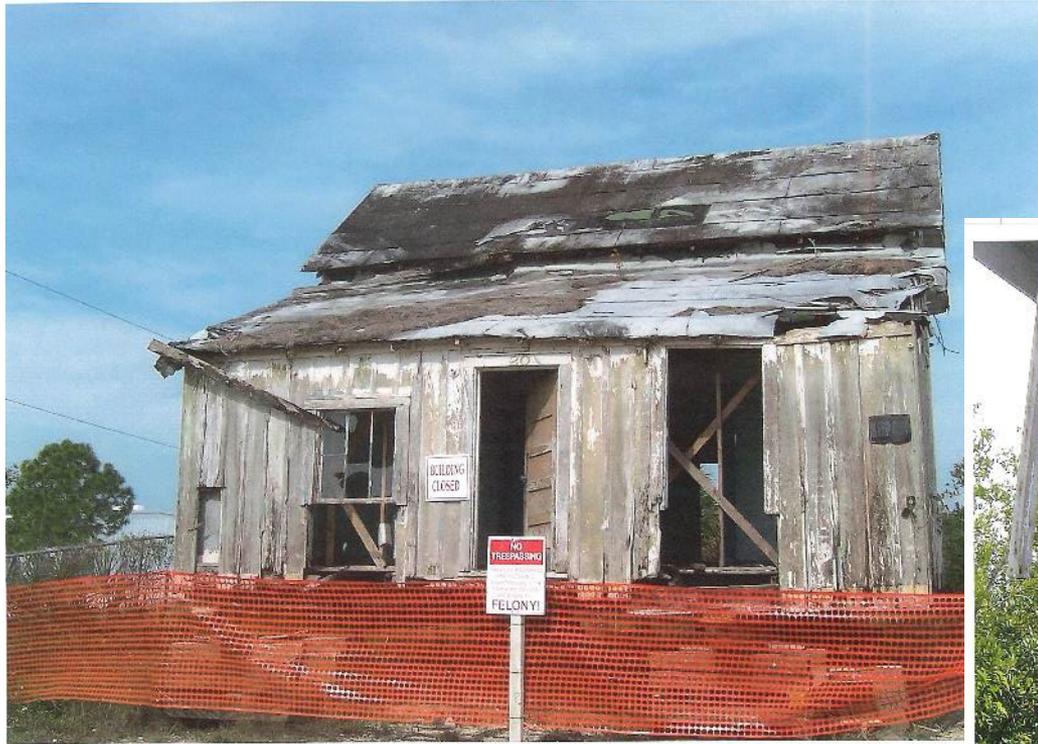
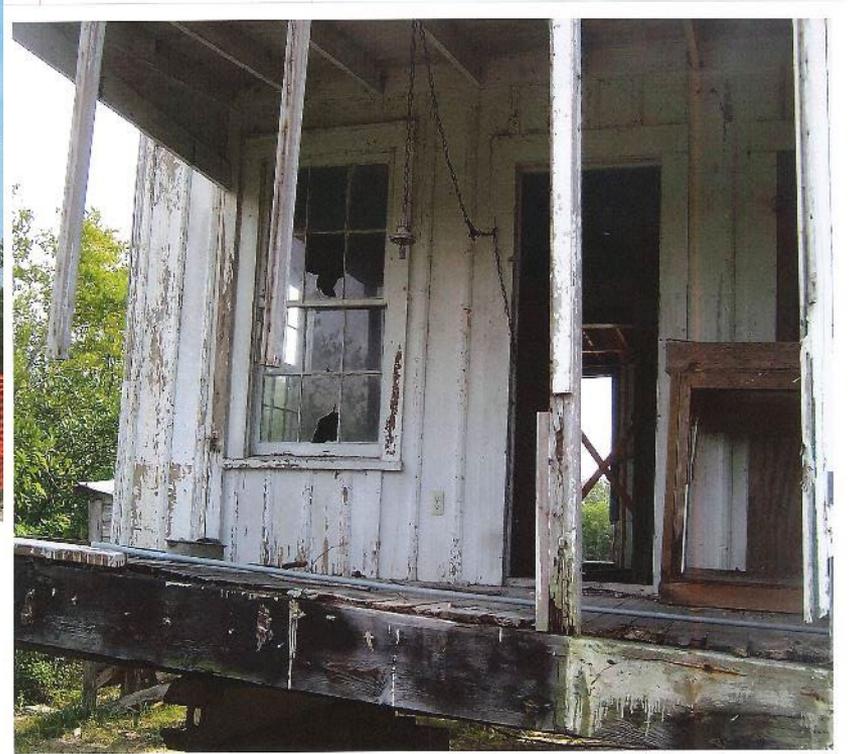
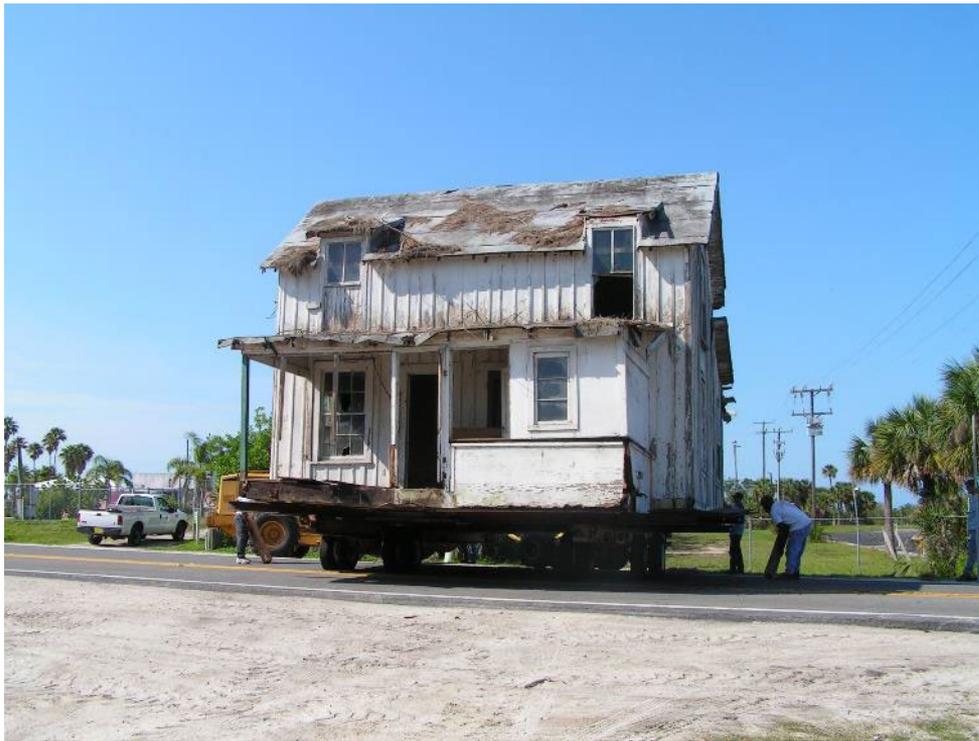
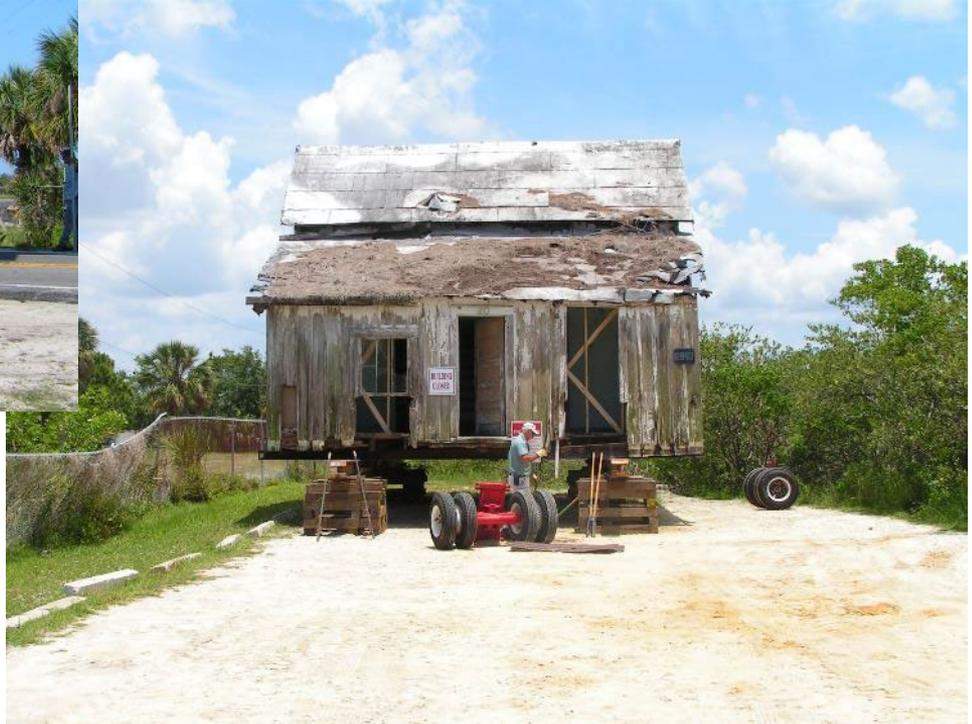
The County stabilized it for the initial moves in 2005 and 2007

Additional stabilization was funded and completed in the years 2011-2013 including:

- Interior structural supports
- Flooring stabilization
- Exterior sheathing
- Roofing
- Window securing
- Security fencing

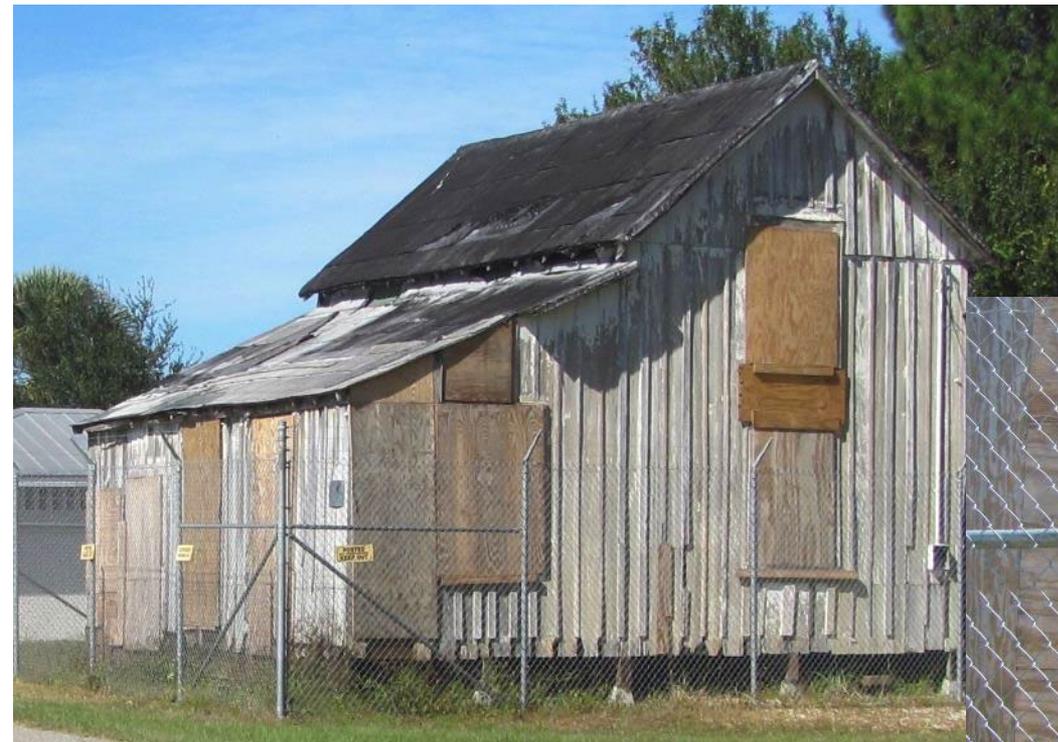
PLACIDA BUNK HOUSE

The Placida Bunk House was built about 1907 by the Charlotte Harbor & Northern Railroad to house their employees. The line was laid to transport phosphate to docks at South Boca Grande on Gasparilla Island. Several families called the building home, as railroad transportation encouraged early settlement of the Placida area. Over the years, it has been the site of a local school, post office, and meeting place for a local church. It is linked with several longtime families who established the community here in the 1900s.

The wood-framed building style is a local example of pre-1920s Florida Frame Vernacular architecture, which is significant to the state's history and development. Despite severe weather and neglect, the Florida yellow pine frame resisted deterioration over the years.

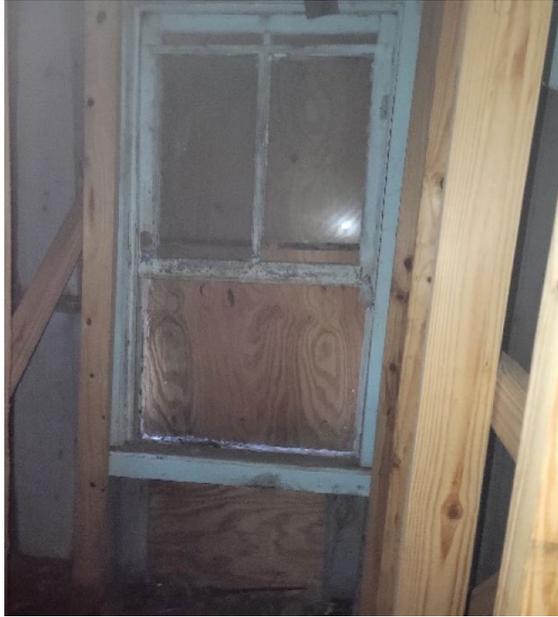
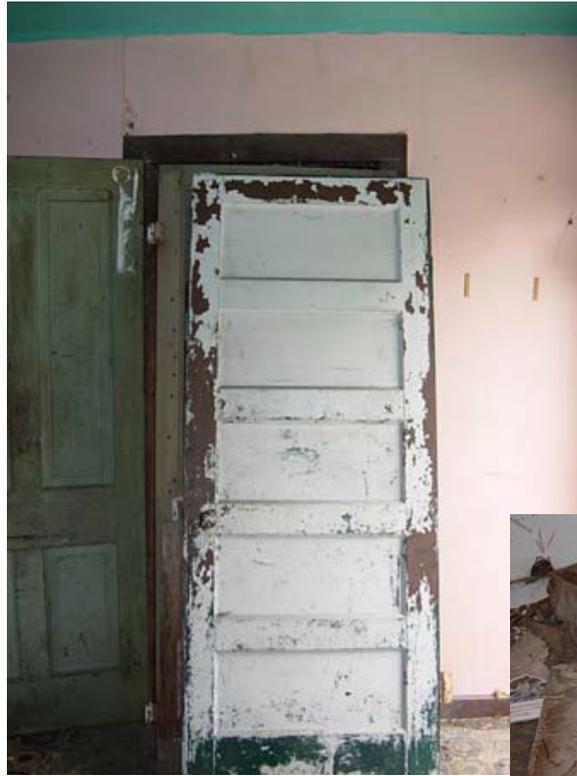
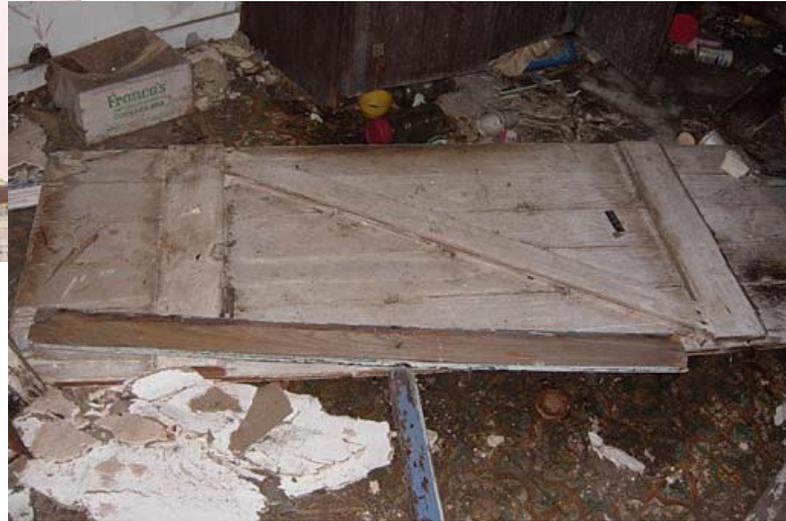
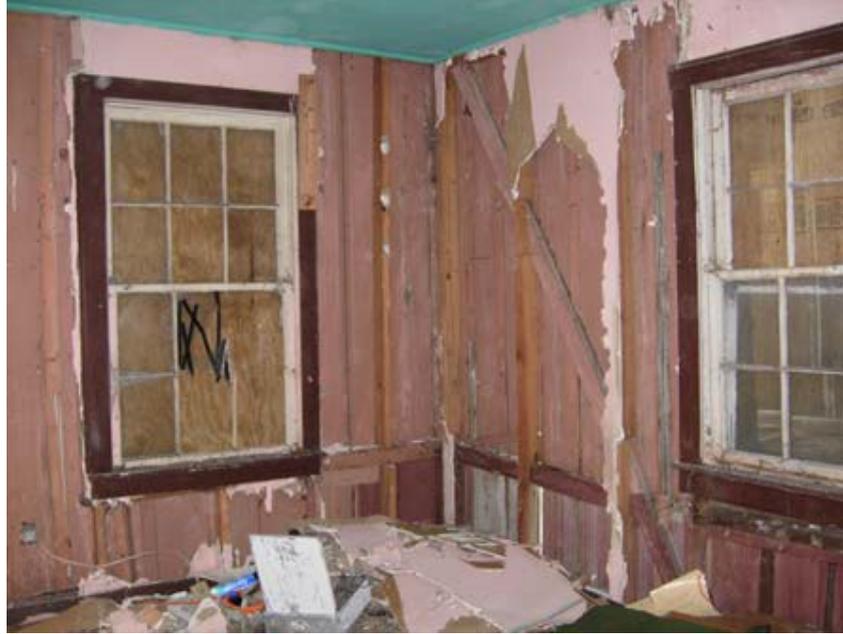
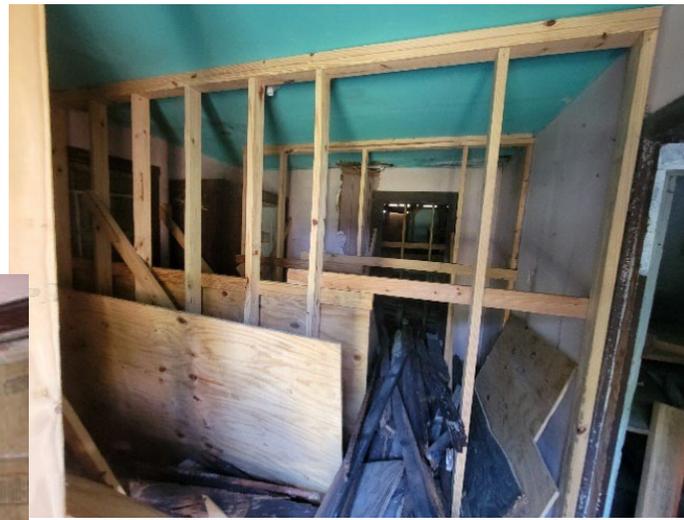
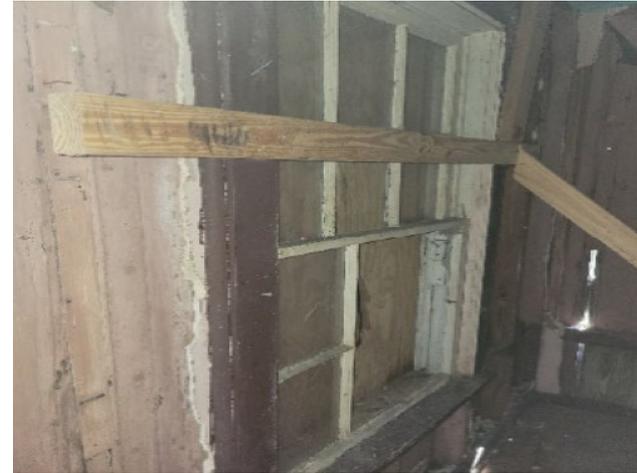
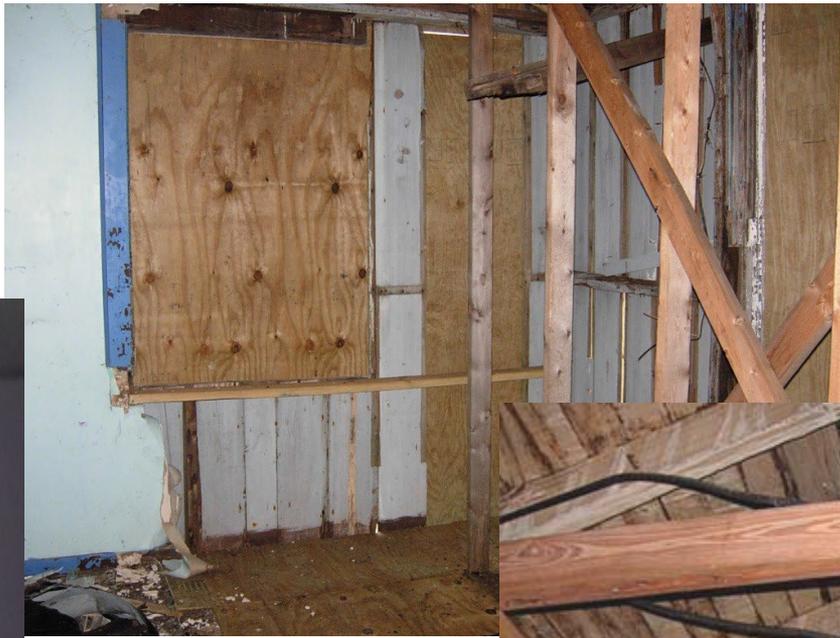
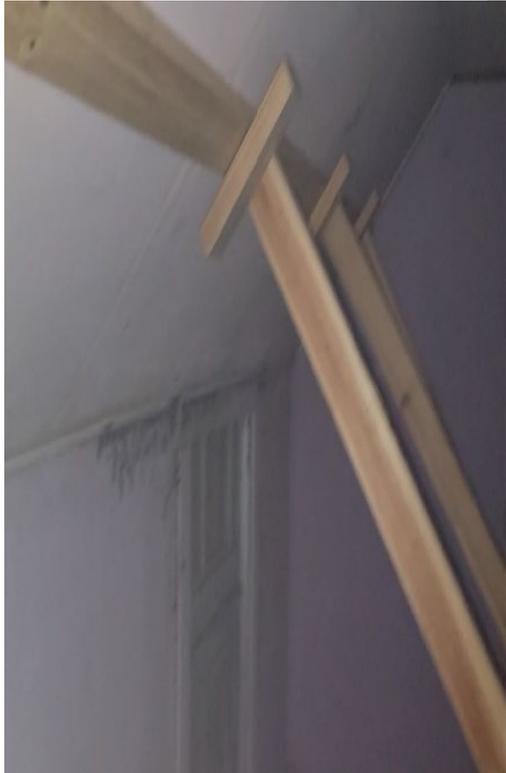
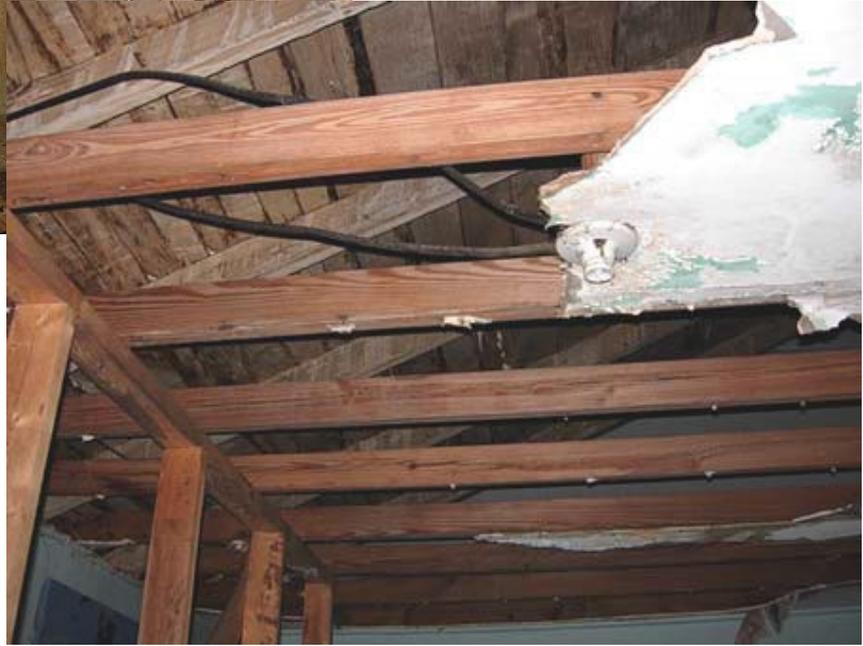
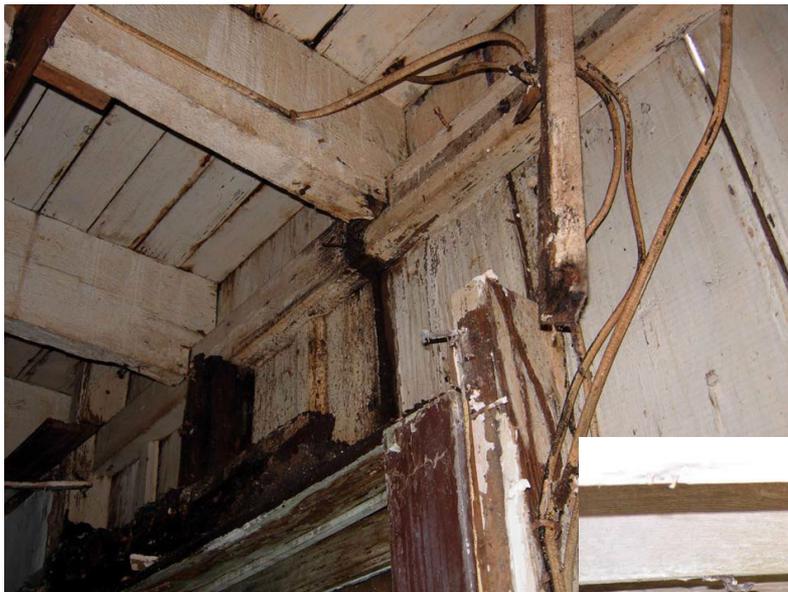
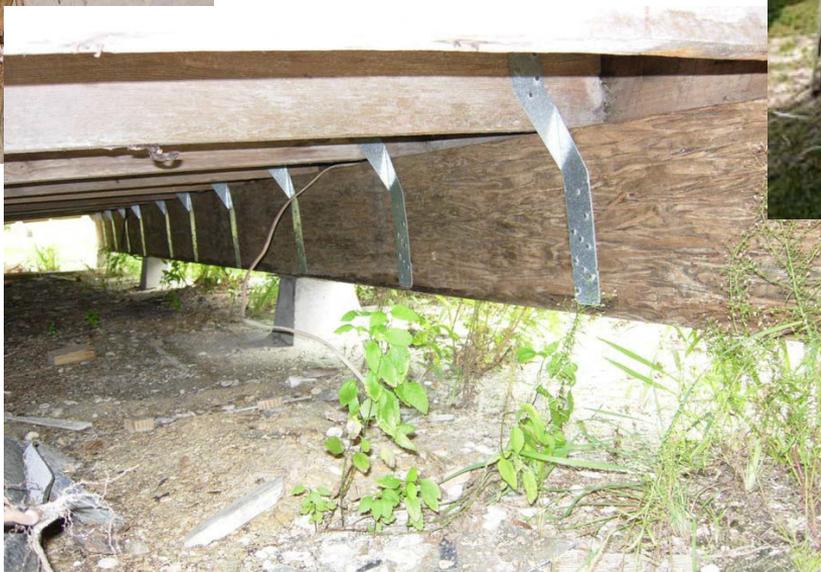
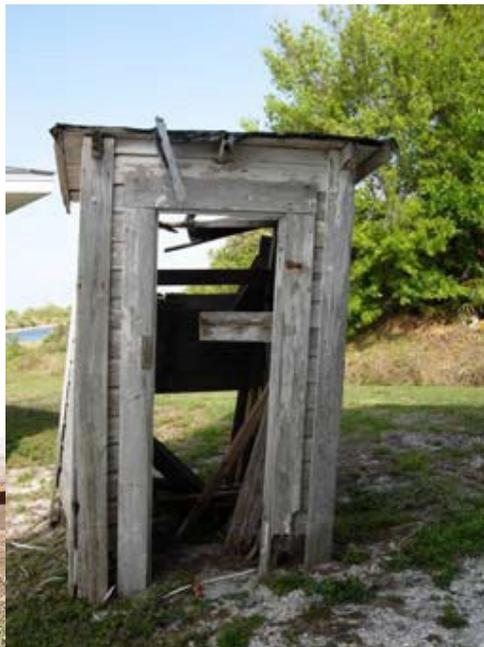
- **Existing conditions**
- **Site** - The site is well maintained, and the building has been secured
- **Roof** - The roof covering, related flashings and aluminum drip edges have aged as anticipated since their installation are in fair condition

- **Rafters** - Damaged rafter ends have been replaced in the 2012 stabilization project
 - **Deck** - The 2012 stabilization project addressed this area by replacing damaged areas of the original deck

- **Cladding** - Some of the original beveled battens have been replaced with various sizes and types of batts
- **Interior** - The interior of the first floor of the structure is in very poor condition and is full of debris. The second floor, while free of most debris, has several shoring walls erected for roof support

- **Windows** - The windows are overall in poor condition and will need extensive restoration/ reconstruction to be re-used in any future endeavor
- **Exterior doors** - The three doors can potentially be salvaged and reused
