Cultural Center

Cultural Center of Charlotte County

Board Presentation

January 2024

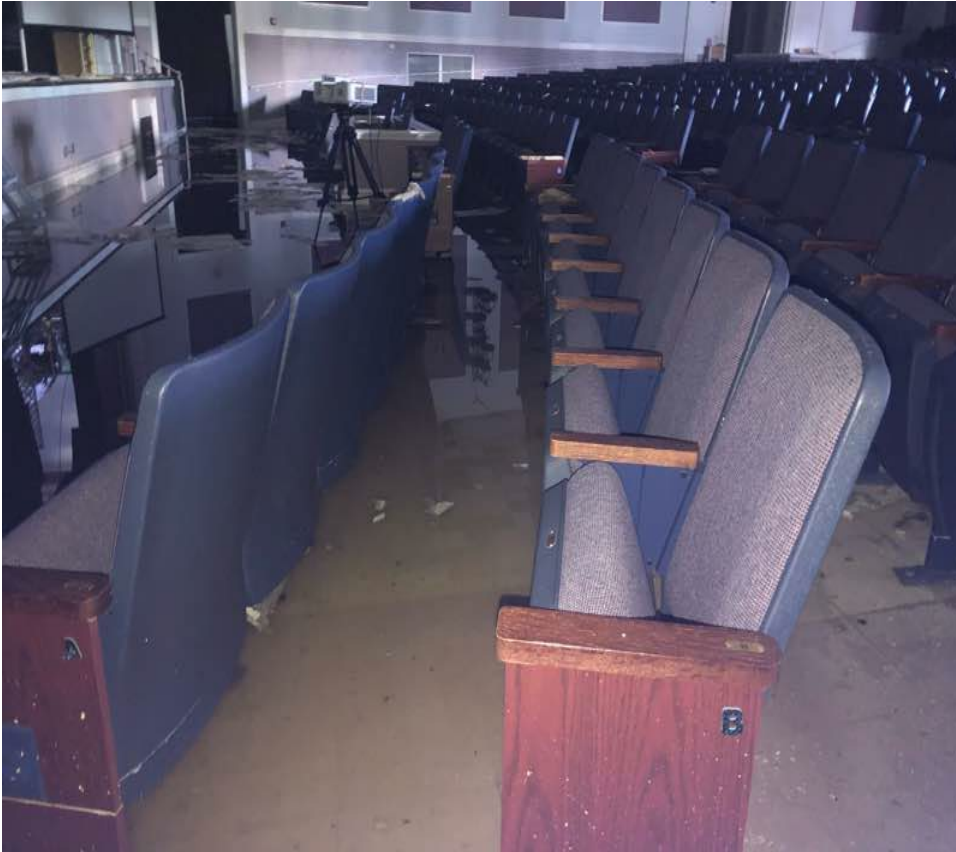
Theater & Learning Center

Sustained major damage later to be defined as catastrophic.

“The CSA Consultant team found catastrophic damage to building materials, furniture and finish products throughout this building section. Standing water, strong odors and saturated ceiling tiles on the floor were noted throughout all rooms and areas. The CSA Consultant team also noted several breaks in the building envelope’s ceilings and walls throughout the entire building. Building air conditioning was inoperative.”

“Based on the anticipated amount of additional work required to establish the full extent of mold contamination and all necessary measures for proper antimicrobial treatment and remediation of remaining building elements; and further considering the significant amount of structural design changes to the Senior and Conference Center / Learning Center / Theater building sections needed to meet current Federal, State and Local Codes and Ordinances; and finally, the associated duration and cost of building programming, design, permitting, and construction; it would be more efficient and lower risk for the County to proceed with full facility demolition, removal and disposal of hazardous construction debris, and new construction of the functional building areas of the Senior and Conference Center / Learning Center / Theater building sections.”

Post Hurricane Ian much of the facility required extensive evaluations to determine levels of damages vs pre-existing conditions. Considering these factors, we share the consultant's recommendation that the entire structure be demolished.

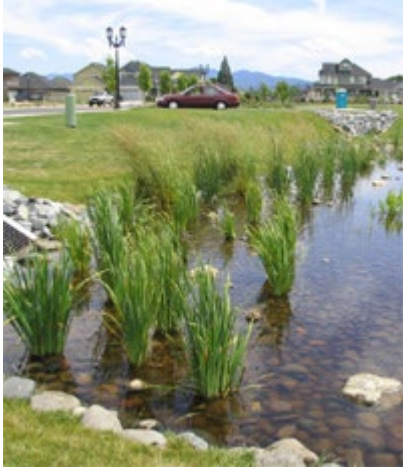
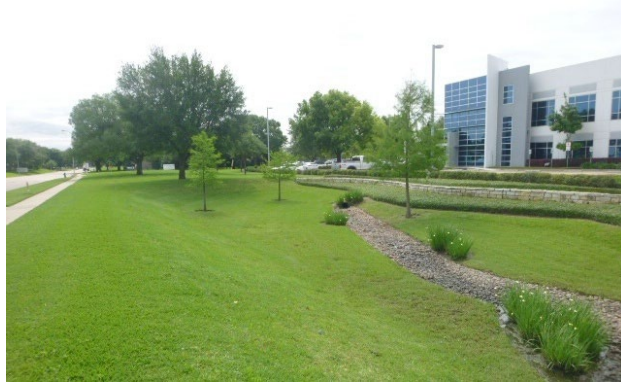
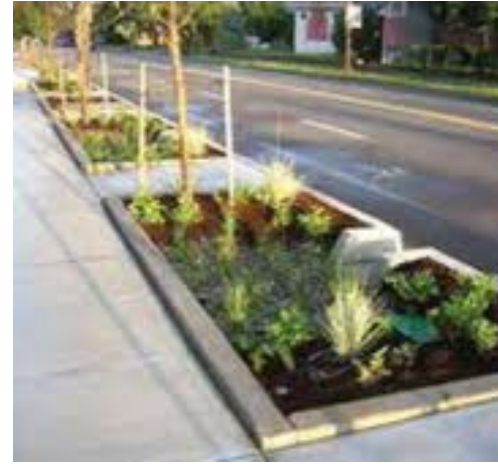
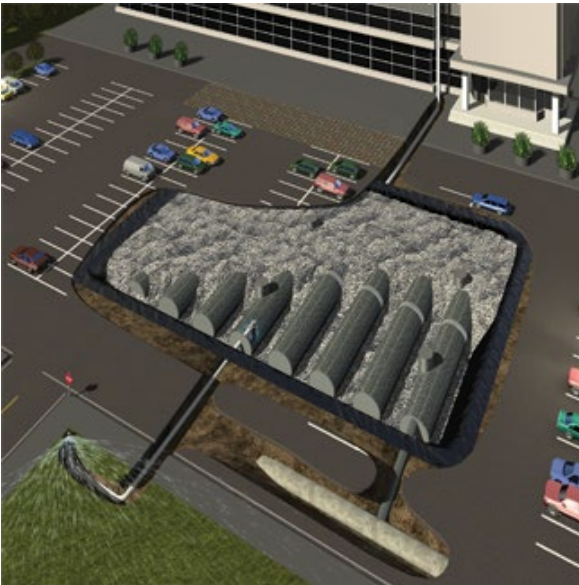
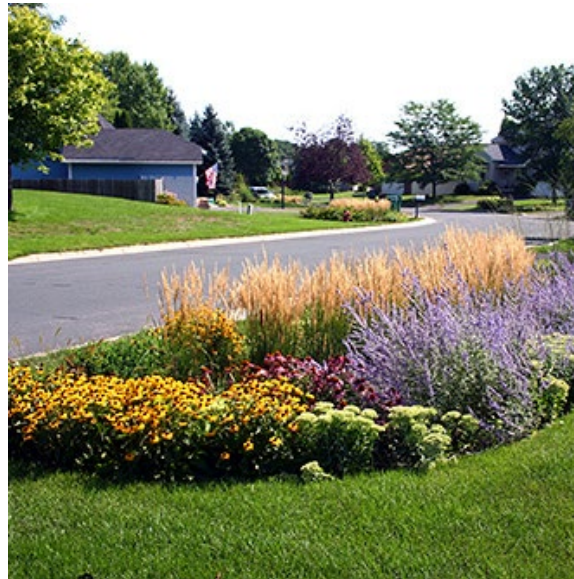
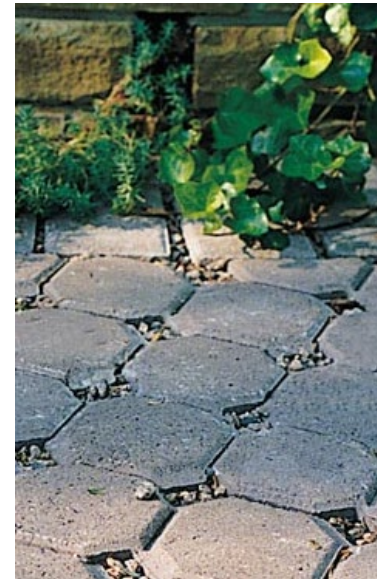
Stormwater Design Examples

1. Wet Detention
2. Dry Retention
3. Tree Wells
4. Stormwater vaults
5. Rain Gardens
6. Pervious Pavement
7. Green Roofs

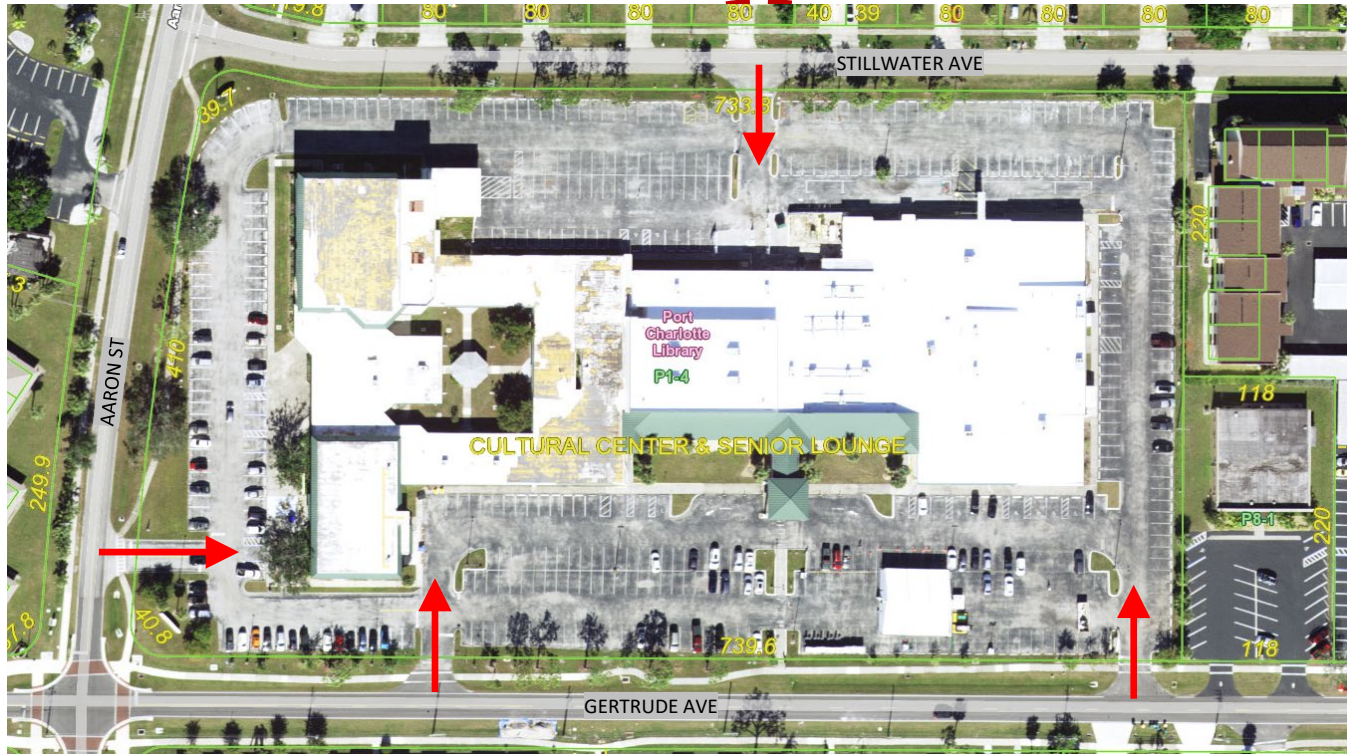
Existing Site Access

- One (1) full-access driveway onto Stillwater Avenue (Northern Driveway);
- Two (2) full-access driveways onto Gertrude Avenue (Southern Driveways); and
- One (1) full-access driveway onto Aaron Street (Western Driveway).
