**Site Inspection Report for  
Charlotte County –  
East Port Environmental Campus  
Administration Building A  
Cost Benchmarking Revision 3  
Florida Hurricane Ian (DR-4673-FL)**

Prepared for:  
Charlotte County, Florida

February 26, 2024

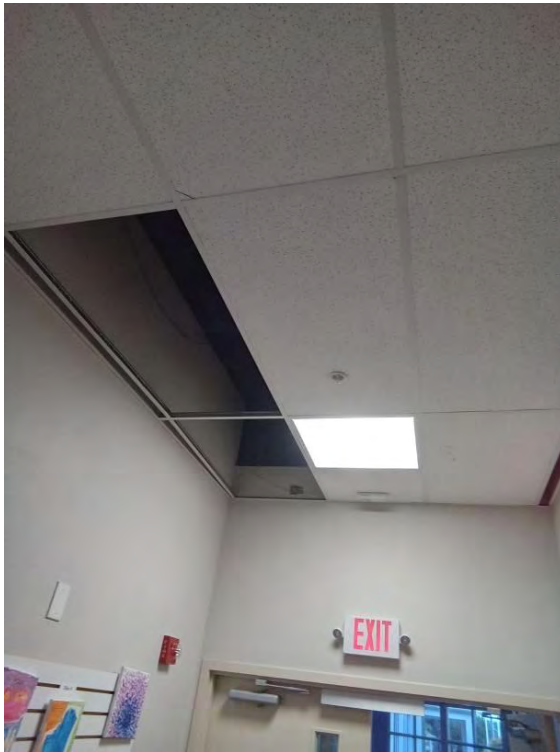
(1)

**Group:** 118 Hall 1

**Cause of Damage:** Wind Driven Rain

- Acoustical Ceiling Tiles
- Ceiling Batt Insulation

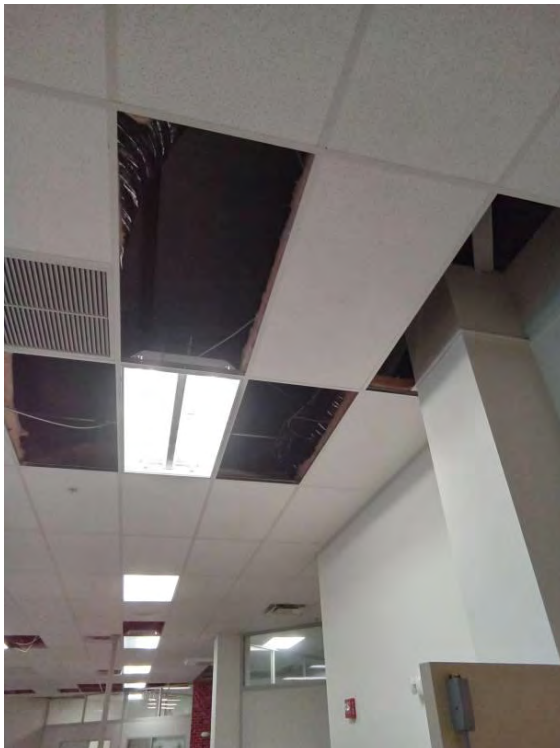
(2)

**Group:** 130 Engineering 1

**Cause of Damage:** Wind Driven Rain

- Acoustical Ceiling Tiles
- Ceiling Batt Insulation

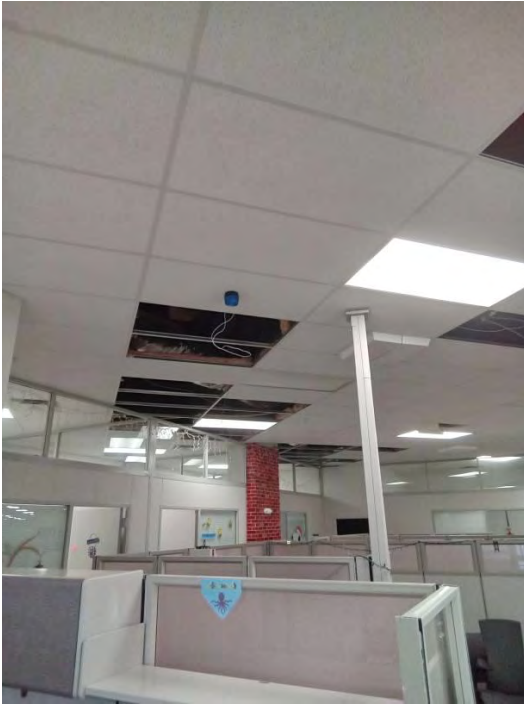
(3)

**Created:** Thu 27 Jul 07:31  
2023  
**Group:** 130 Engineering 1  
- Acoustical Ceiling Tiles  
- Ceiling Batt Insulation

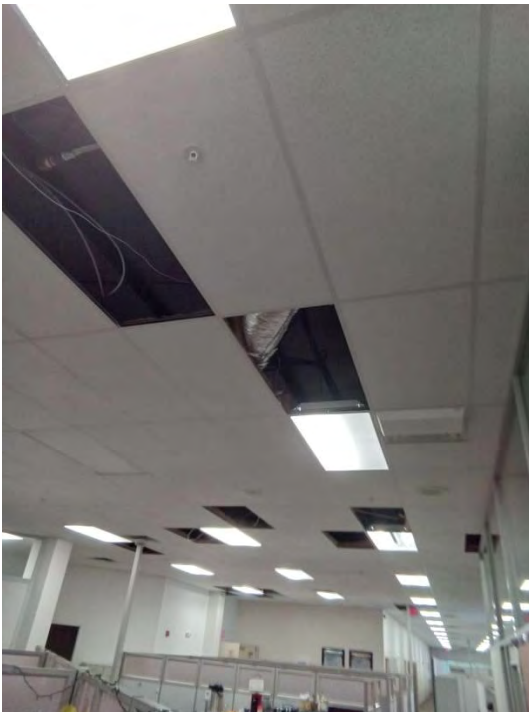
(4)

**Created:** Thu 27 Jul 07:33  
2023  
**Group:** 130 Engineering 1  
- Acoustical Ceiling Tiles  
- Ceiling Batt Insulation

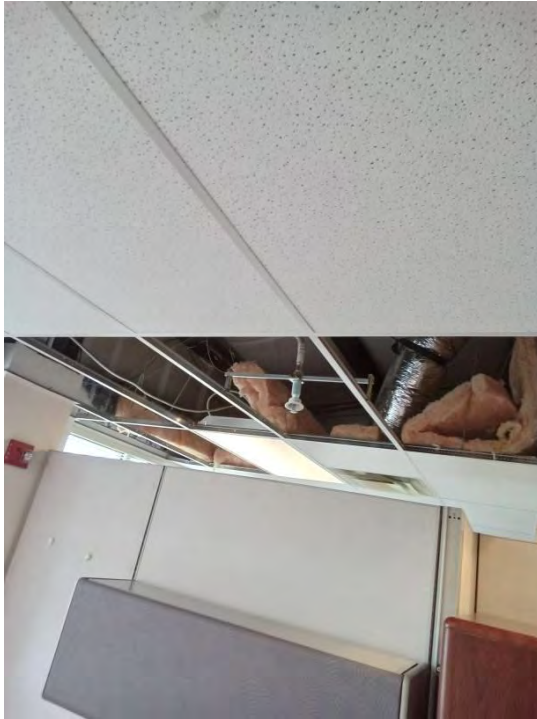
(5)

**Created:** Thu 27 Jul 07:33 2023  
**Group:** 130 Engineering 1  
 - Acoustical Ceiling Tiles  
 - Ceiling Batt Insulation

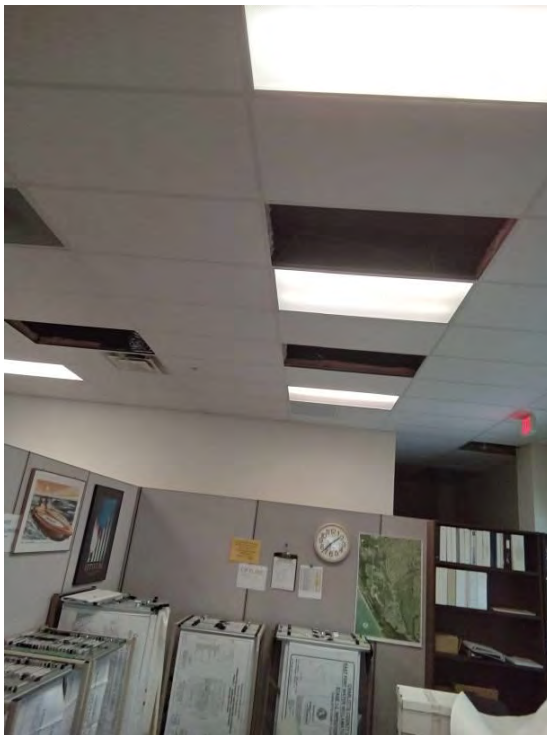
(6)

**Created:** Thu 27 Jul 07:35 2023  
**Group:** 130 Engineering 1  
 - Acoustical Ceiling Tiles  
 - Ceiling Batt Insulation

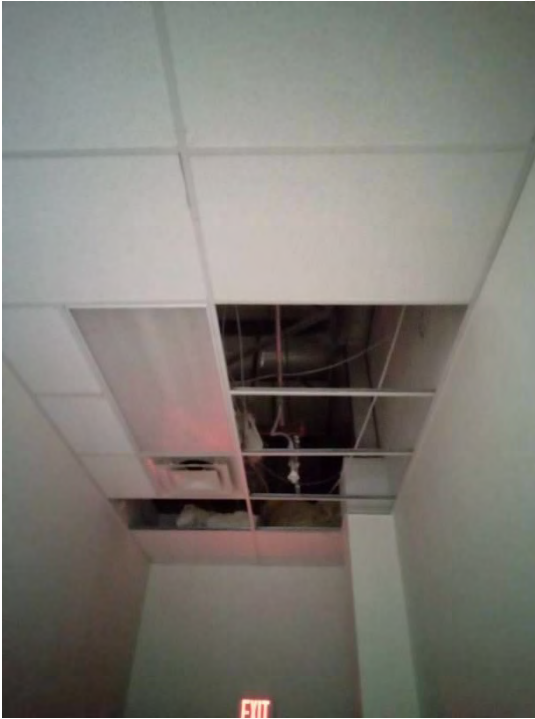
(7)

**Created:** Thu 27 Jul 07:36 2023  
**Group:** 130 Engineering 1  
 - Acoustical Ceiling Tiles  
 - Ceiling Batt Insulation

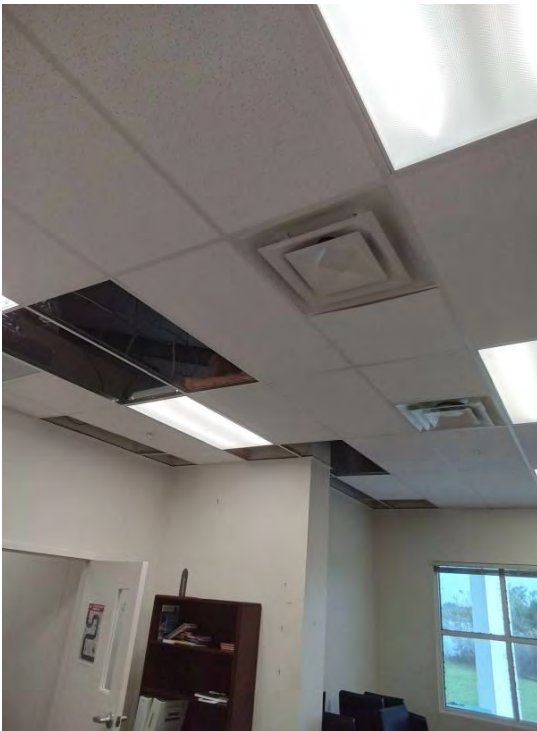
(12)

**Created:** Thu 27 Jul 07:54 2023  
**Group:** 141 Fiscal Manager

- Acoustical Ceiling Tiles
- Ceiling Batt Insulation

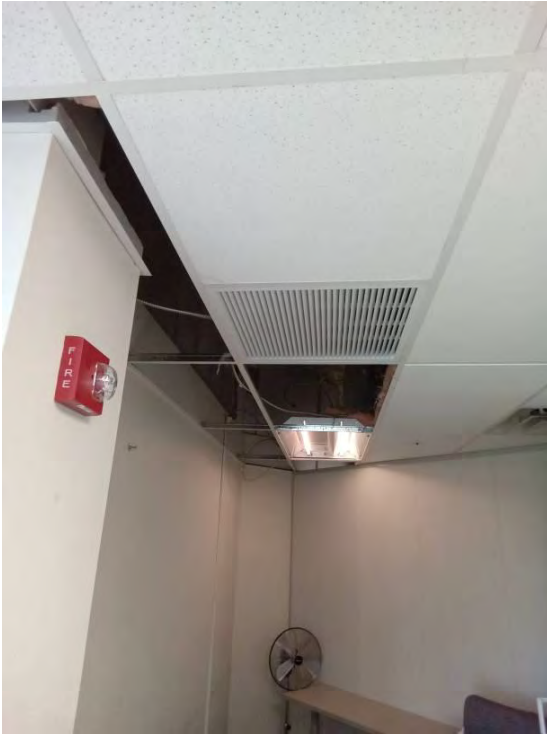
(15)

**Created:** Thu 27 Jul 08:00 2023  
**Group:** 139 Director Conference

- Acoustical Ceiling Tiles
- Ceiling Batt Insulation

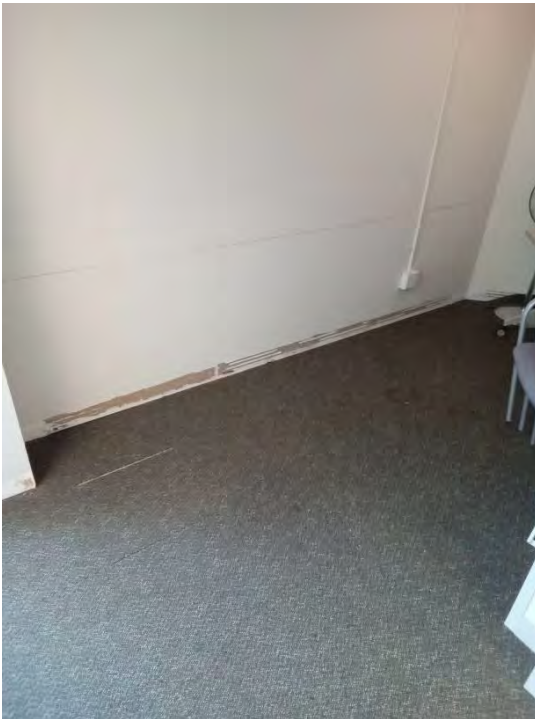
(16)

**Created:** Thu 27 Jul 08:02 2023  
**Group:** 139 Director Conference

- Vinyl Baseboards

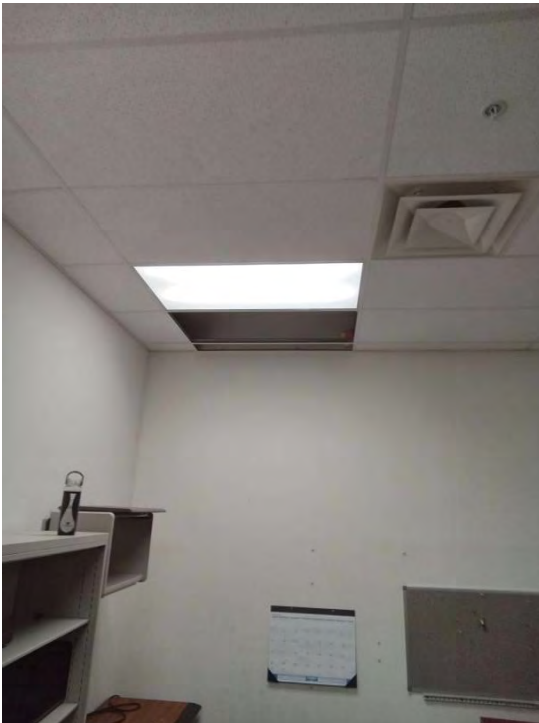
(28)

**Created:** Thu 27 Jul 08:50 2023  
**Group:** 123 Engineering  
 - Acoustical Ceiling Tiles  
 - Ceiling Batt Insulation

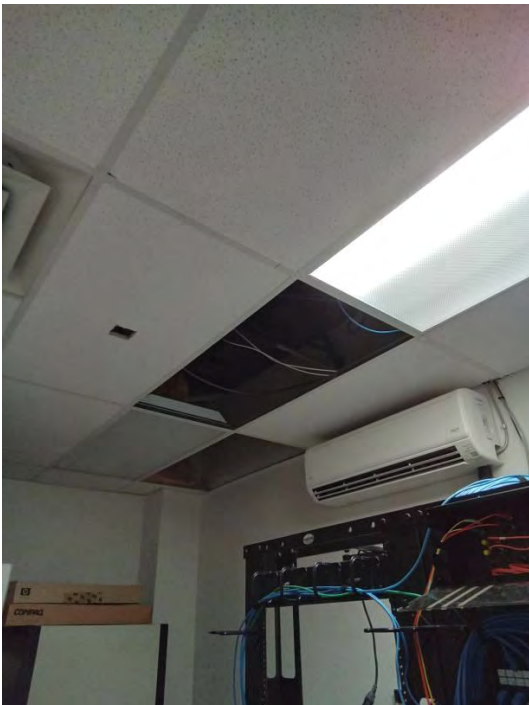
(30)

**Created:** Thu 27 Jul 08:56 2023  
**Group:** 133 Computer Room  
**Component Description:**

- Acoustical Ceiling Tiles
- Ceiling Batt Insulation

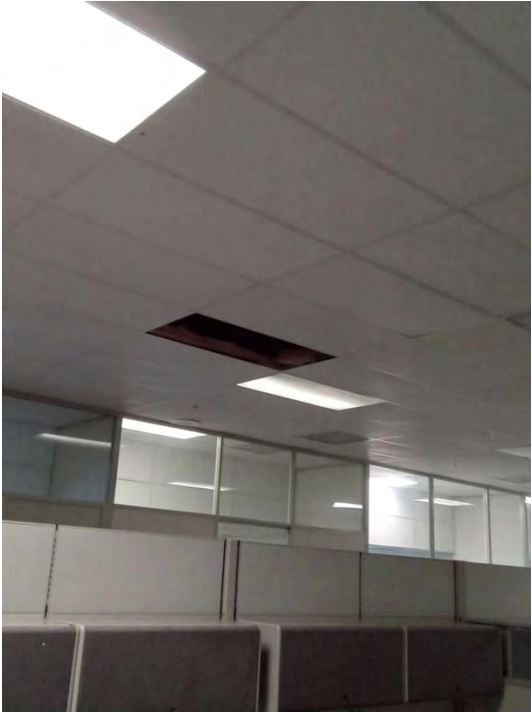
(33)

**Group:** 120 Customer Service

- Acoustical Ceiling Tiles
- Ceiling Batt Insulation

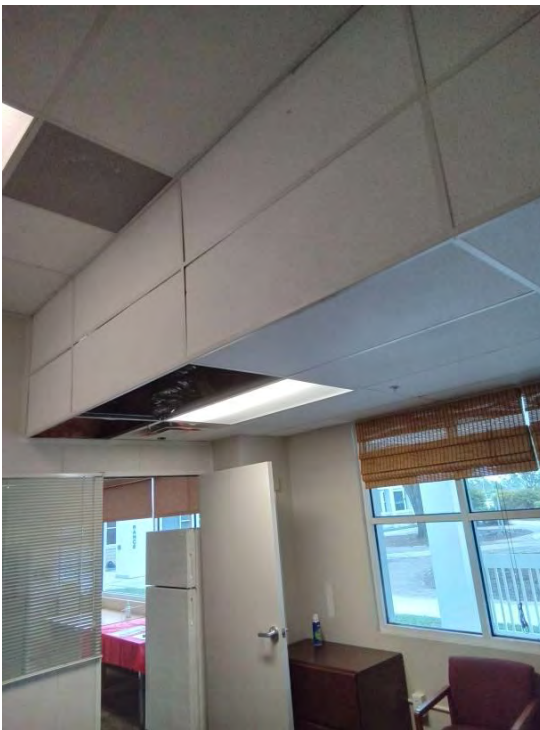
(34)

**Group:** 120 Customer Service

- Acoustical Ceiling Tiles
- Ceiling Batt Insulation

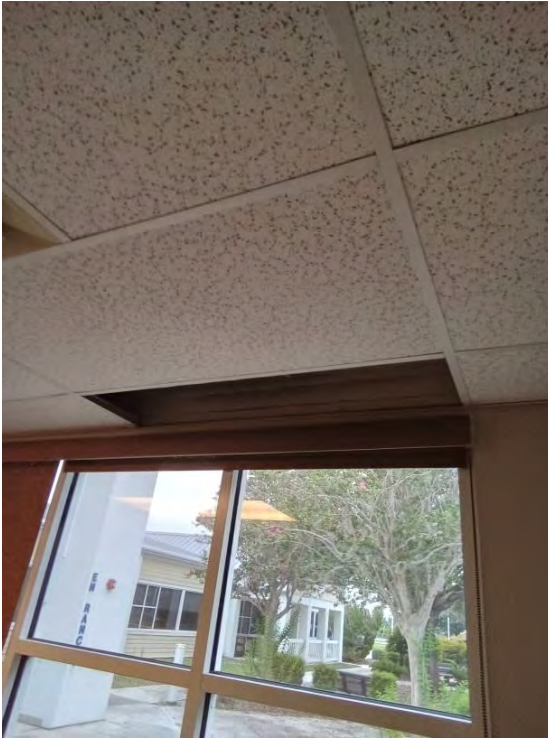
(35)

**Group:** 120 Customer Service

- Acoustical Ceiling Tiles
- Ceiling Batt Insulation

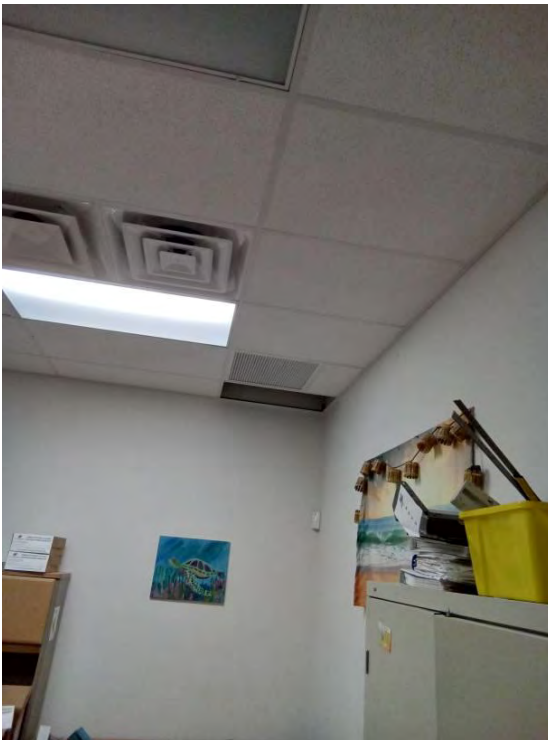
(36)

**Group:** 126 Office 1

**Cause of Damage:** Wind Driven Rain

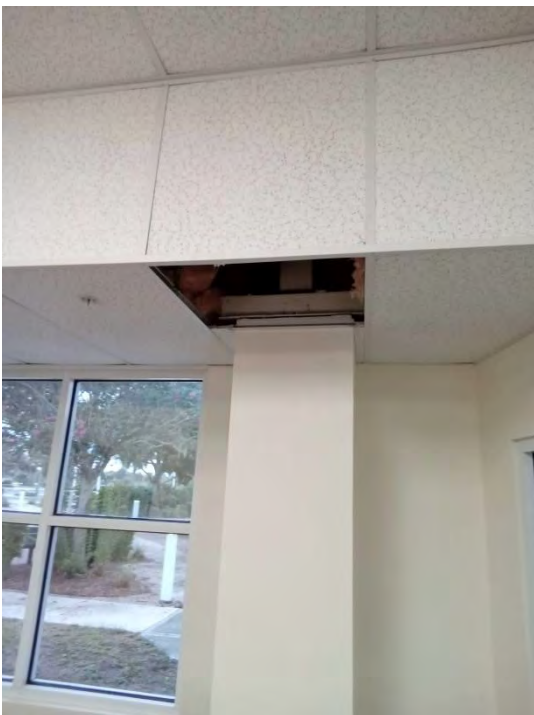
(38)

**Created:** Thu 27 Jul 09:16 2023  
**Group:** 142 Work Room 1

- Acoustical Ceiling Tiles
- Ceiling Batt Insulation

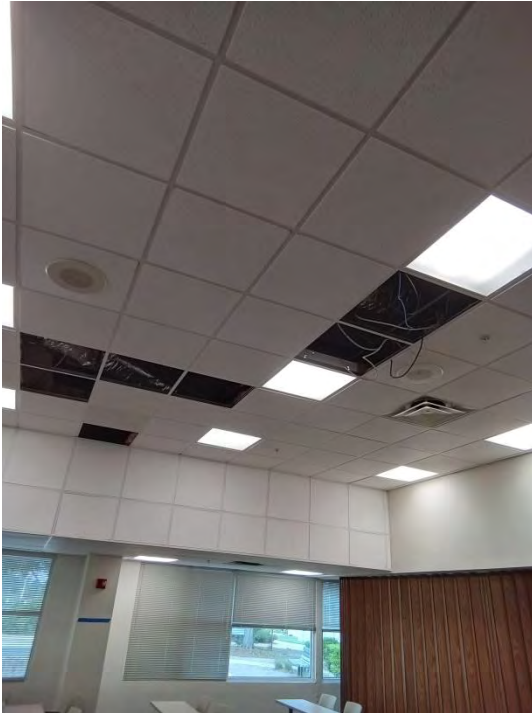
(45)

**Created:** Thu 27 Jul 09:31 2023  
**Group:** 156 Training 2  
 - Acoustical Ceiling Tiles  
 - Ceiling Batt Insulation

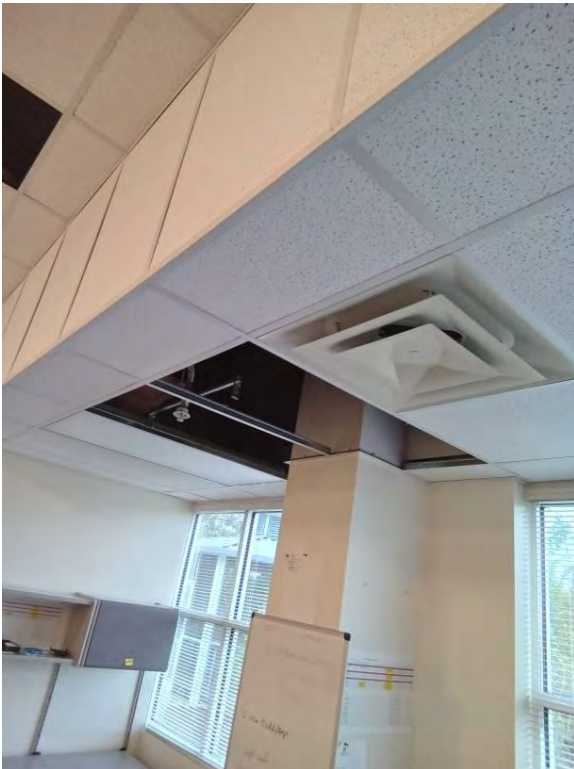
(52)

**Created:** Thu 27 Jul 09:40 2023  
**Group:** 159 Work Area 1  
 - Acoustical Ceiling Tiles  
 - Ceiling Batt Insulation

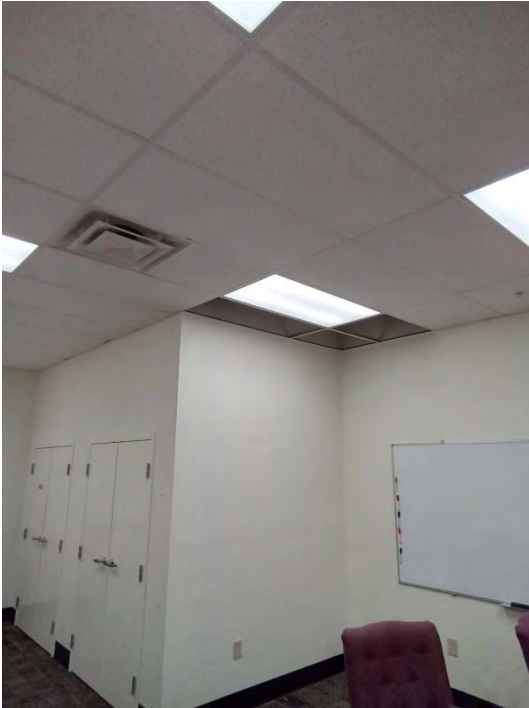
(55)

**Group:** 159 Work Area 1  
 - Acoustical Ceiling Tiles  
 - Ceiling Batt Insulation

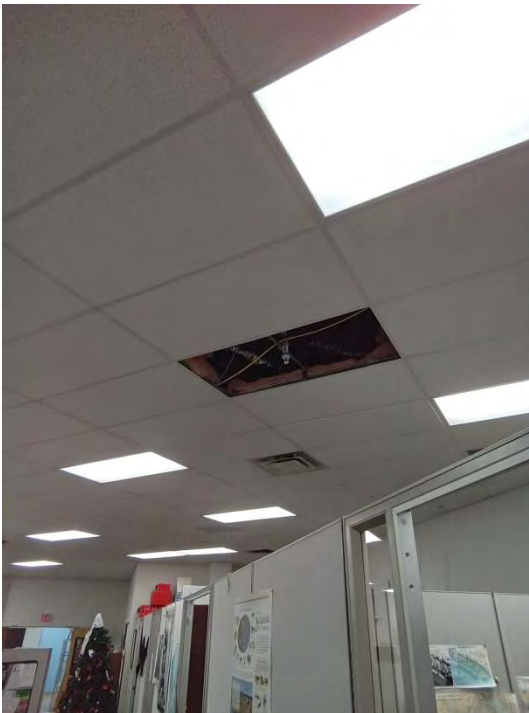
(56)

**Group:** 146 Environmental  
**Cause of** Wind Driven Rain

- Acoustical Ceiling Tiles
- Ceiling Batt Insulation

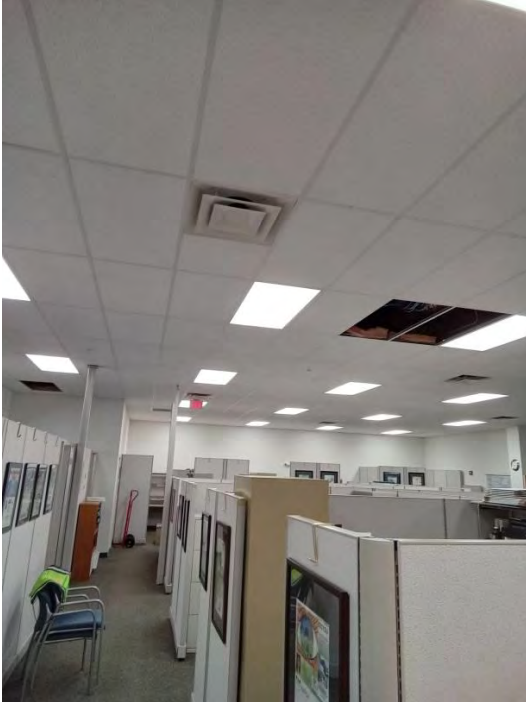
(57)

**Created:** Thu 27 Jul 09:51 2023  
**Group:** 146 Environmental  
 - Acoustical Ceiling Tiles  
 - Ceiling Batt Insulation

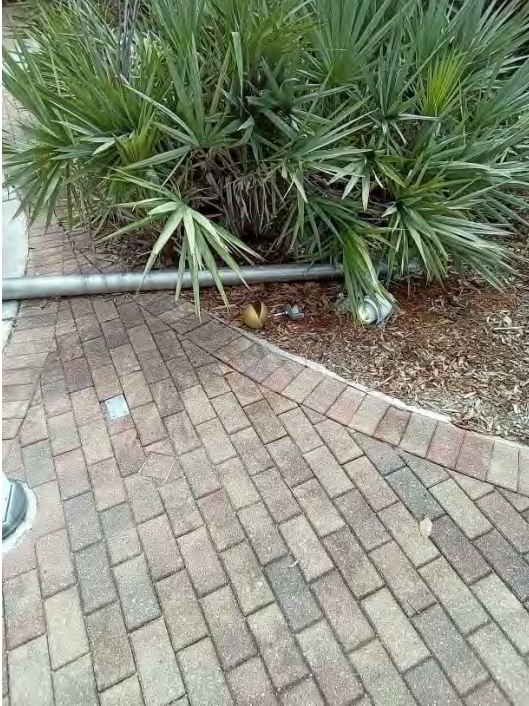
(59)

**Created:** Thu 27 Jul 10:37 2023  
**Group:** Exterior  
 - LED light pole

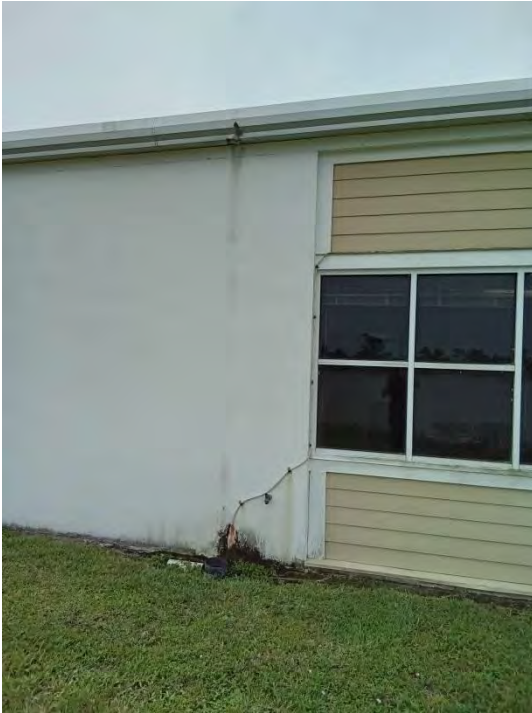
(63)

**Created:** Thu 27 Jul 10:44  
 2023  
**Group:** Exterior  
 - Downspouts

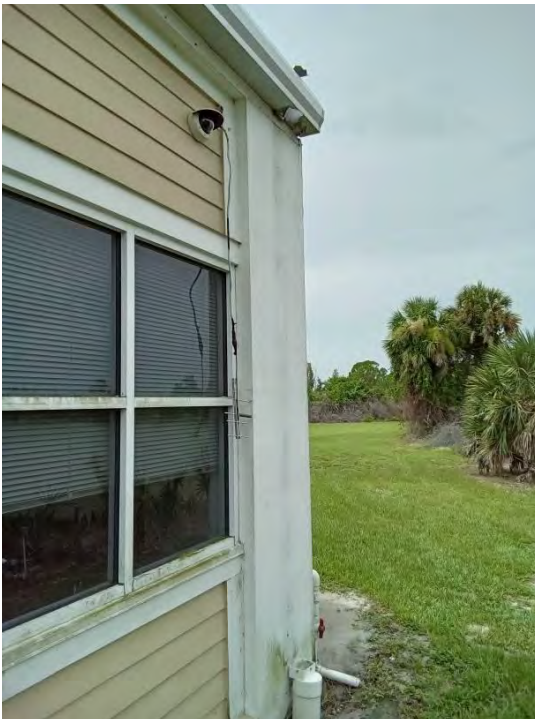
(64)

**Created:** Thu 27 Jul 10:45  
 2023  
**Group:** Exterior  
 - Downspouts

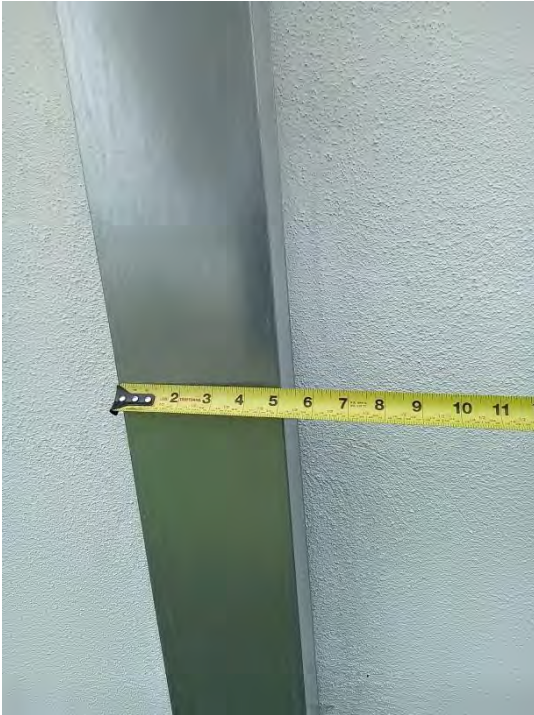
(65)

**Group:** Exterior  
 - Downspouts

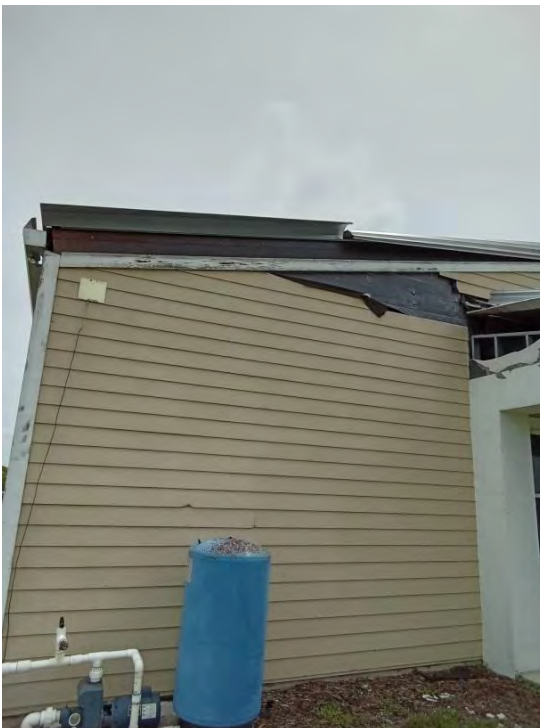
(66)

- Fiber Cement Siding panels
- Roof Gutters

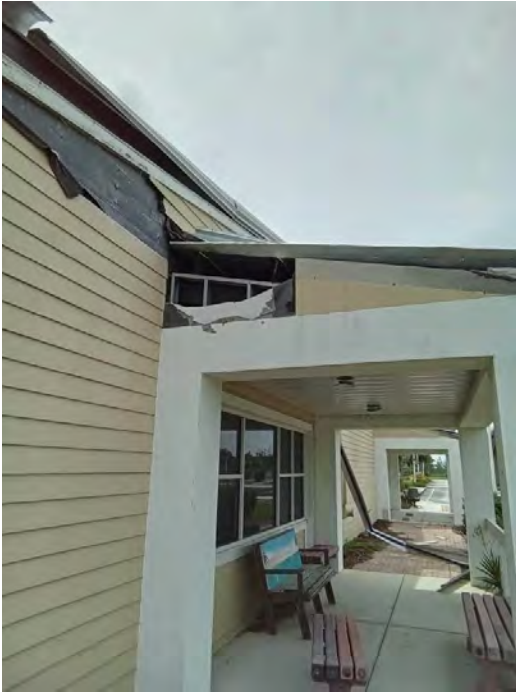
(67)

**Created:** Thu 27 Jul 10:48 2023  
**Group:** Exterior  
 - Fiber Cement Siding panels  
 - Roof Gutters

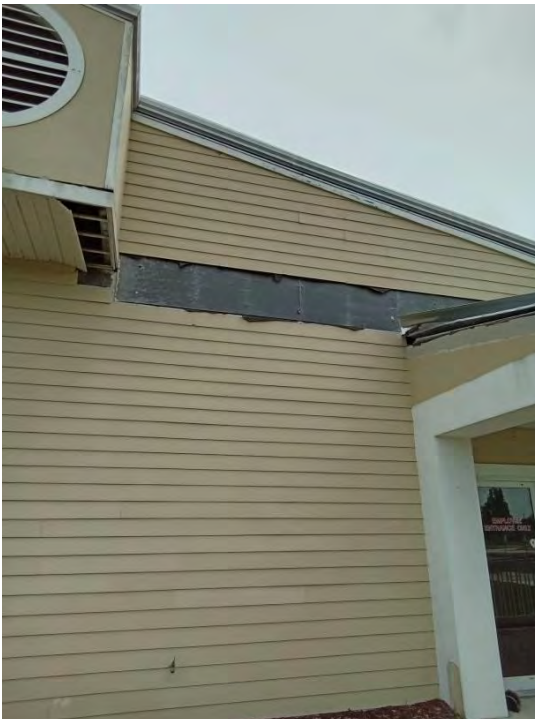
(70)

**Created:** Thu 27 Jul 10:50 2023  
**Group:** Exterior  
**Cause of Damage:** High Winds  
**Component Description:**

- Fiber Cement Siding panels
- Metal Soffit Panels

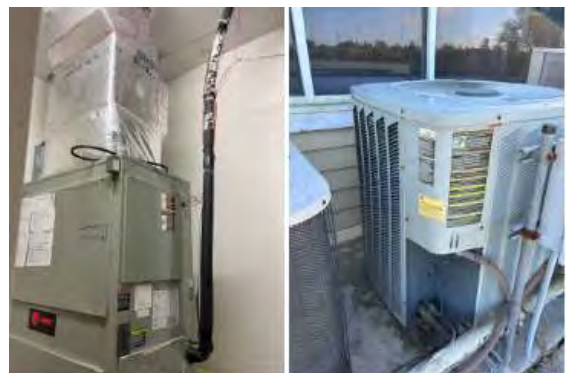
While most of the AHUs proved functional, a few showed low air flow, and most would not produce heat when heat mode was enabled at the corresponding thermostat. There were at least two mismatch systems observed, in which compatible condenser were mated with original AHUs. From the HVAC Systems Performance Report, it is worth noting that the installed systems exceed design airflow values, but fall short on cooling BTUs.

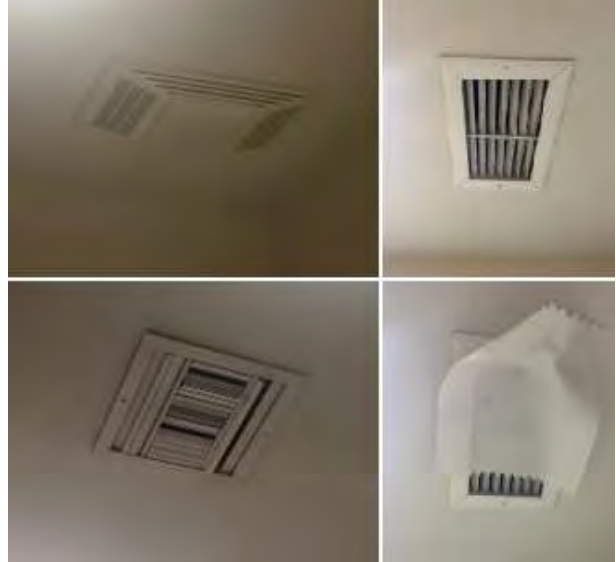
There are two exhaust fans serving this building. One inline fan serves the restrooms within the building. This fan was found to be operational, as tested at several exhaust grilles. Another fan, which is a combination fan/light assembly, serves a space which used to be a single occupant restroom, but is now used as a storage closet. The fan and the light were not operational when tested, but considering the new space use, it does not require replacement. The inline exhaust for the large restrooms should be replaced, as it is at the end of its ESL and storm-force winds have been shown to have detrimental effects on exhaust fans.

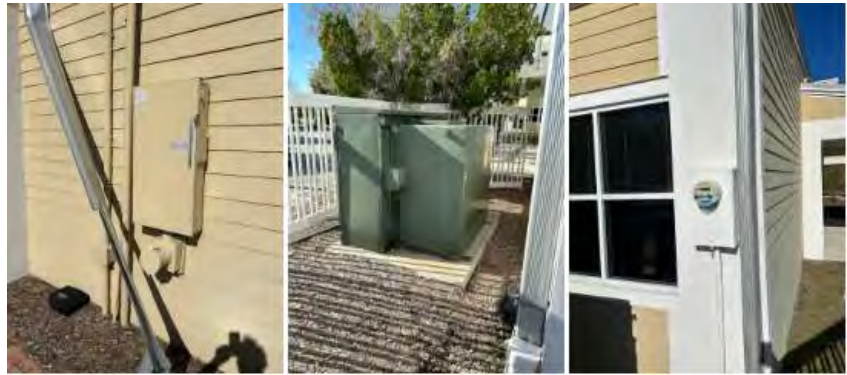
## Incoming Service

Incoming service from the utility provider appeared to be in good condition and there was stable power to the facility. It is still advised that the infrastructure and power quality are inspected by the appropriate providers.

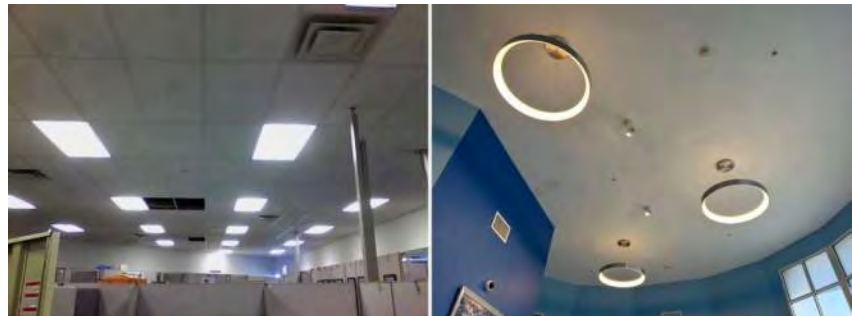
## Interior Lighting

Other than a few observed bad bulbs, all interior lighting and switches functioned properly. Thermal imaging was also done to check for hot spots in the ceiling, but none were discovered.

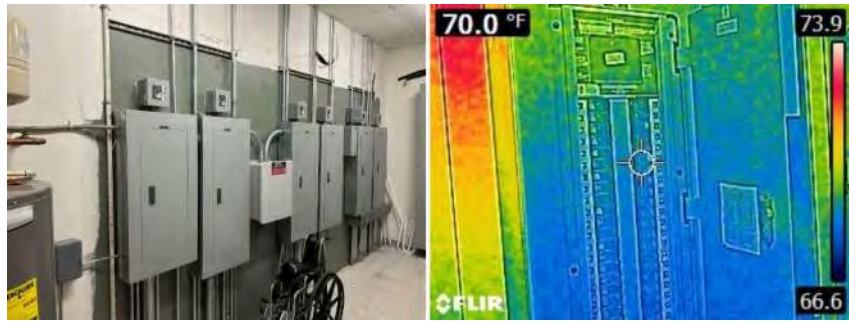
## Electrical Switchgear

Electrical switchgear, to include panels, breakers, and transformers, were visually inspected and scanned. No issues were found, and system components were within operating temp range.

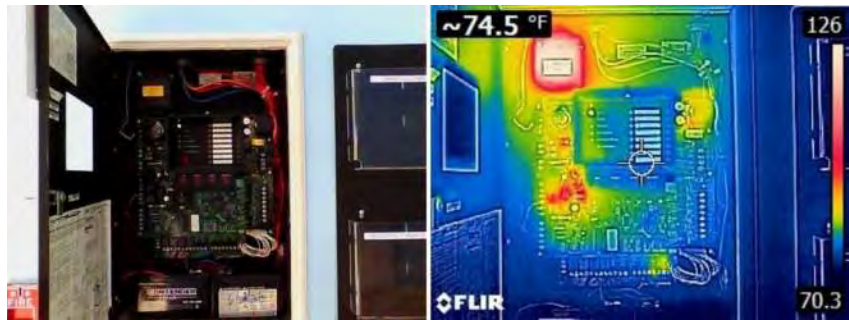
## Low Voltage - Fire

The main fire alarm panel and peripheral low voltage components were visually assessed and scanned for issues and hot spots. All board components were within normal temp ranges.

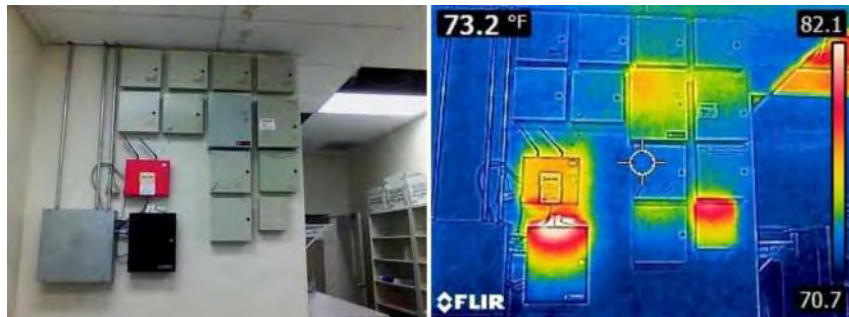
## Low Voltage - Security

Security and other low voltage peripheral panels were visually assessed and scanned for issues and hot spots. All board components were within normal temp operating ranges.

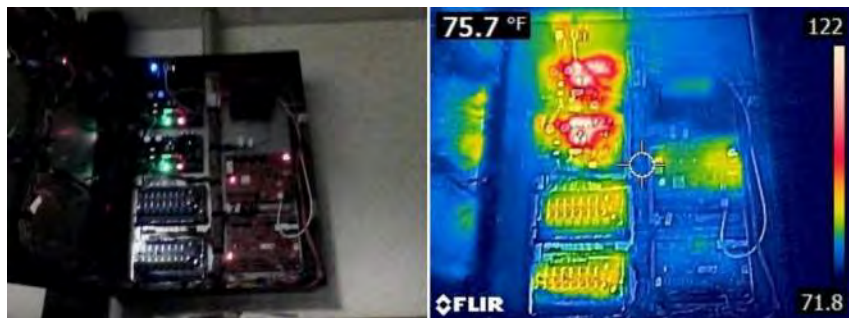
## Low Voltage - IT

Various IT equipment, closets racks, and components were visually assessed and thermal scanned for hot spots. All of the assessed IT components were within normal temp operating ranges.

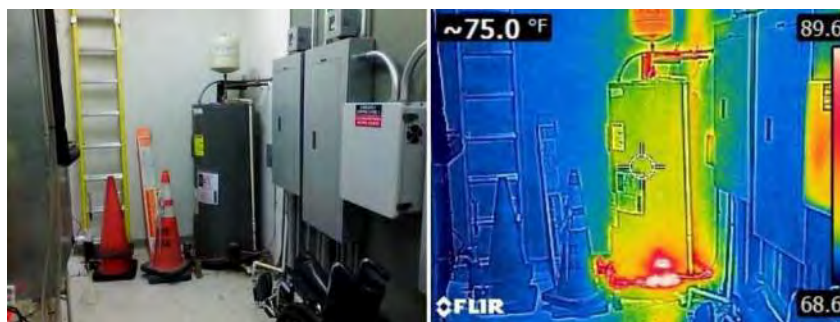
### Water Heating System

The Water Heating System was observed to be in great condition and performing like new, with no apparent damage. Thermal imaging shows profile of the water heater and the recirc pump.

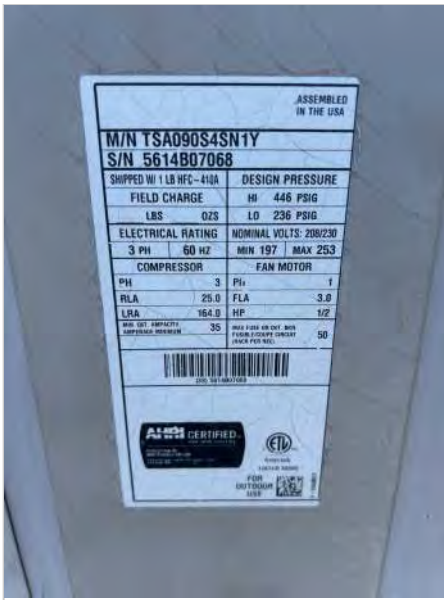
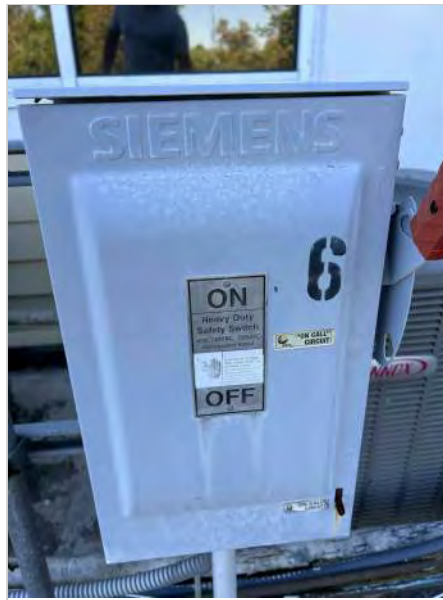
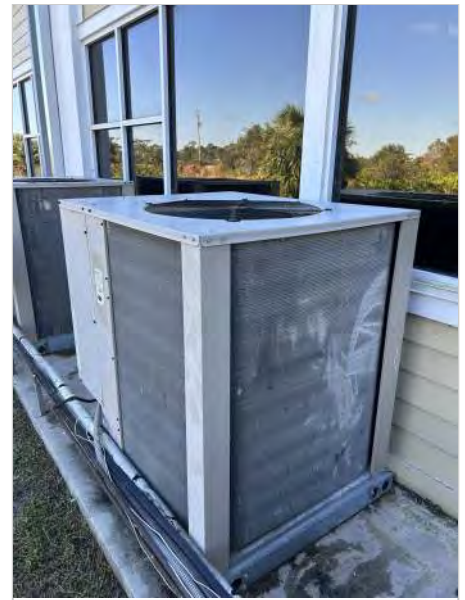
The outdoor unit features UV degradation and corrosion on the top and fan area. Many of the fasteners on this unit were also rusted. The fins are slightly damaged which could have been sustained during the hurricane.

Visually the indoor unit appears to be in good condition given its age and remaining service life. Copper tubing and insulation appeared to be free of damage.

The diffusers and return grilles for this unit were in good condition. This indicates that there is proper filtration from this unit and humidity has been properly controlled.

During testing, heating did not function. This unit is equipped with electric heat strips. It is possible that electrical surges damaged the heat strips.

Differences in the layout of the ductwork were found between the field conditions and original drawings. Return grilles do not align with drawing. Since there are known changes in the space it is possible that the intended airflow through each diffuser or grille is different than what was listed in the original design.

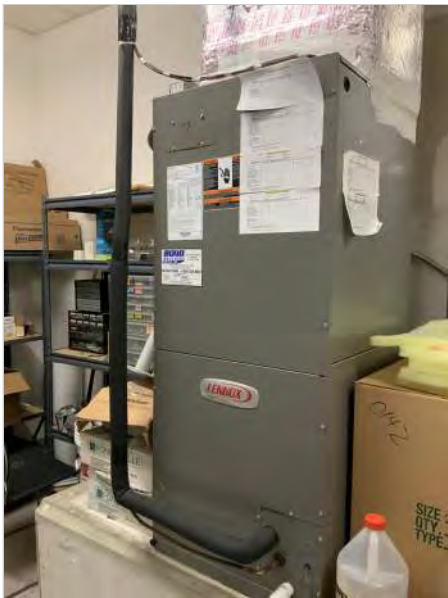
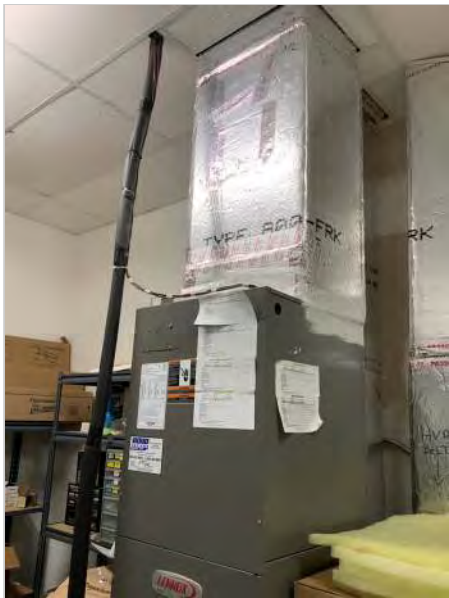
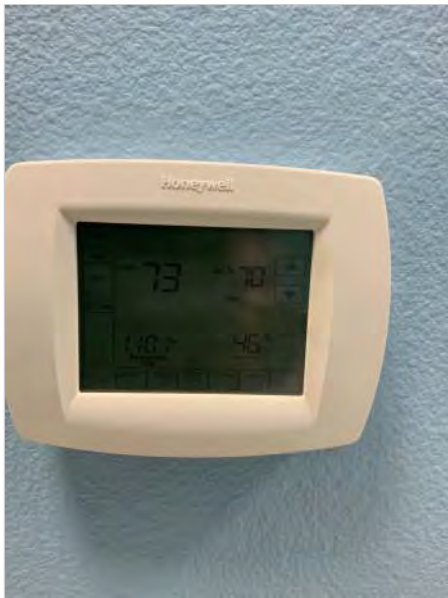
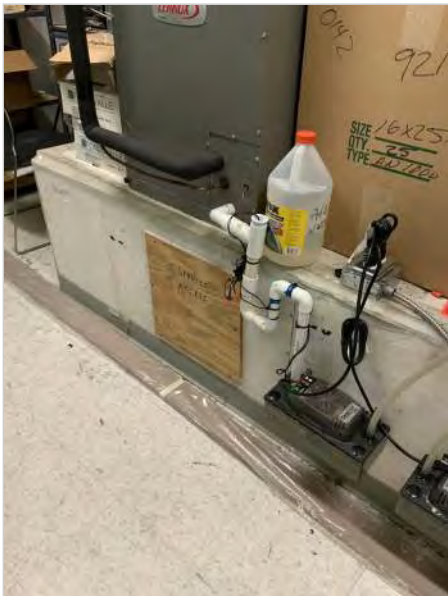
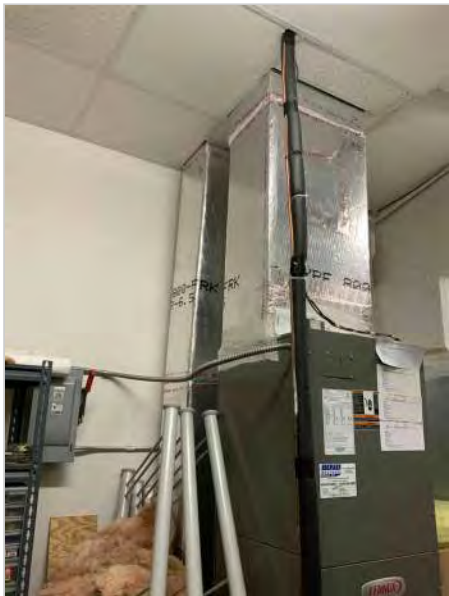
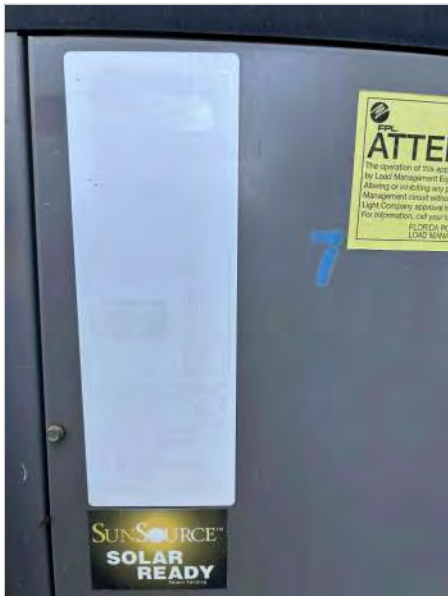
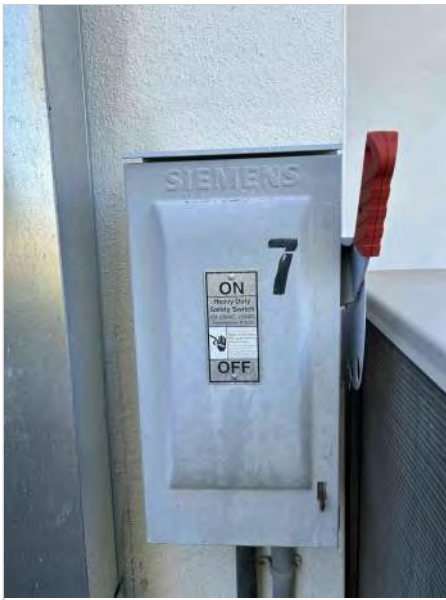
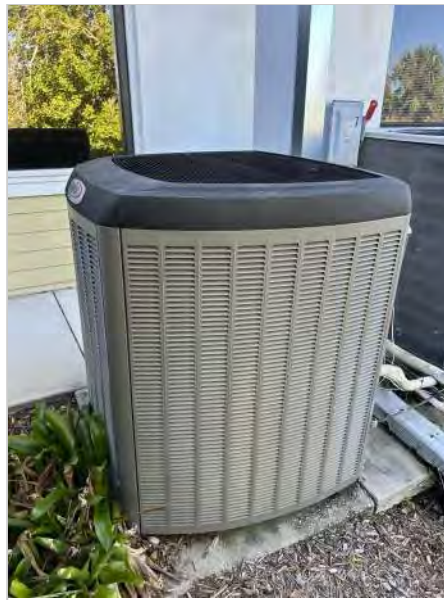
The condenser was observed to be functional. Other observations included minor degradation to refrigerant line insulation, faded paint, and minor damage to condenser coil fins, possibly caused by Hurricane Ian.

Visually the indoor unit appears to be in newer condition given its age and remaining service life. Copper tubing and insulation appeared to be free of damage.

The diffusers and return grilles for this unit were in good condition. This indicates that there is proper filtration from this unit and humidity has been properly controlled.

During testing, it was found that the air handler provides sufficient heating and cooling.

Major differences in the layout of the ductwork were found between the field conditions and the provided drawings. Return and supply grills do not align with drawing. Since there are known changes in the space it is possible that the intended airflow through each diffuser or grille is different than what was listed in the original design.

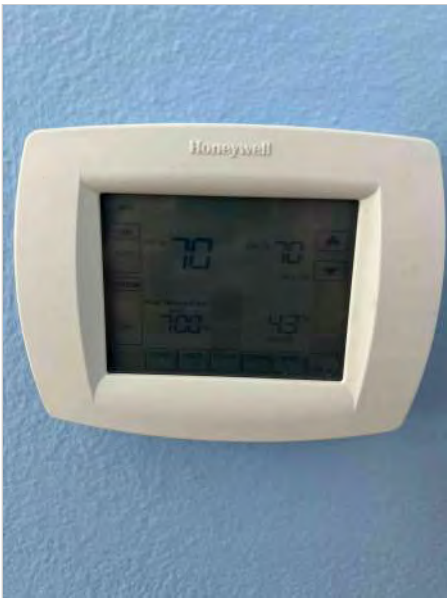
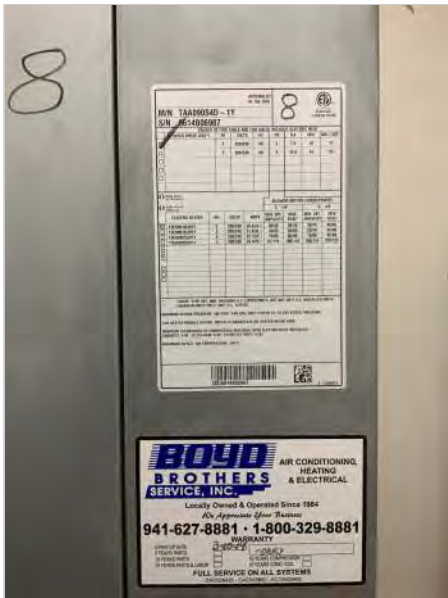
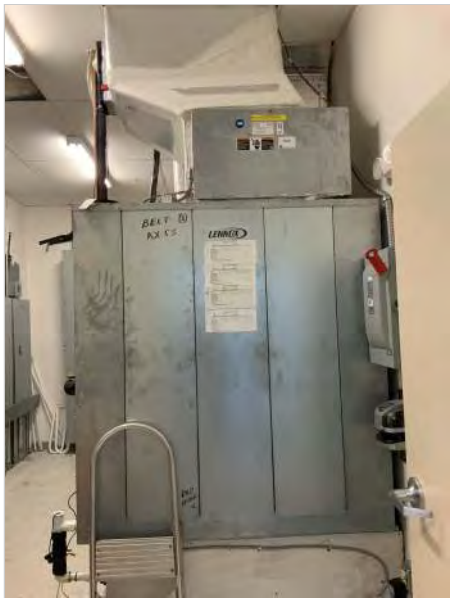
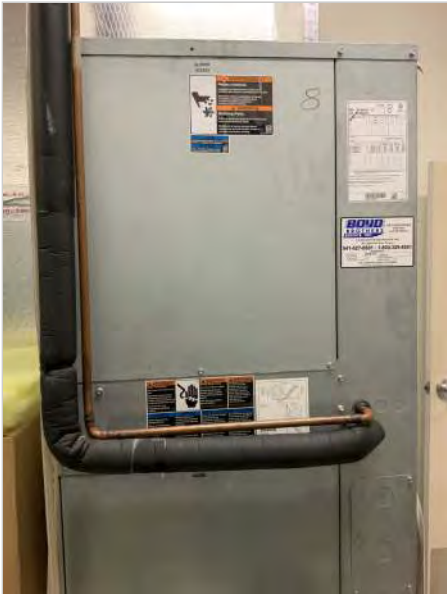
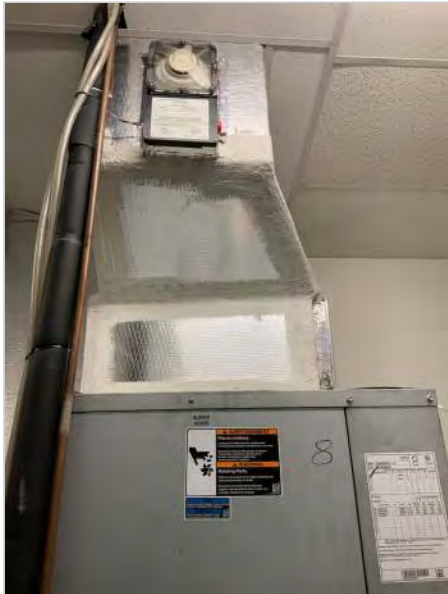
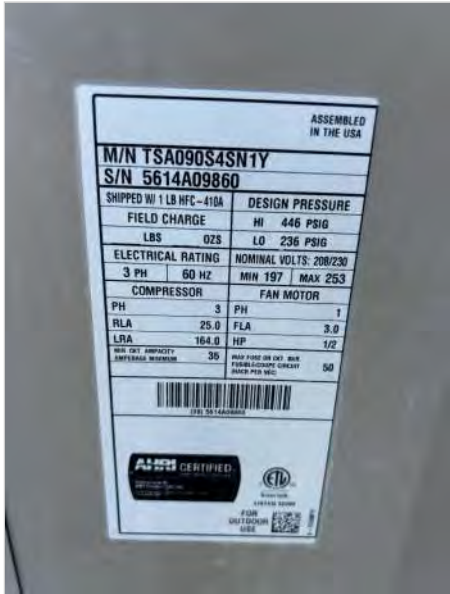
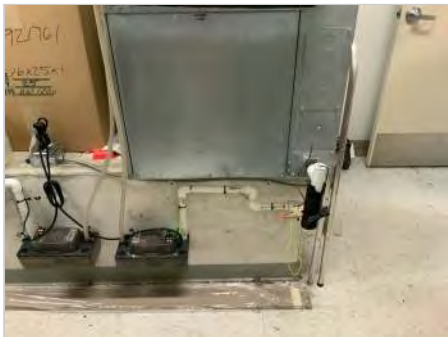
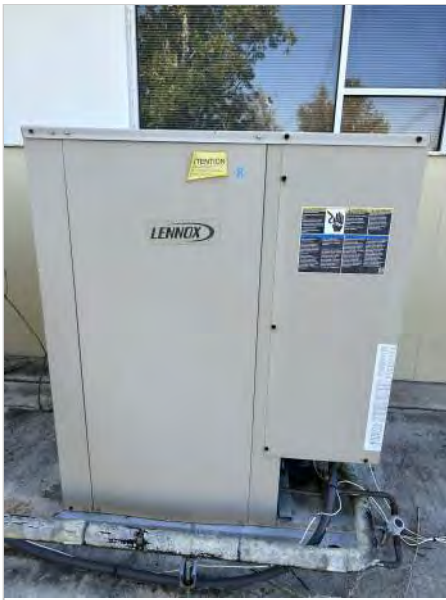
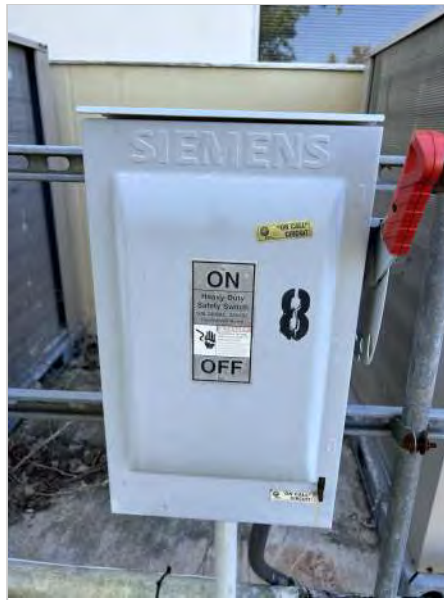
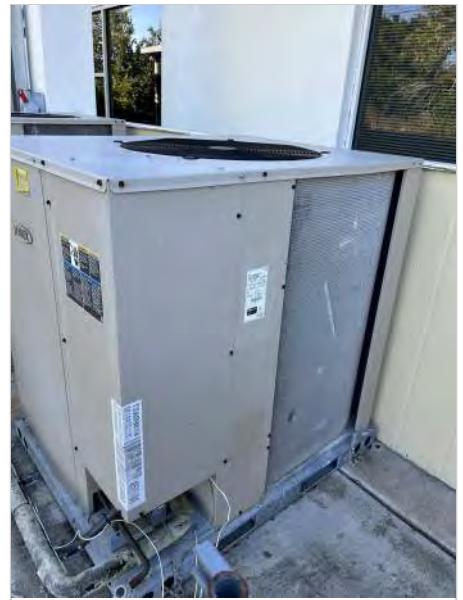
During testing, it was observed that the fan within the air handler was functional but did not provide heating or cooling.

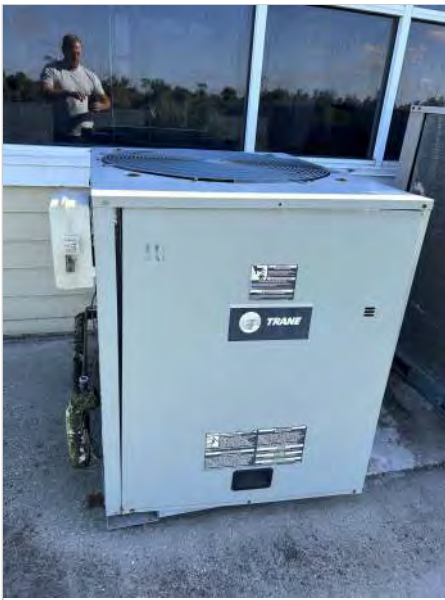
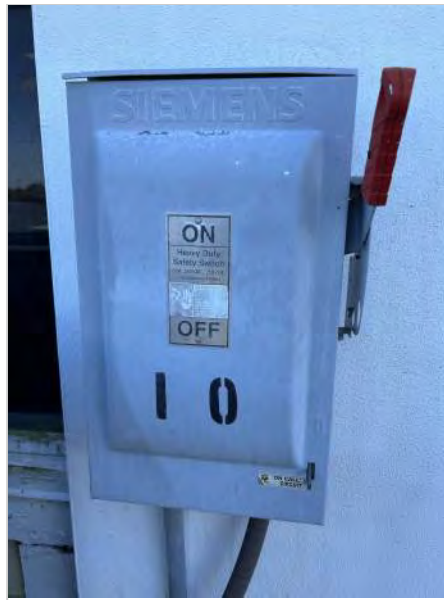
The condenser was found to be functional, with only minor degradation to refrigerant line insulation, faded paint, and minor damage to condenser coil fins, possibly caused by Hurricane Ian. The sheet metal access panel was observed to be loose/compromised at the time of assessment.

The indoor unit appears to be in good condition considering its age and expected remaining service life. This unit features slightly more noise when operating compared to other units but this is not beyond a reasonable level. There is a stain on the ceiling tile near where the refrigerant lines penetrate the ceiling grid. This may indicate that there is condensation forming on the line. Leak may have also been relating to envelope or other piping systems.

The diffusers and return grilles for this unit were in good condition. This indicates that there is proper filtration from this unit and humidity has been properly controlled.

During testing, heating did not function. This unit is equipped with electric heat strips. It is possible that power surges during the hurricane could have resulted in damage to the heat strips. Due to ambient conditions and limitations on the thermostat, cooling mode could not be enabled or confirmed.
