**Site Inspection Report for  
Charlotte County –  
East Port Environmental Campus  
Administration Building A  
Cost Benchmarking Revision 3  
Florida Hurricane Ian (DR-4673-FL)**

Prepared for:  
Charlotte County, Florida

February 26, 2024

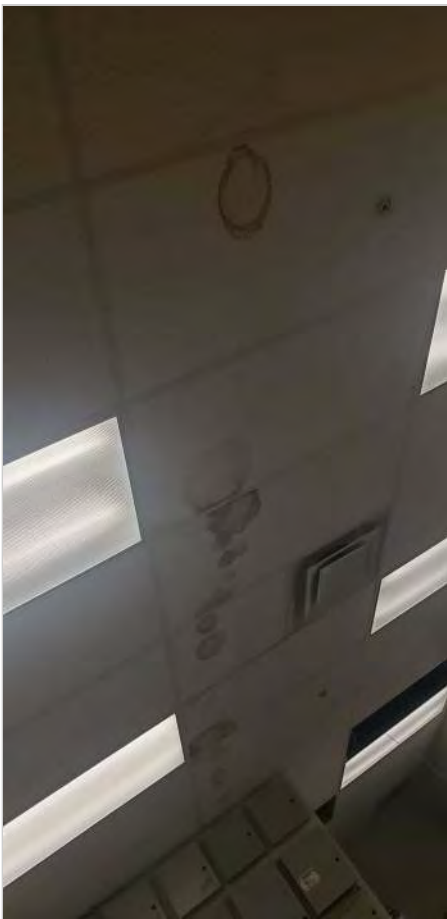
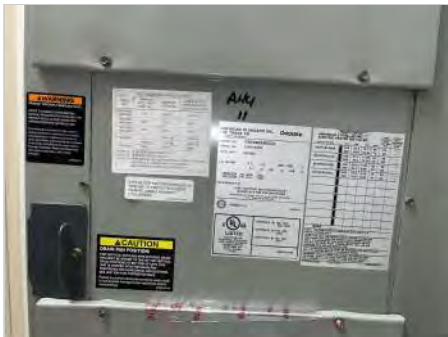
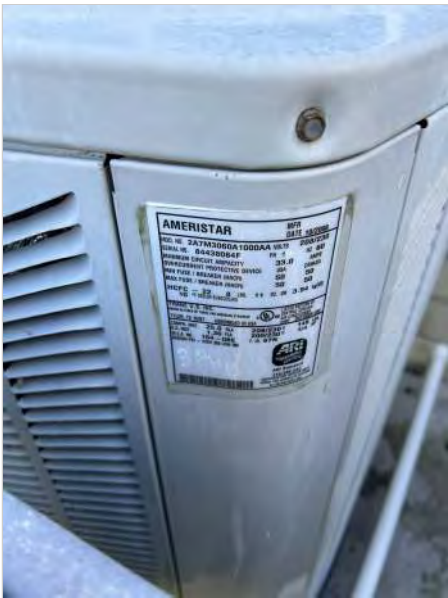
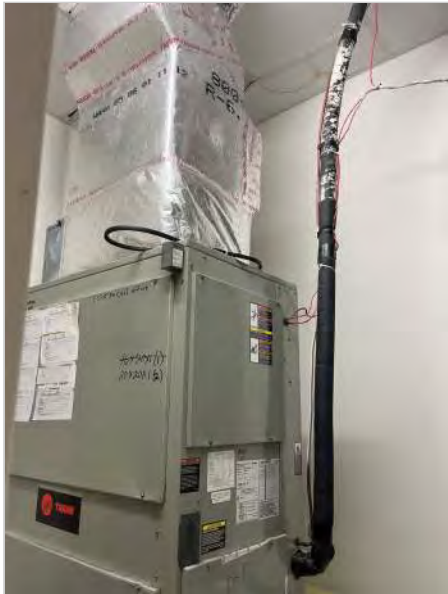
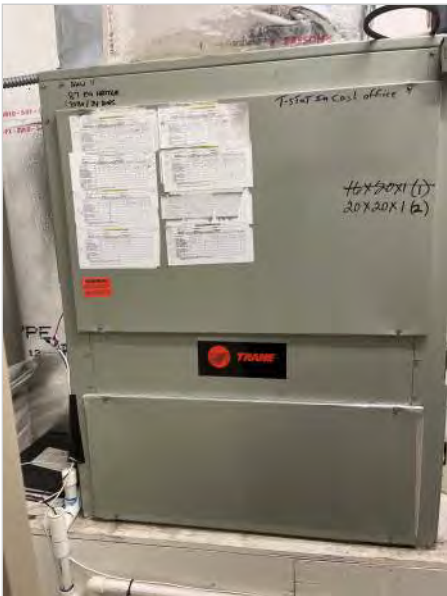
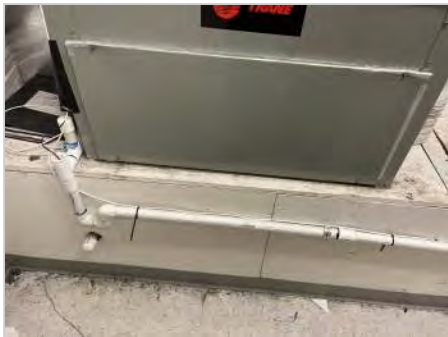
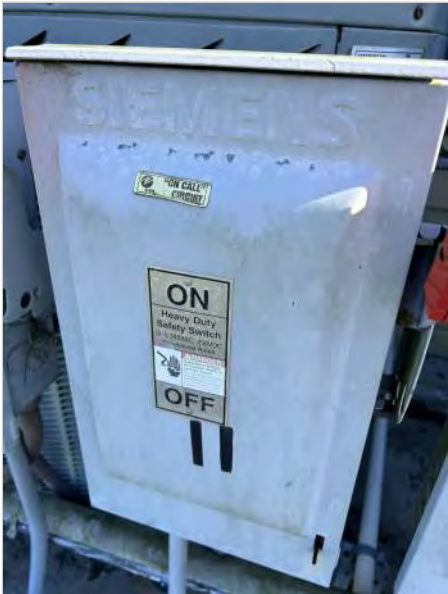
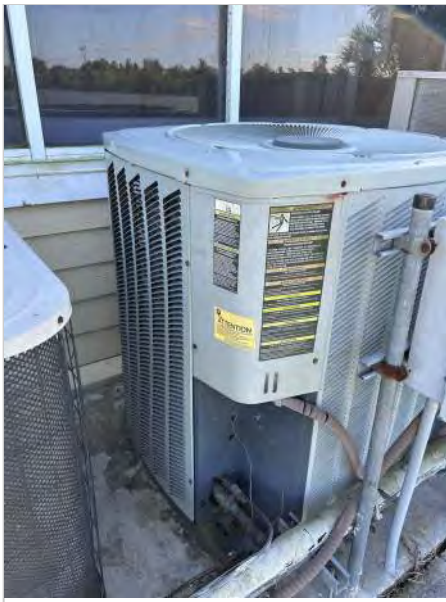
The condenser was found to be functional, with degradation to refrigerant line insulation, faded paint, and a compromised incoming power whip. The air handler was in fair condition.

Visible ductwork and interior refrigerant piping and insulation appeared to be in good condition.

The diffusers and return grilles for this unit were in good condition, which indicates that there was likely proper maintenance and filtration of this unit and that humidity has been properly controlled in the space it served.

The system tested functional in cooling mode, but the observed flows for this system were very low - granted the design flows are rather low as well. The use of this space has changed from storage to office spaces and thus should warrant a higher airflow to satisfy the occupants. Heating functionality could not be confirmed, as heat was not produced when it was placed in heat mode. We recommend replacement of this system.

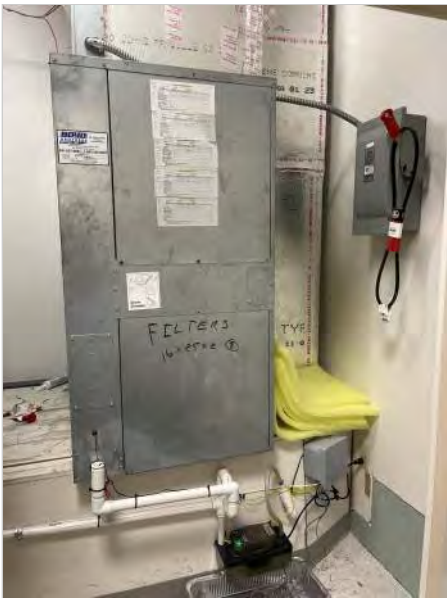
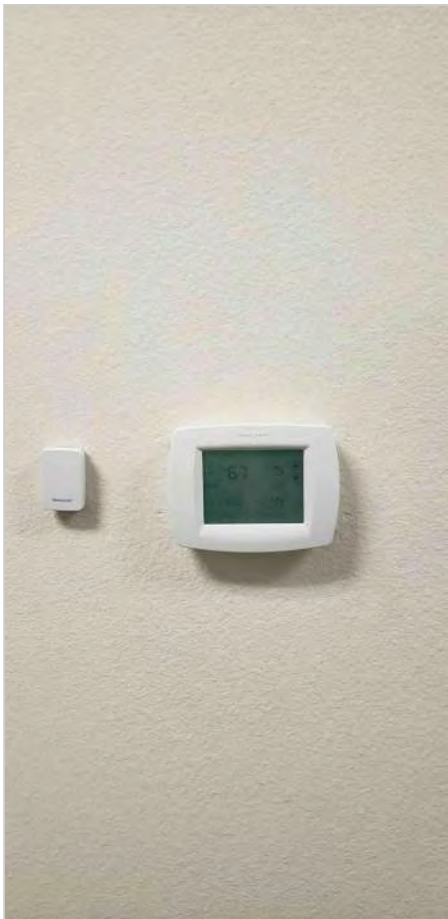
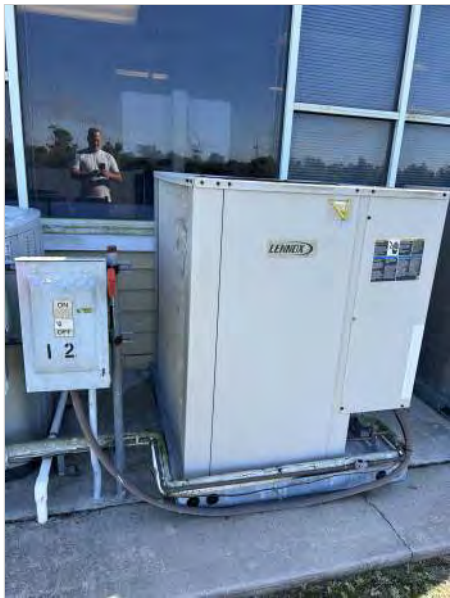
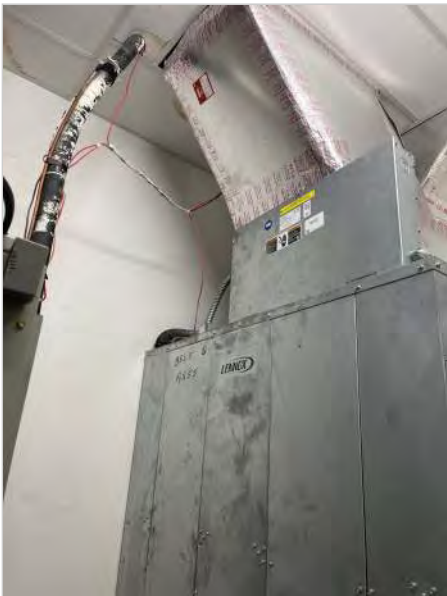
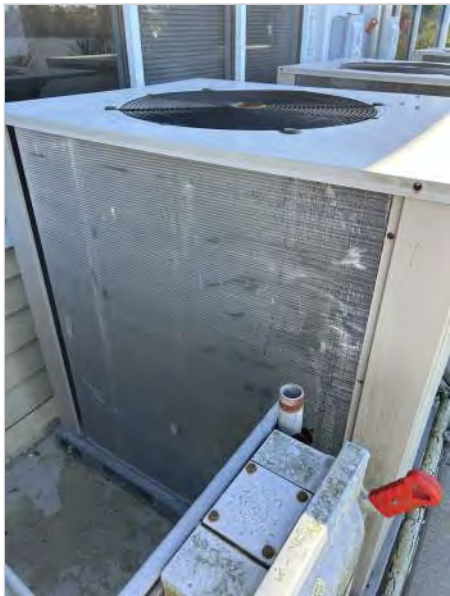
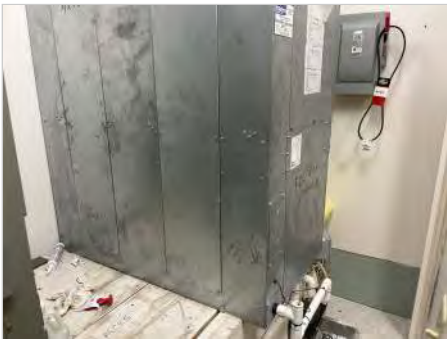
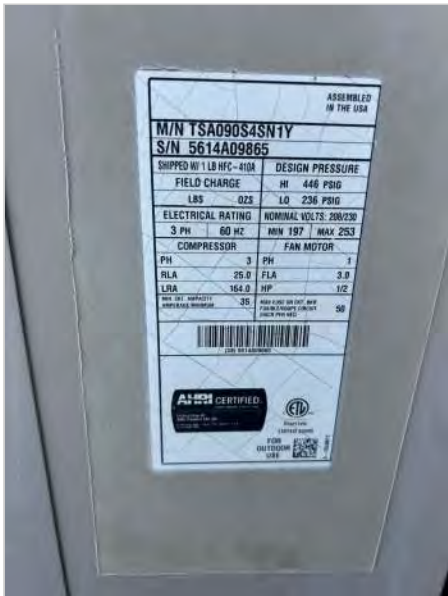
The condenser was found to be functional, with only minor degradation to refrigerant line insulation, faded paint, and minor damage to condenser coil fins, possibly caused by Hurricane Ian.

The air handler also appeared to be in good condition. Visible ductwork and interior refrigerant piping and insulation appeared to be in good condition. Nameplate data could not be gathered for the indoor unit since it is covered and thus inaccessible.

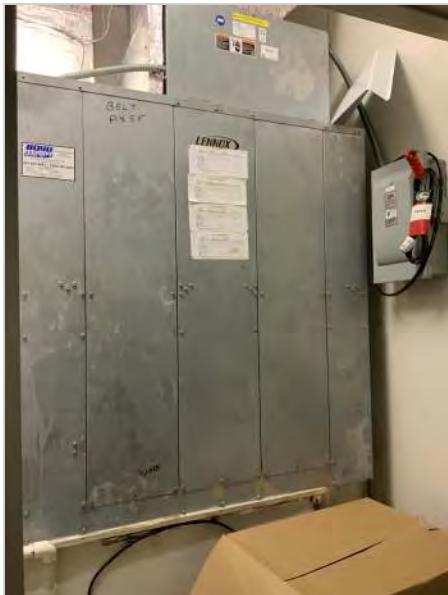
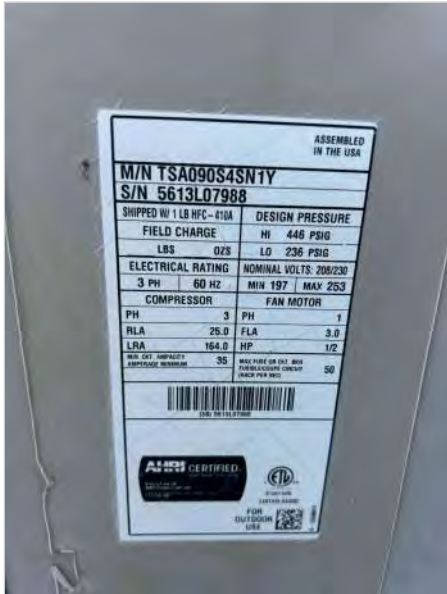
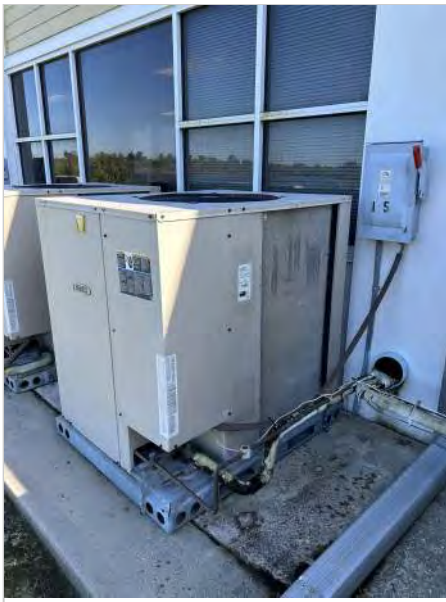
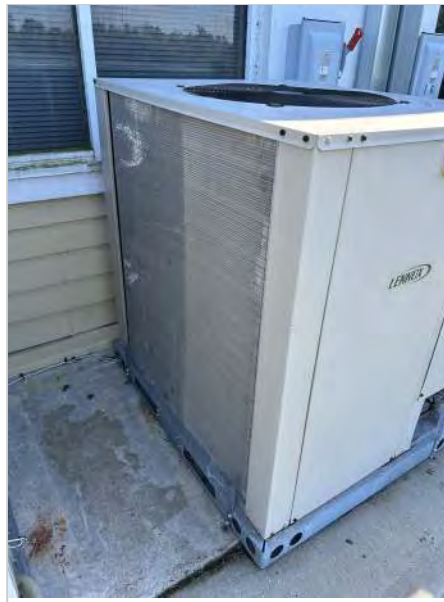
The condenser was found to be functional, with only minor degradation to refrigerant line insulation, faded paint, and minor damage to condenser coil fins, possibly caused by Hurricane Ian.

The air handler also appeared to be in good condition. Visible ductwork and interior refrigerant piping and insulation appeared to be in good condition.

The diffusers and return grilles for this unit were in good condition, which indicates that there was likely proper maintenance and filtration of this unit and that humidity has been properly controlled in the space it served.

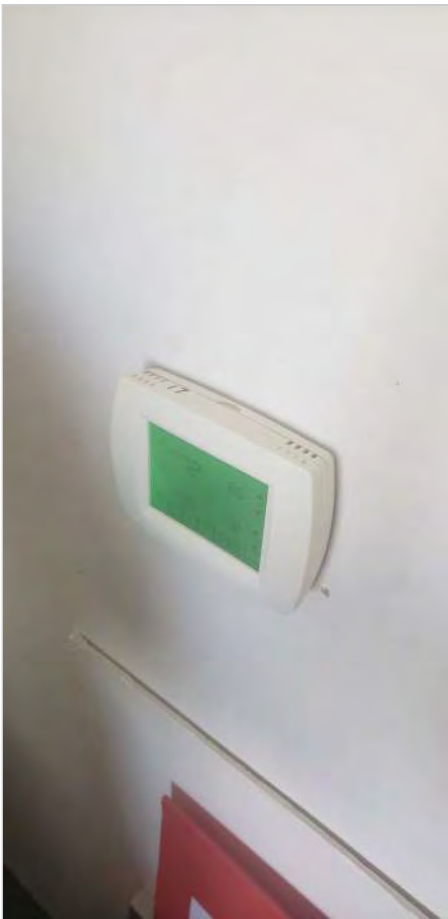
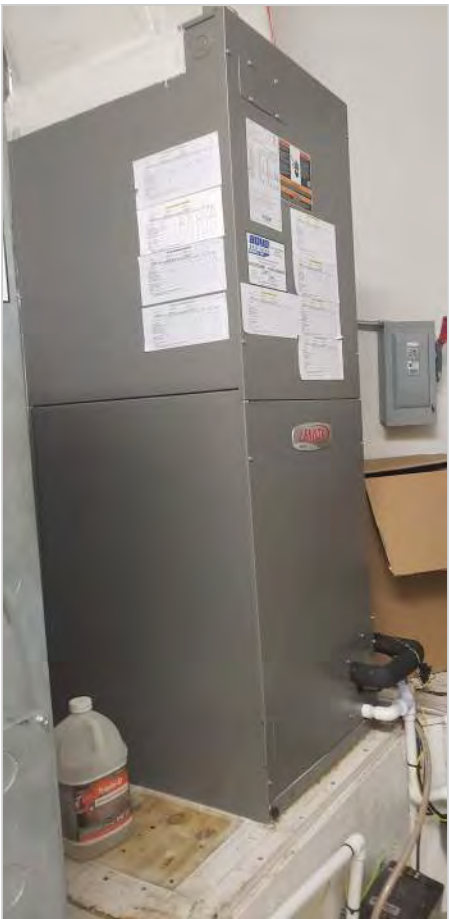
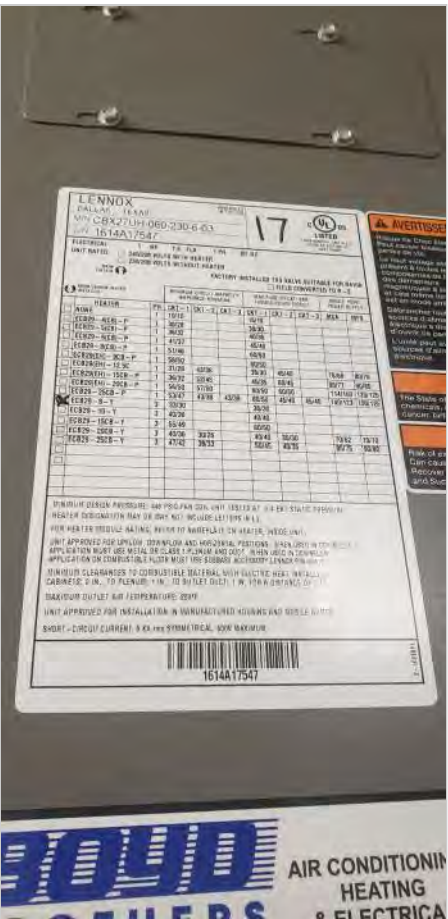
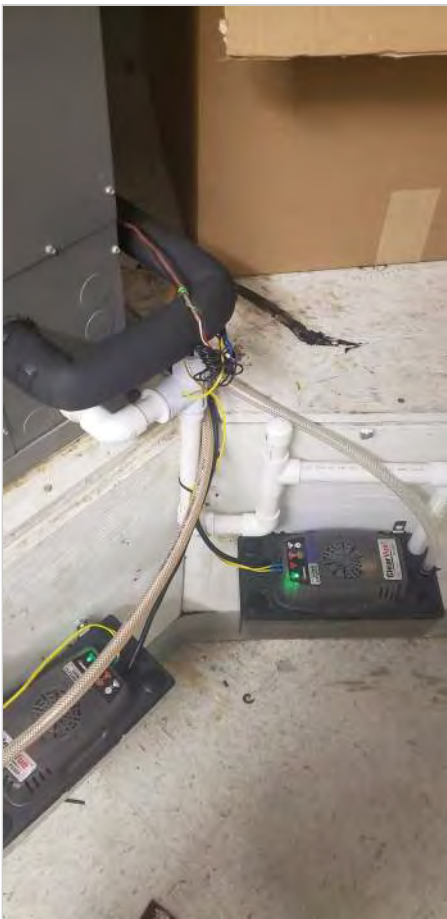
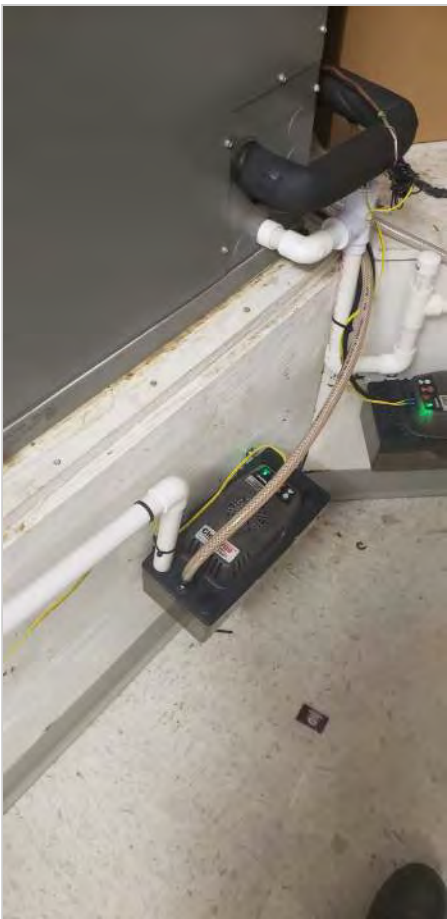
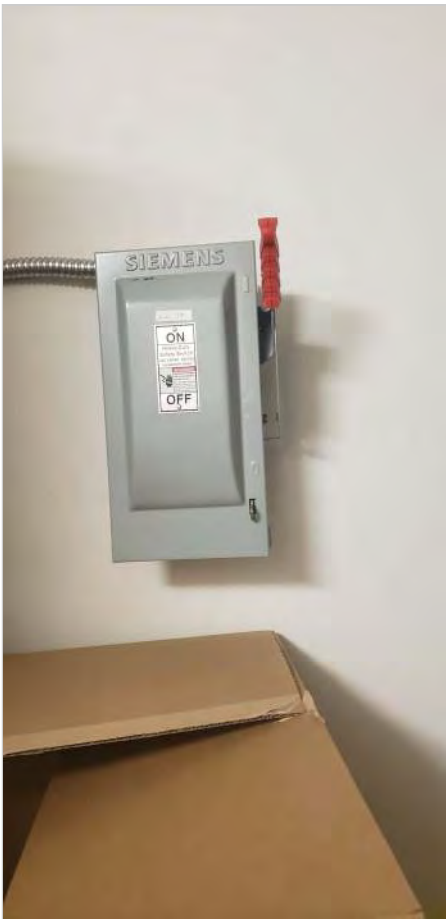
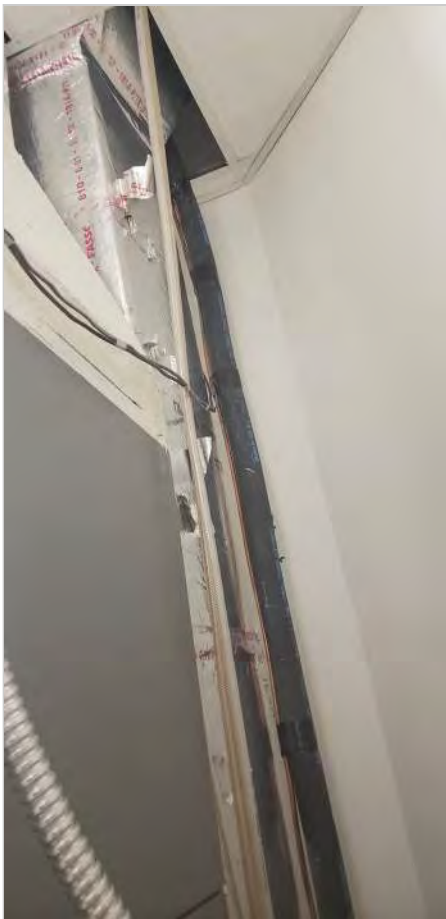
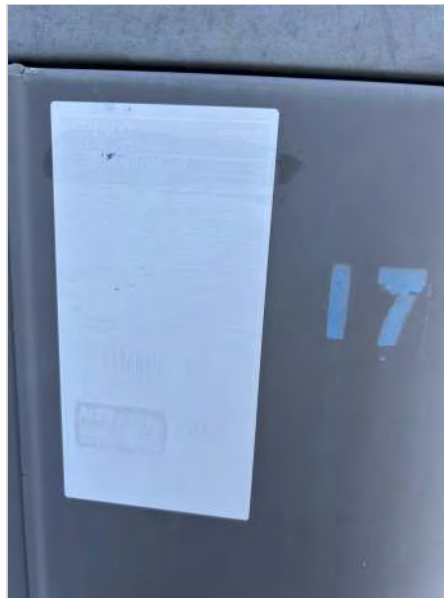
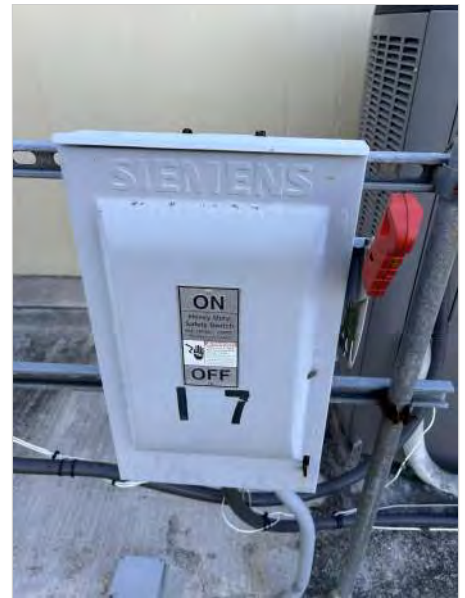
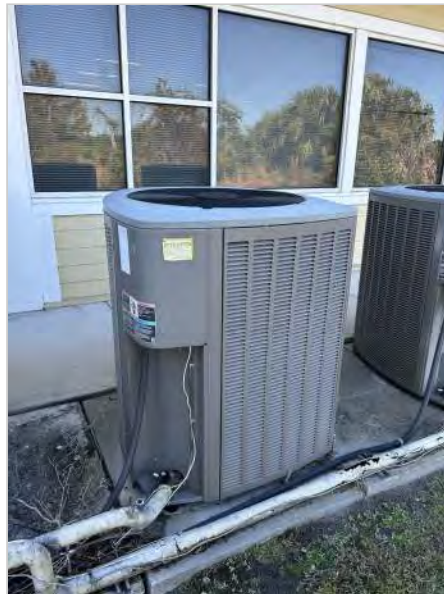
The condenser was found to be functional, with only minor degradation to refrigerant line insulation, faded paint, and minor damage to condenser coil fins, possibly caused by Hurricane Ian. See System Performance Report for recorded airflows and temperatures.

Visually, the indoor unit appeared to be in good condition. The insulation and refrigerant lines that were visible were free from damage. The condition of this unit aligned with this unit's age and estimated remaining service life.

The diffusers and return grilles for this unit were in good condition. This indicates that there is proper filtration from this unit and humidity has been properly controlled.

The unit was found to be capable of both heating and cooling.

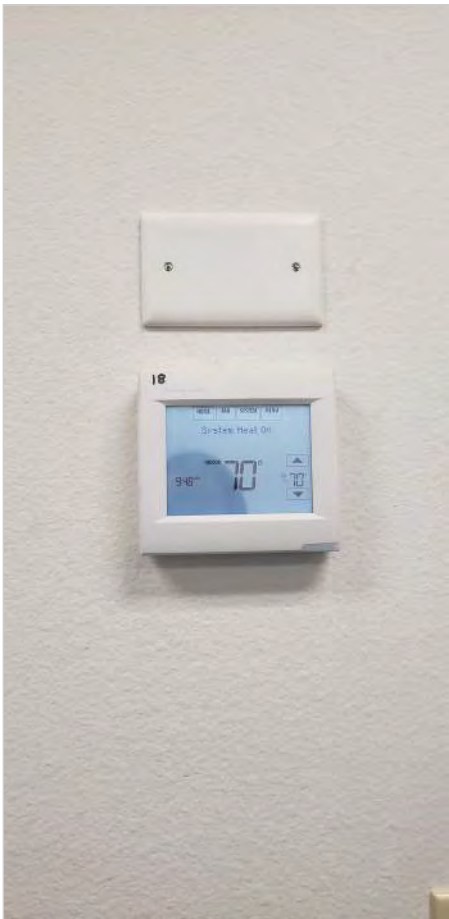
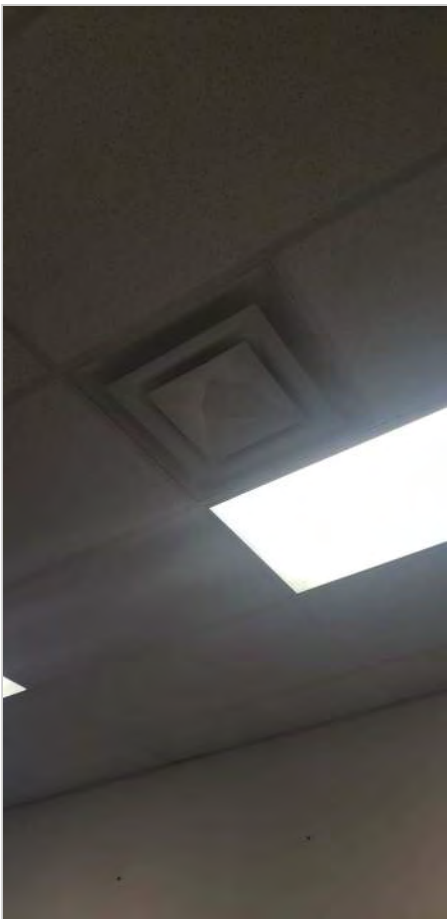
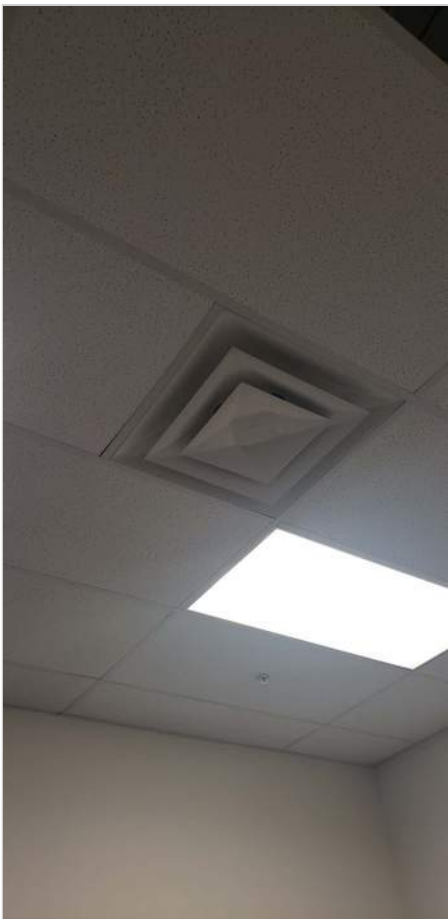
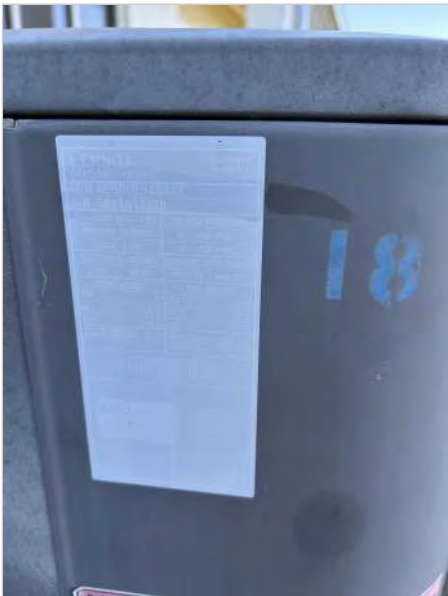
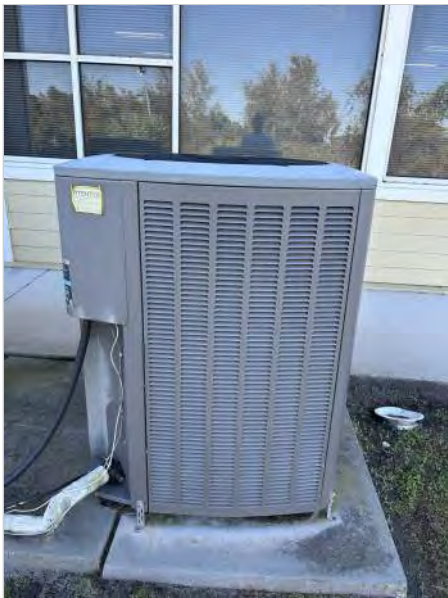
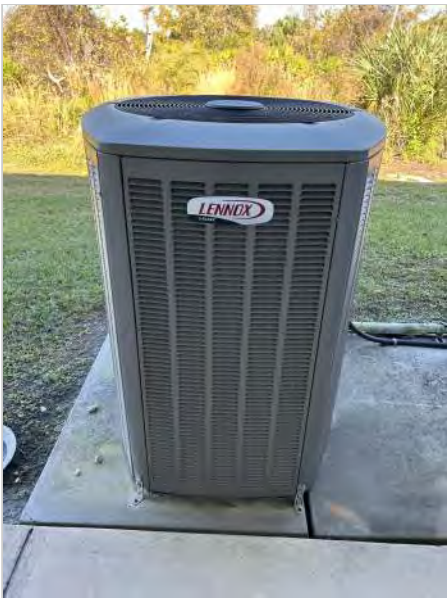
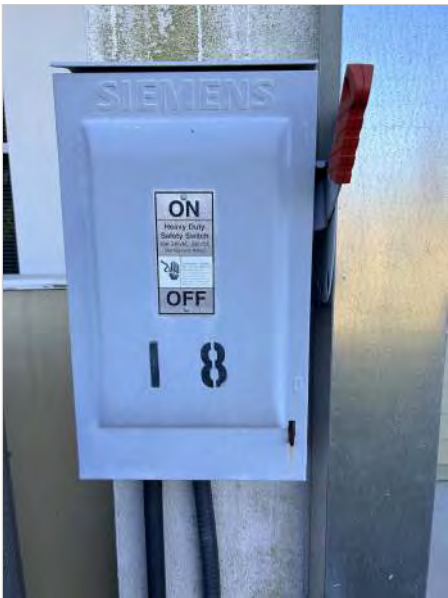
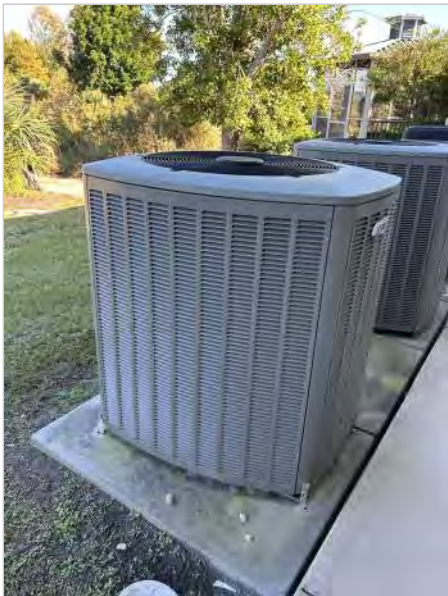
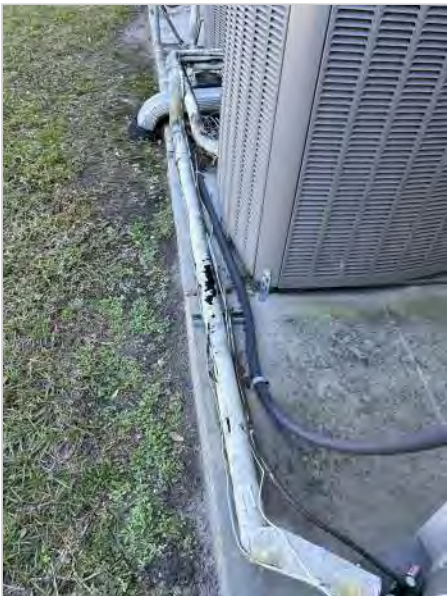
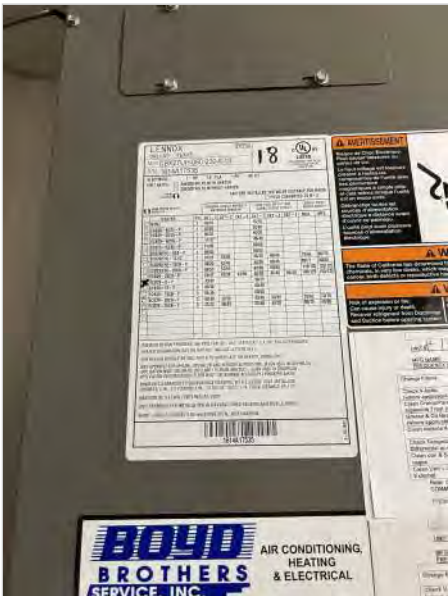
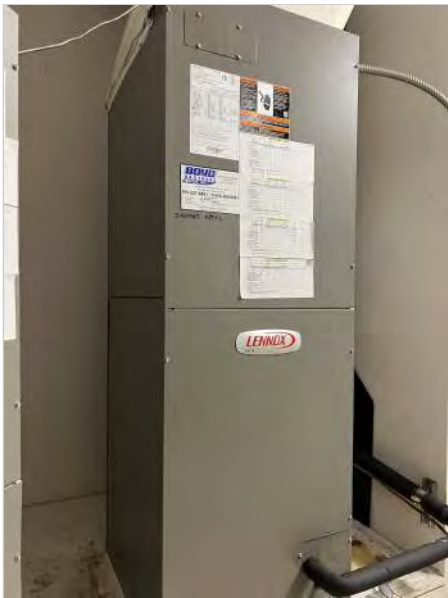
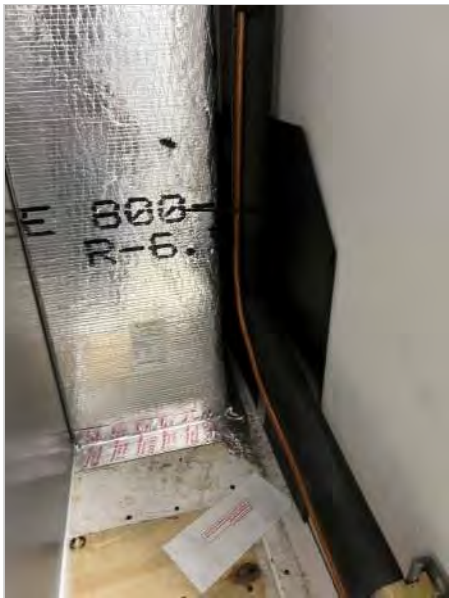
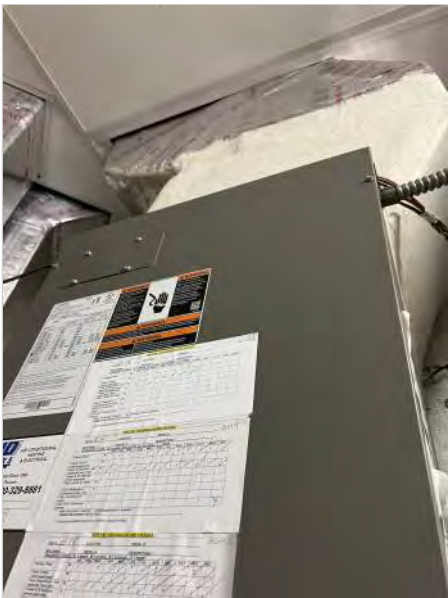
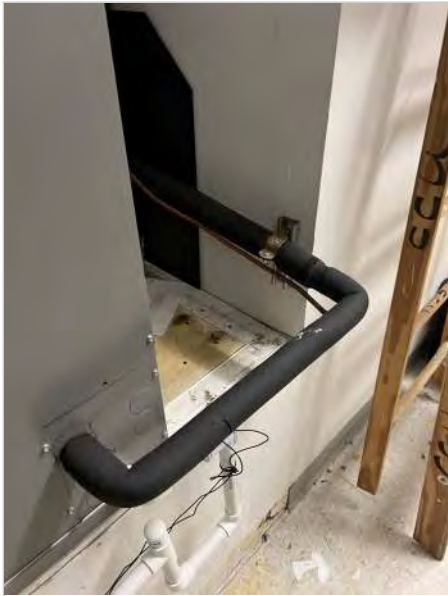
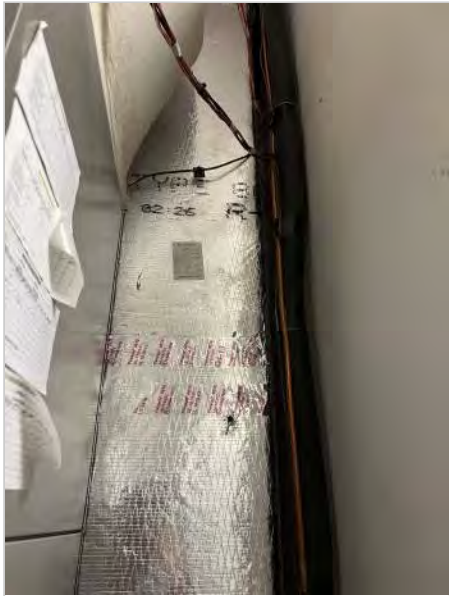
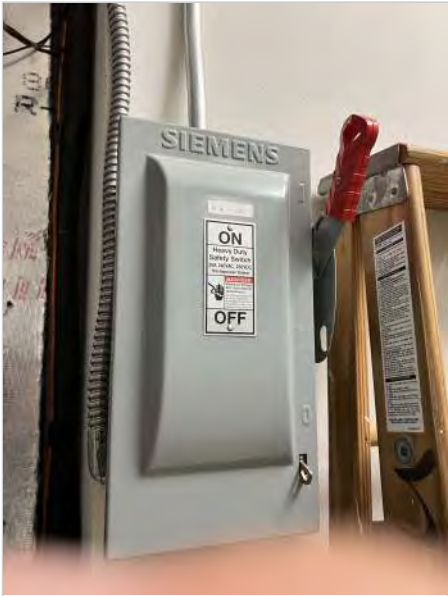
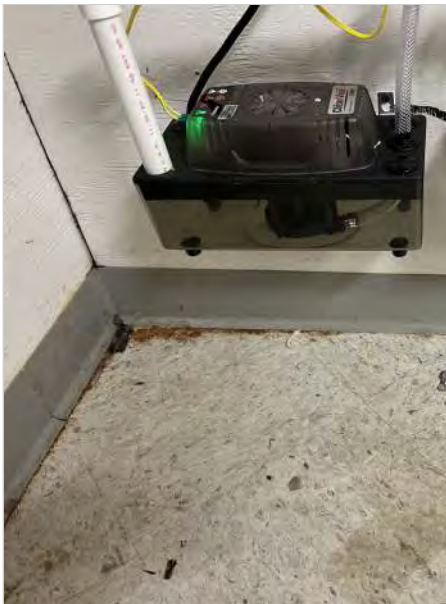
The condenser was found to be functional, with only minor degradation to refrigerant line insulation, faded paint, and minor damage to condenser coil fins, possibly caused by Hurricane Ian.

The indoor unit appeared to be in good condition, operating quietly without any excessive noise. The insulation and tubing inside also seemed to be well-maintained.

The diffusers and return grilles were notably clean, suggesting effective air conditioning function and filtration.

The unit was found to be capable of both heating and cooling.

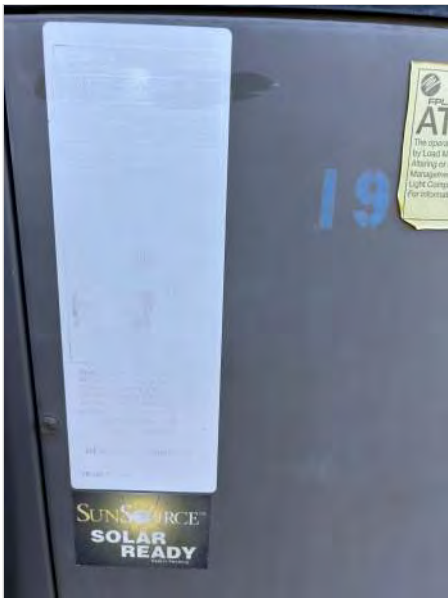
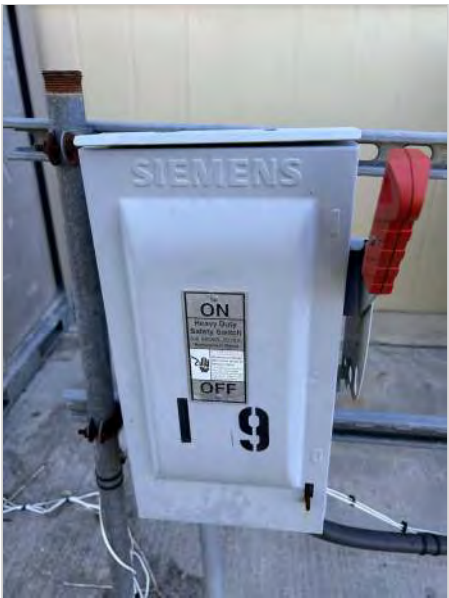
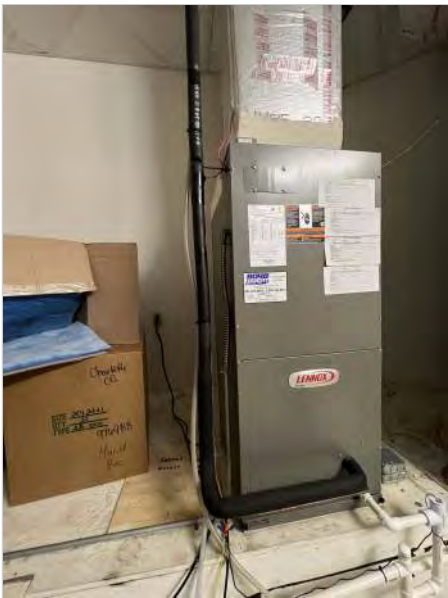
The condenser was found to be functional, with only minor degradation to refrigerant line insulation, faded paint, and minor damage to condenser coil fins, possibly caused by Hurricane Ian.

The indoor unit appeared to be in good condition, operating quietly without any excessive noise. The insulation and tubing inside also seemed to be well-maintained.

The diffusers and return grilles were notably clean, suggesting effective air conditioning function and filtration.

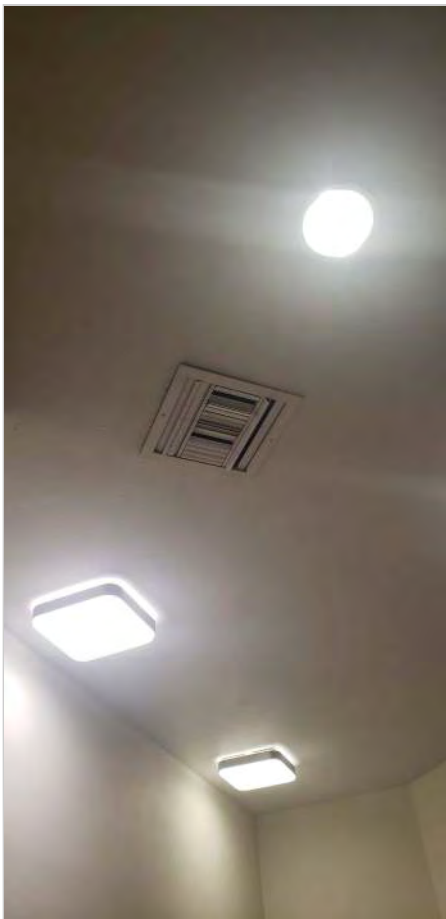
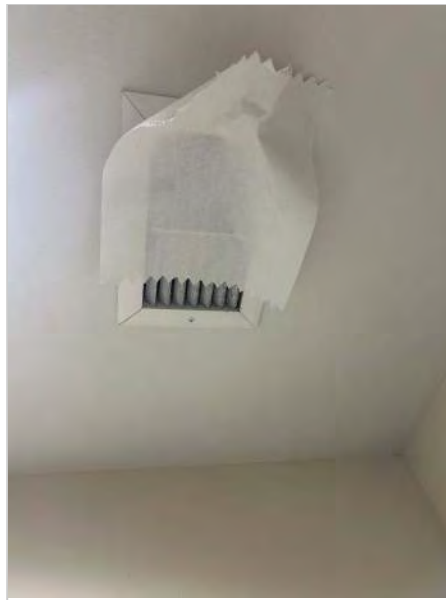
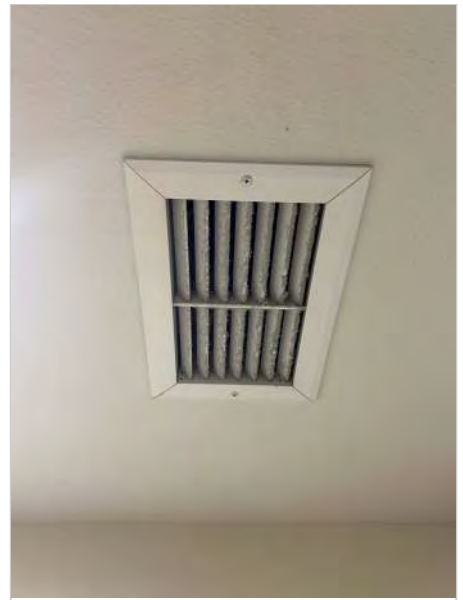
This unit is an inline exhaust fan that serves the restrooms. The fan was found to be functional. The fan itself was not accessible so it is assumed to be the original fan.

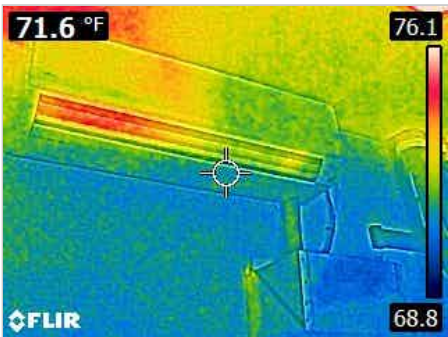
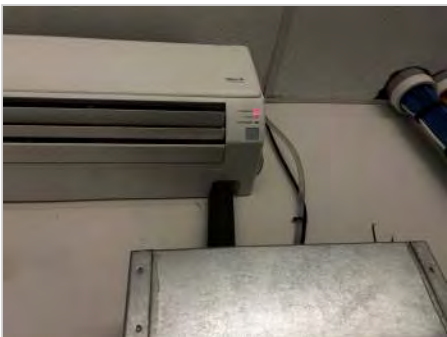
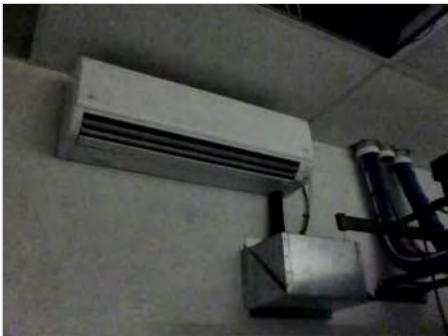
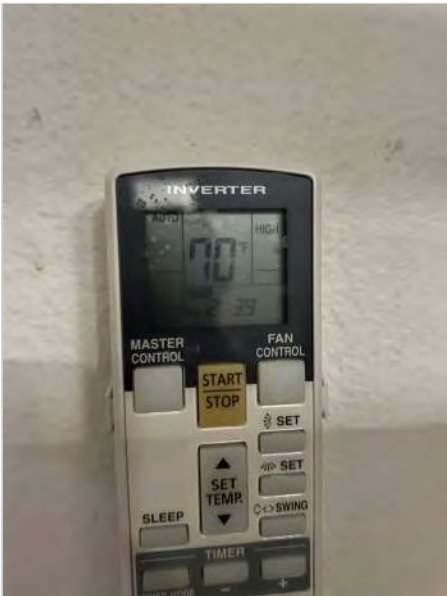
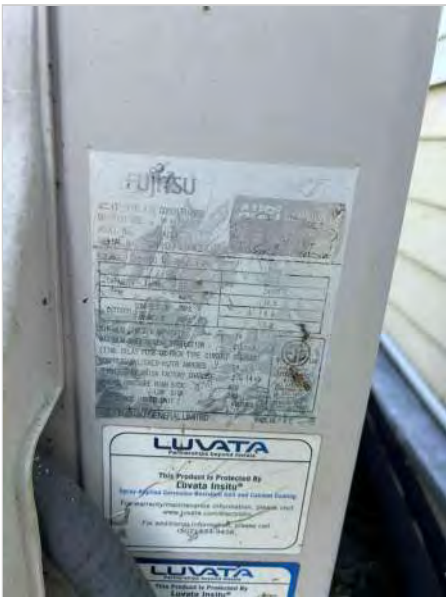
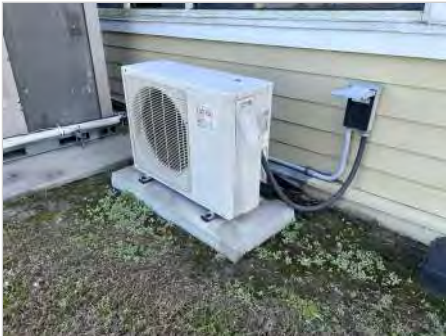
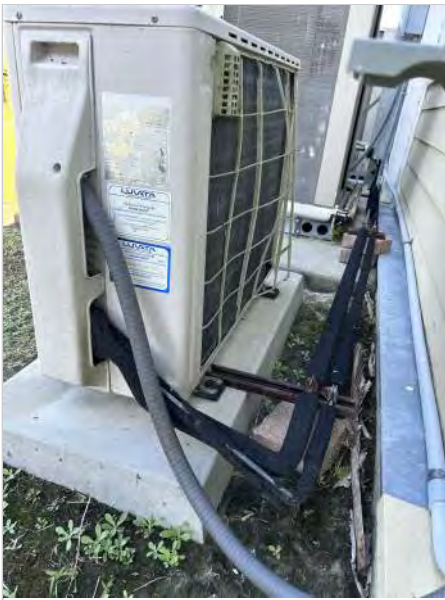
FCU/ IDU observed moving air with a flashing alarm indicator. Unit was calling for cooling but outside condenser was not running. Exterior line set insulation was deteriorated and rear plastic guard appeared warped and detached from condenser chassis. Fujitsu support confirmed 1/10/2013 as date of manufacture. Higher SEER units are available.
