**Site Inspection Report for  
Charlotte County –  
East Port Environmental Campus  
Administration Building A  
Cost Benchmarking Revision 3  
Florida Hurricane Ian (DR-4673-FL)**

Prepared for:  
Charlotte County, Florida

February 26, 2024

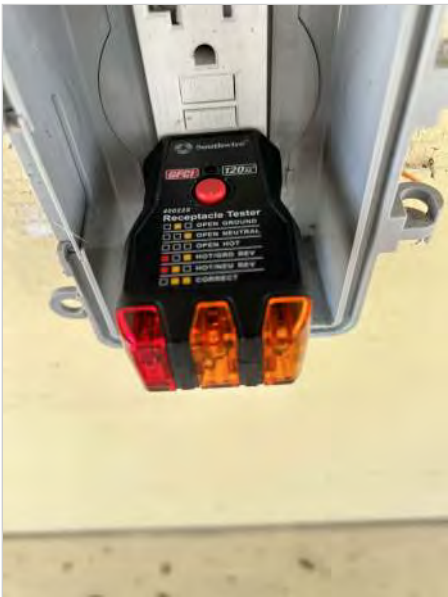
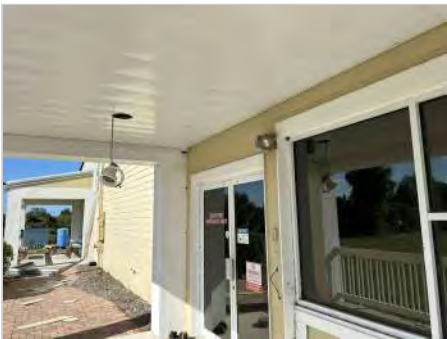
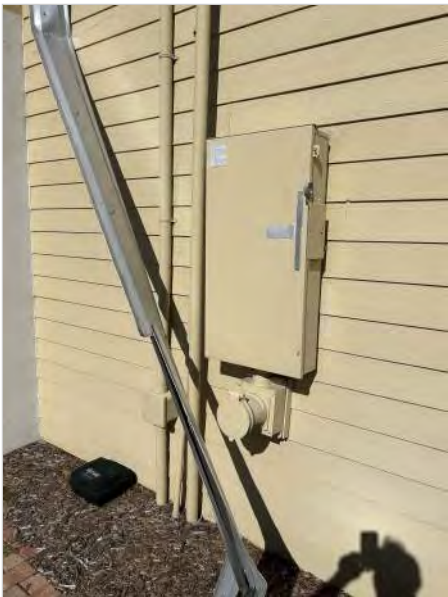
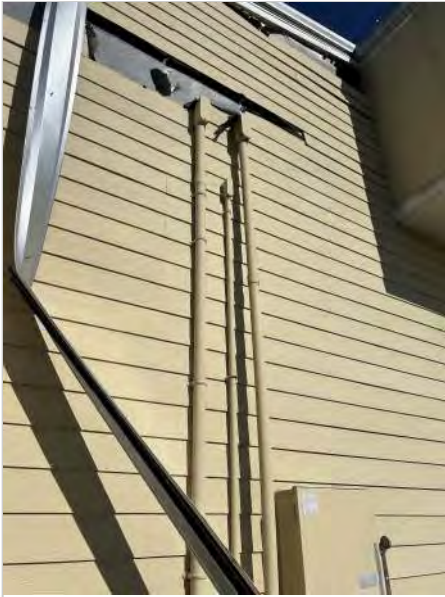
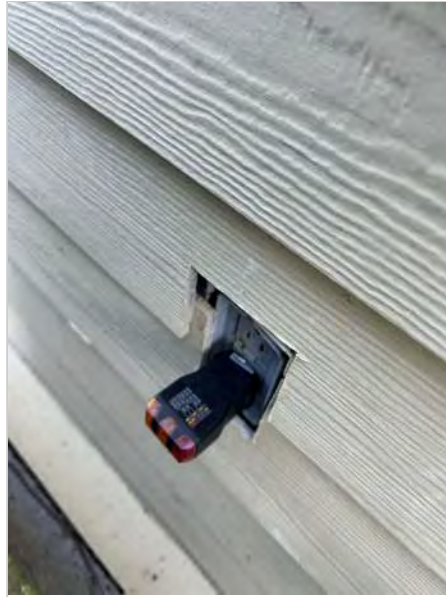
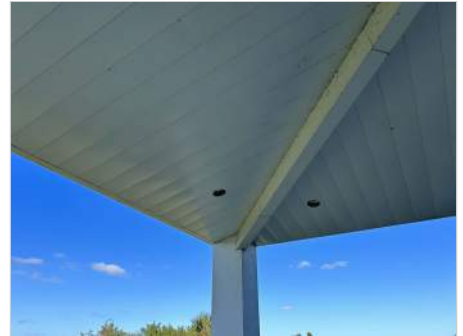
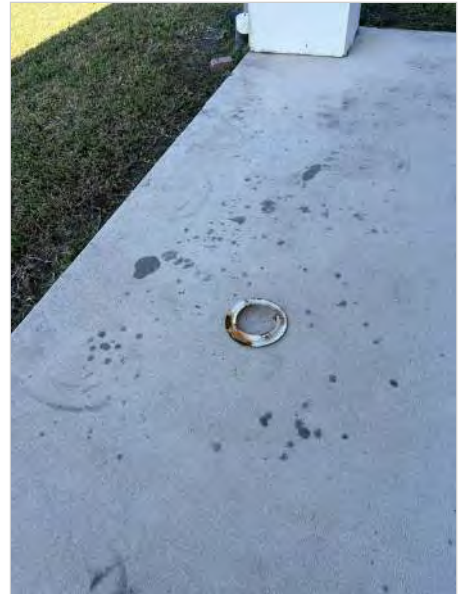
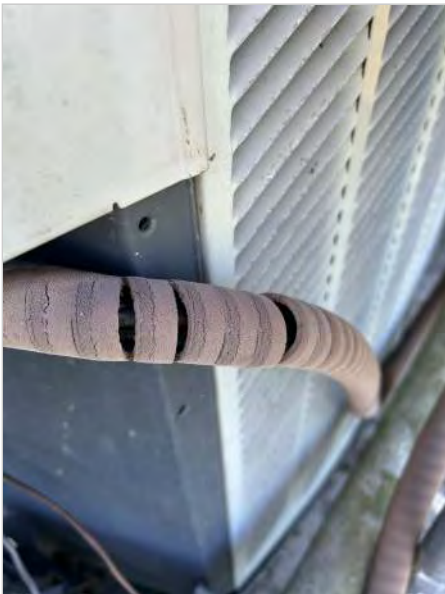
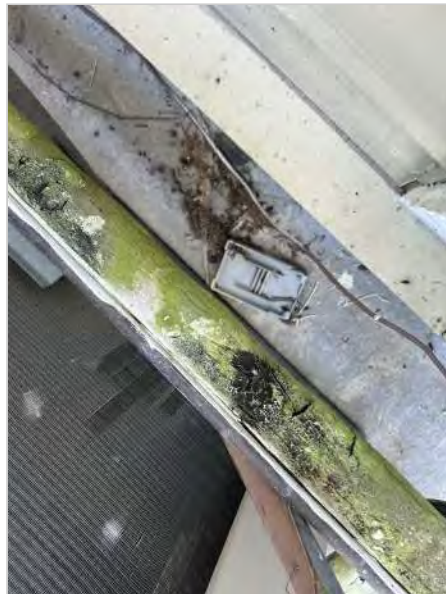
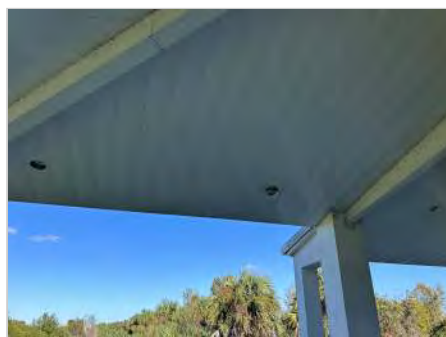
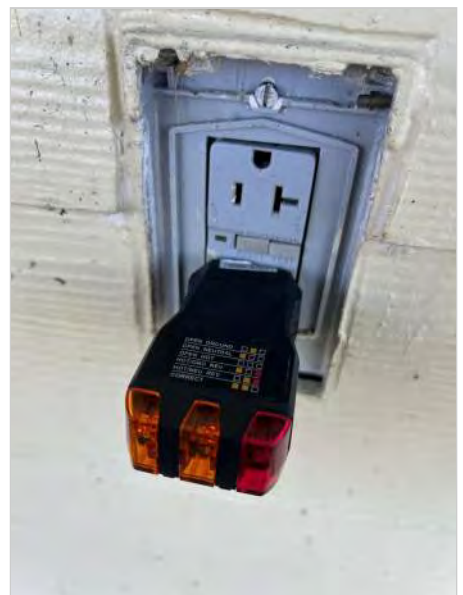
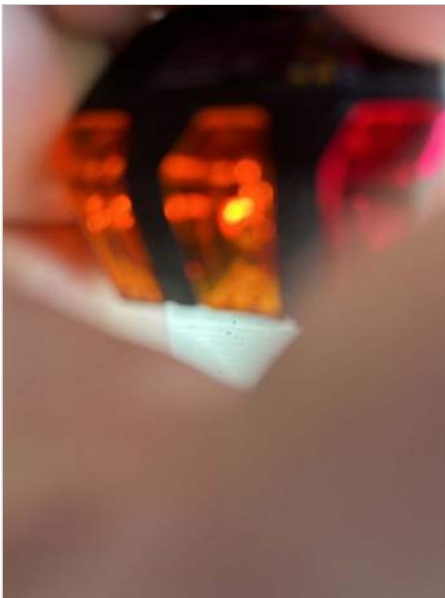
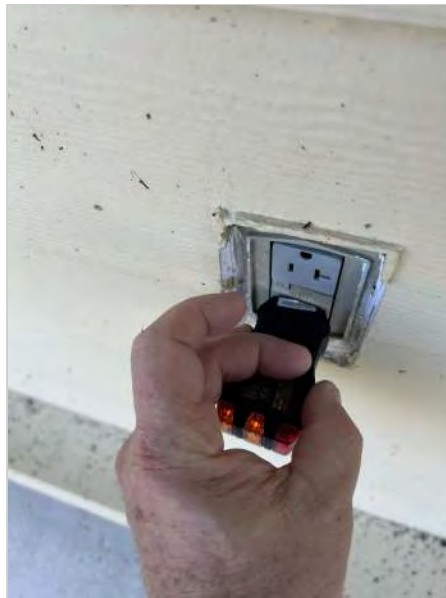
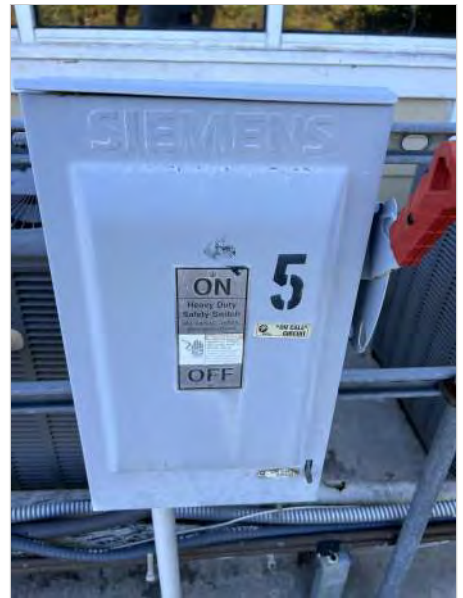
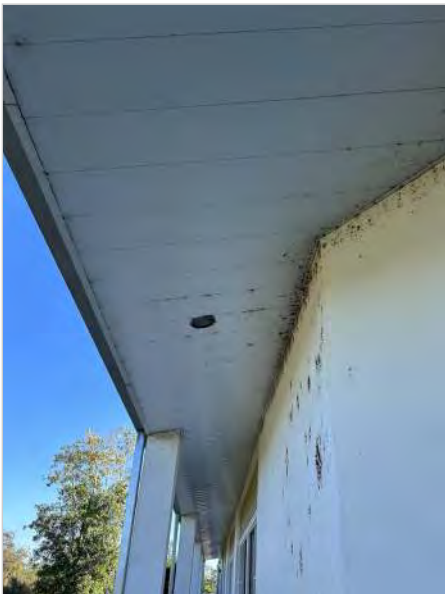
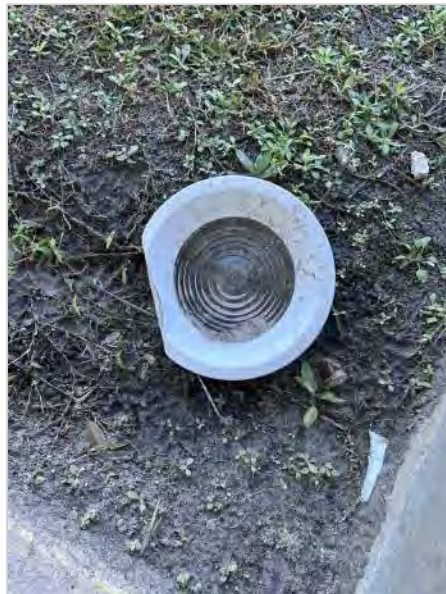
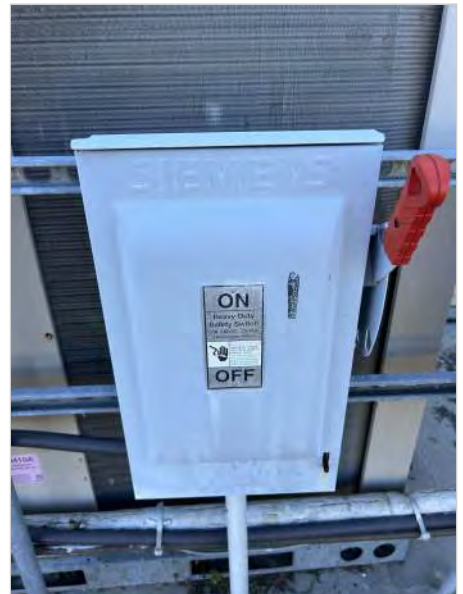
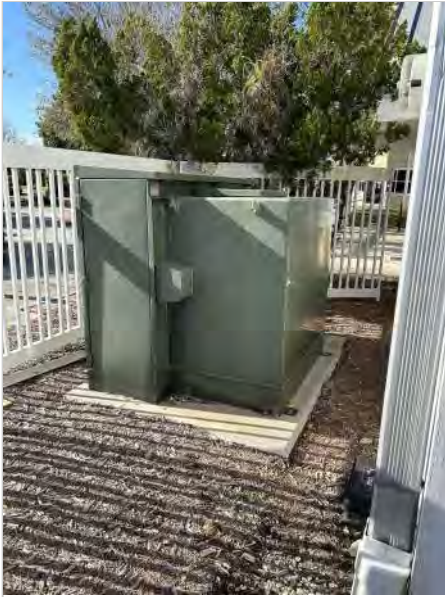
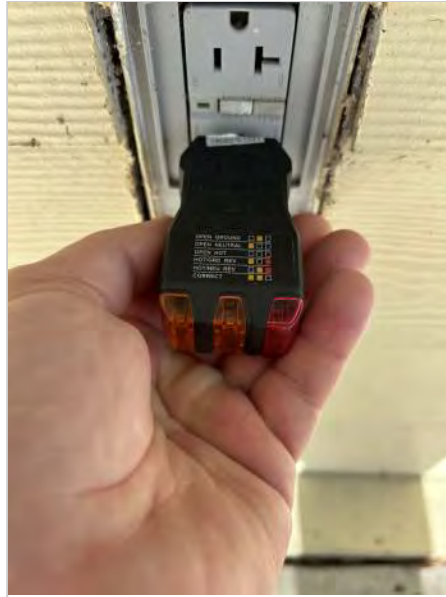
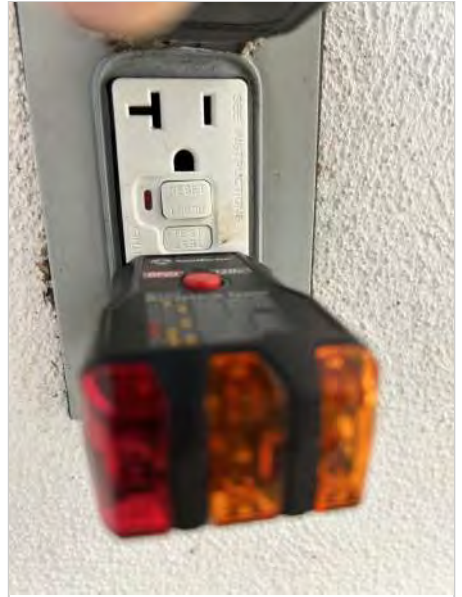
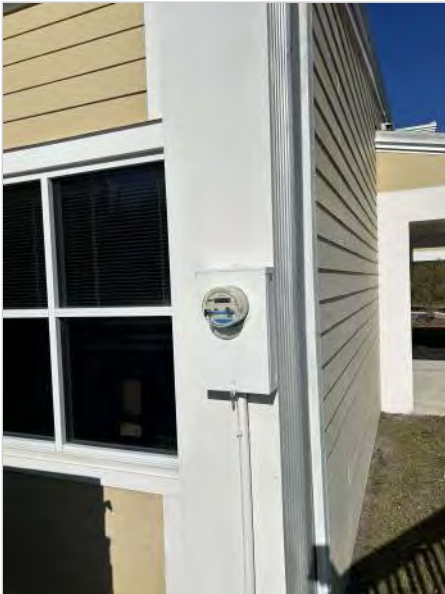
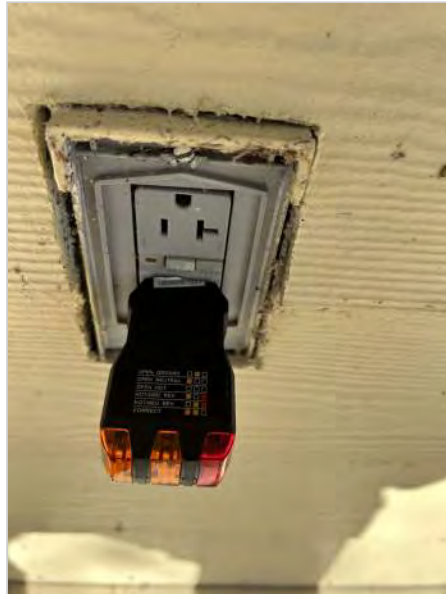
Overall, the exterior electrical and lighting was subject to storm-related damage and is in poor condition and in need of further inspection, repair, or replacement.

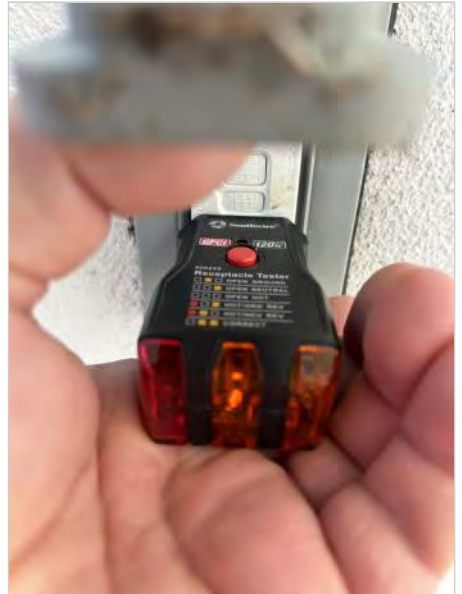
IMG\_3171.JPG

Many of the exterior GFCI power outlets were missing covers and were likely exposed to wind-driven rain and moisture intrusion. While several had power, they would not properly test and reset, indicating that they are compromised and should be replaced.

Several exterior lighting fixtures were observed dislodged and compromised, and lighting components could be seen on the ground around the facility exterior. Stress to the attached flex conduit/ wiring was also apparent. It was uncertain whether the exterior lighting was energized during our assessment, but functional testing was likely unsafe anyway, given the condition of the fixtures.

While the AC disconnects appeared to be in fair condition, many of the attached AC power supply whips were cracked and compromised, exposing the high voltage wiring inside and allowing for moisture intrusion. Their damage is likely due to age, UV exposure, and storm-related winds and vibration.

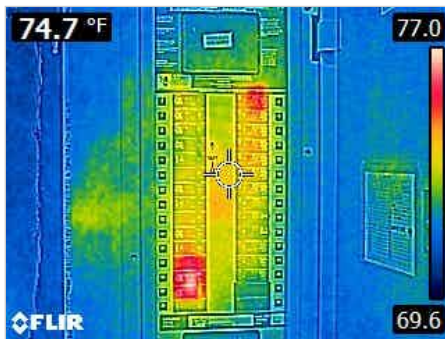
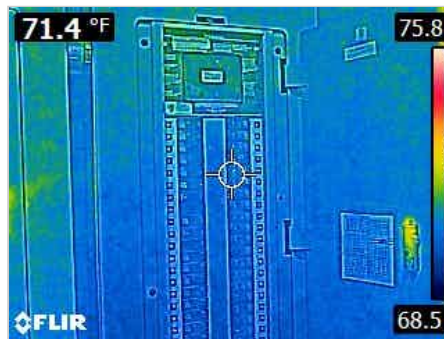
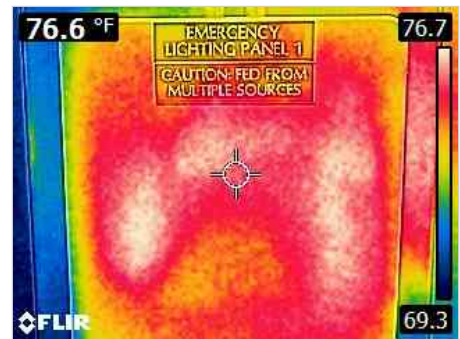
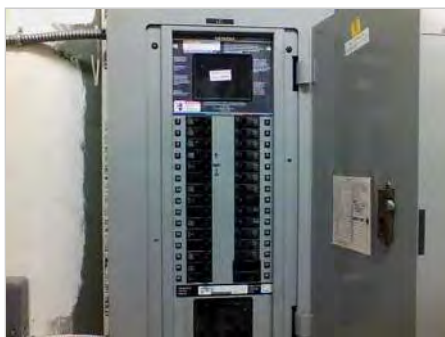
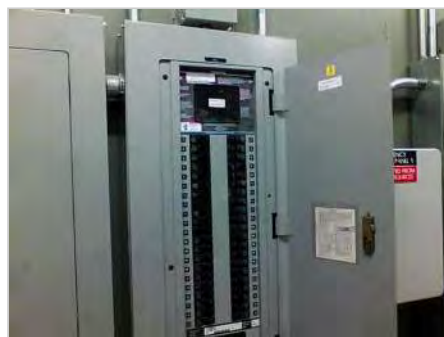
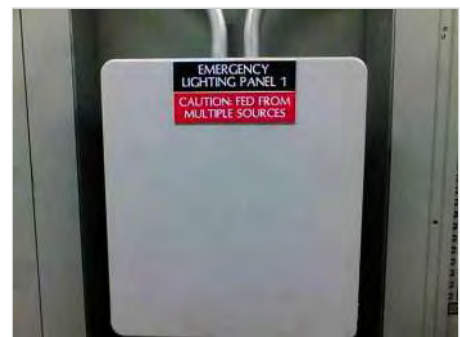
## Photos 110

Overall, the interior high voltage electrical and lighting was observed to be in good working order, with no apparent storm-related damage. While water damage was observed to the interior walls adjacent to the retention area, the conduit appeared damage free, and the outlets still functioned properly.

Switchgear was assessed for damage, tripped breakers, and for hot-spots using thermal imaging. All breakers were observed functional and within normal operating temperatures.

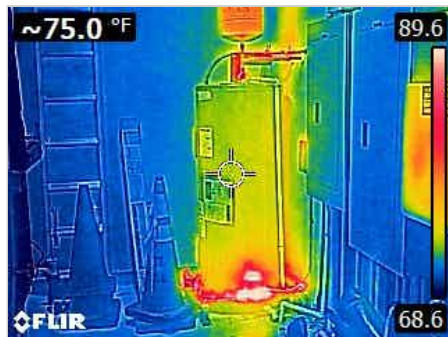
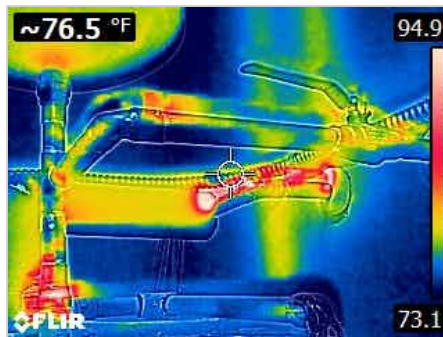
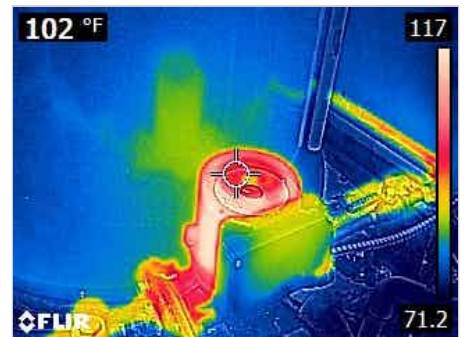
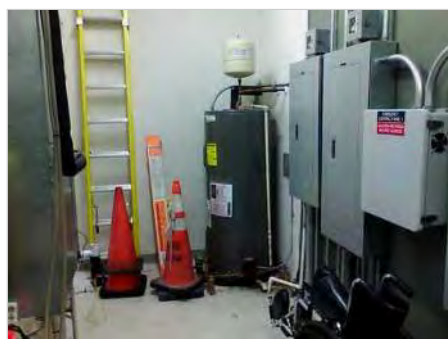
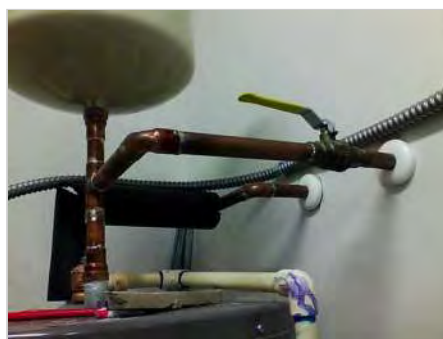
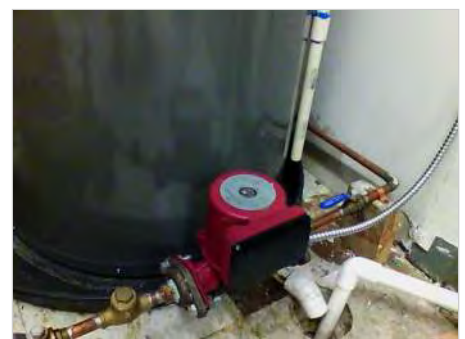
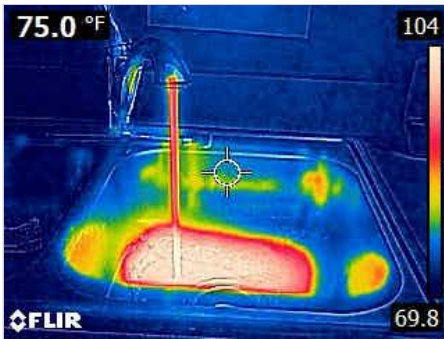
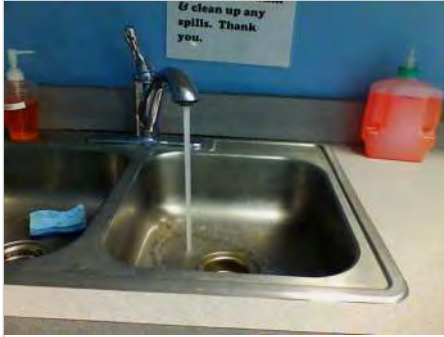
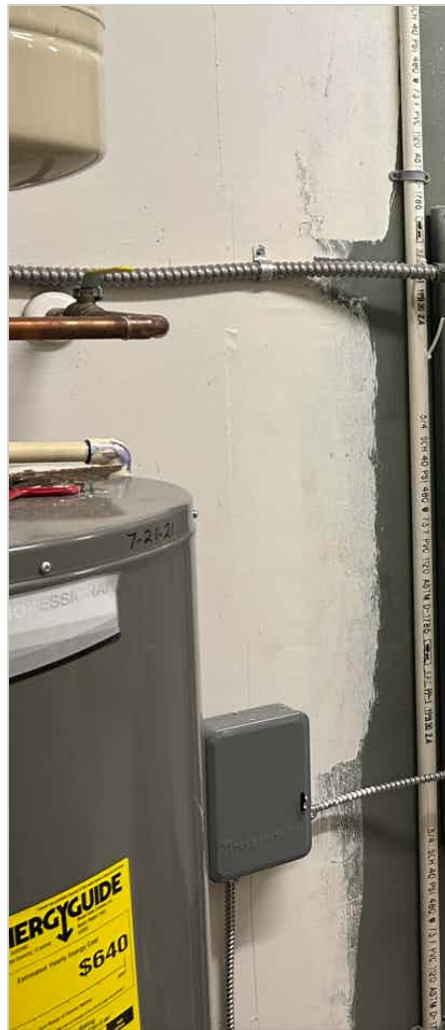
The Water Heating System was observed to be in great condition and performing like new, with no apparent storm-related damage. Thermal imaging shows heat profile of the water heater, the recirc pump, and shows hot water at sampled taps.

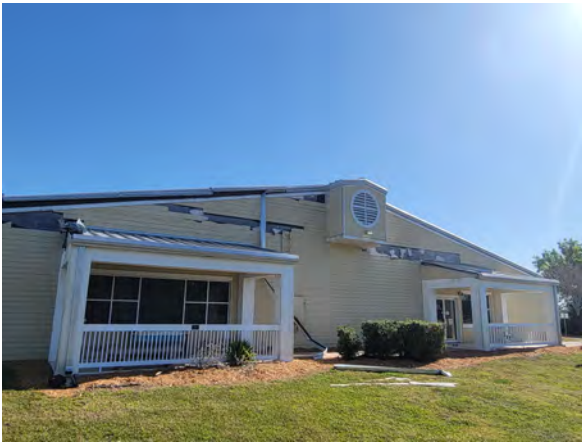
The exterior of the building still exhibited damage from previous storms, with vinyl siding in disrepair along the perimeter of the facility (Figure 4). Along the western entryway, the missing siding along the covered patio exposed the underlying framing elements (Figure 5). The exposed framing elements appeared to be in generally acceptable repair, while the metal flashing adjacent appeared to be damaged (Figure 6).

**Figure 4:** General condition of East Port Environmental Campus exterior.

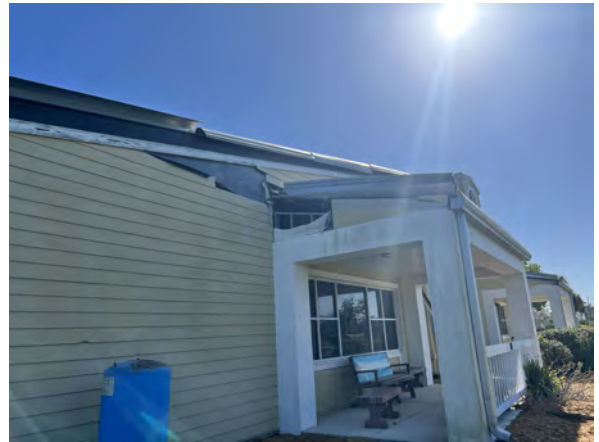
**Figure 5:** Missing siding with framing elements exposed at side entryway.

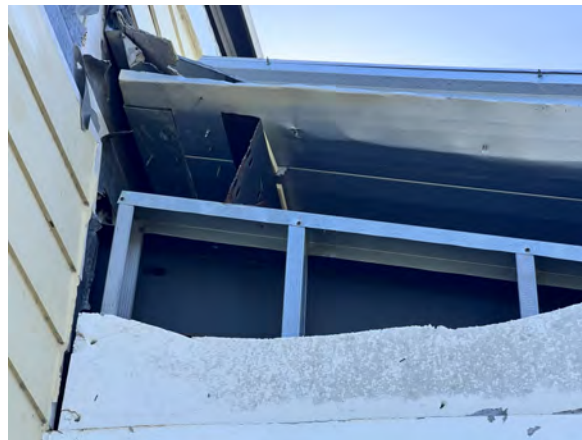
**Figure 6:** Closer view of exposed framing members.

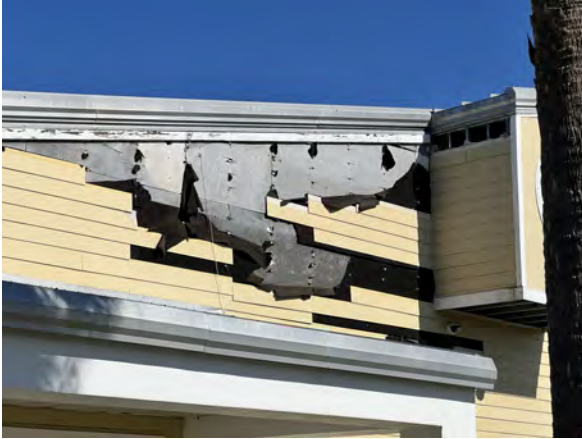
Along the eastern wing exterior, a framed-out covering for the HVAC system was present. The adjacent siding was in disrepair, with the underlying sheathing visible (Figure 7). When viewed from beneath, the structure was noted to have no covering and was exposed (Figure 8). Within the covering structure, HVAC ventilation could be viewed, along with the underside of the roofing material over the covering (Figure 9).

**Figure 7:** Gable end damaged siding near HVAC ventilation.

Along the exterior of the building, damaged and missing siding was visible at multiple locations, e.g. Figure 7 and Figure 11. These areas of damage may permit future water infiltration events that could cause further deterioration of the facility. In addition to the damage to the siding, multiple downspouts along the perimeter of the structure were damaged or missing (see Figures 14 and 15). Degradation of the adjacent grade due to the missing downspouts may continue unless addressed.

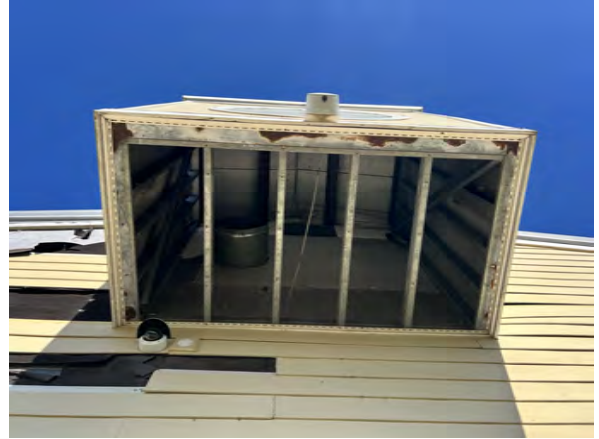
**Figure 8:** Underside view of HVAC ventilation structure.

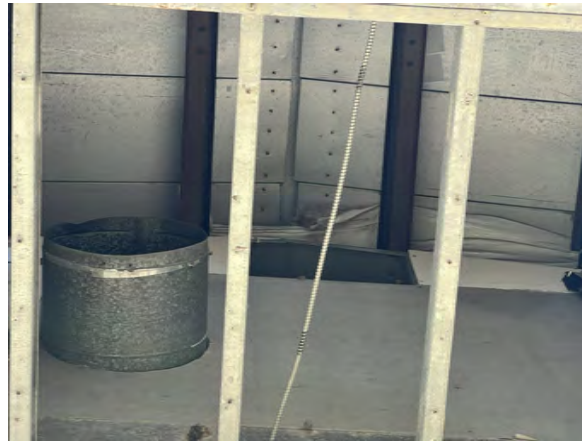
**Figure 9:** Duct visible inside structure.

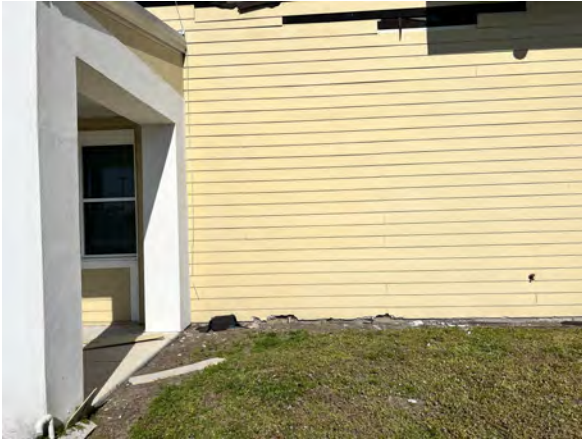
Near the location of the HVAC covering, damage to the siding near the bottom of the wall was noted. A hole through the vinyl siding was visible (Figure 10). On close-up inspection, the batt insulation and wall framing members were visible (Figure 11).

**Figure 10:** Damage to lower portion of wall siding.

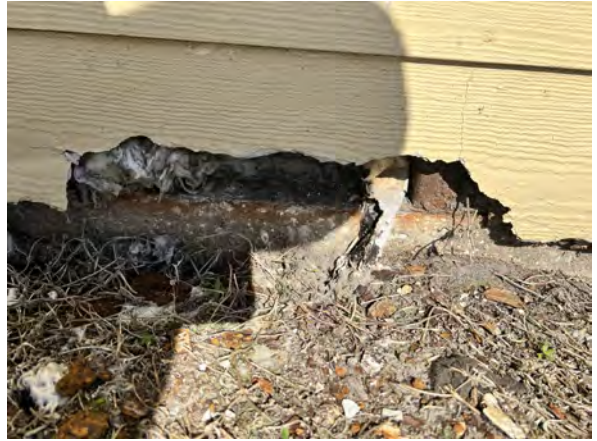
**Figure 11:** Extent of hole in siding, with insulation and metal stud visible.

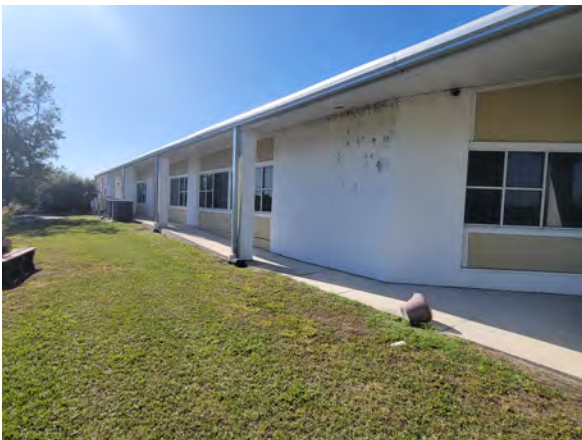
The north corner of the building at the rear of the facility appeared in generally acceptable condition. This area was covered, though no doors were present, only office windows (Figure 12). Along the bottom of the wall in the covered area, minor separation was noted between the slab on grade and the wall, with no expansion joint or sealant visible (Figure 13).

**Figure 12:** Rear wall at north end of building.

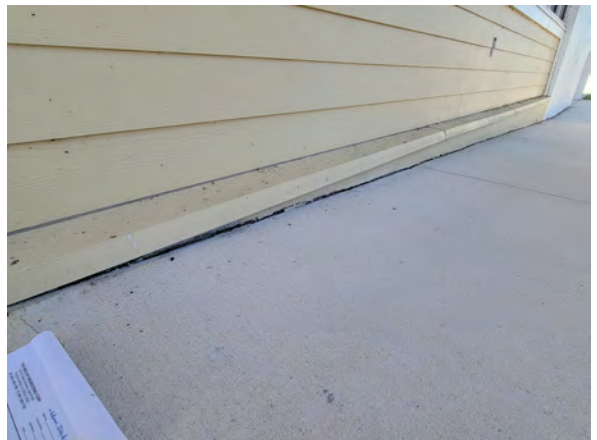
**Figure 13:** Minor separation of the slab on grade from the building.

**Miscellaneous Exterior** The north end of the building had areas where the joint filler between the building and adjacent slab on grade was missing, approximately thirty linear feet (30 LF).

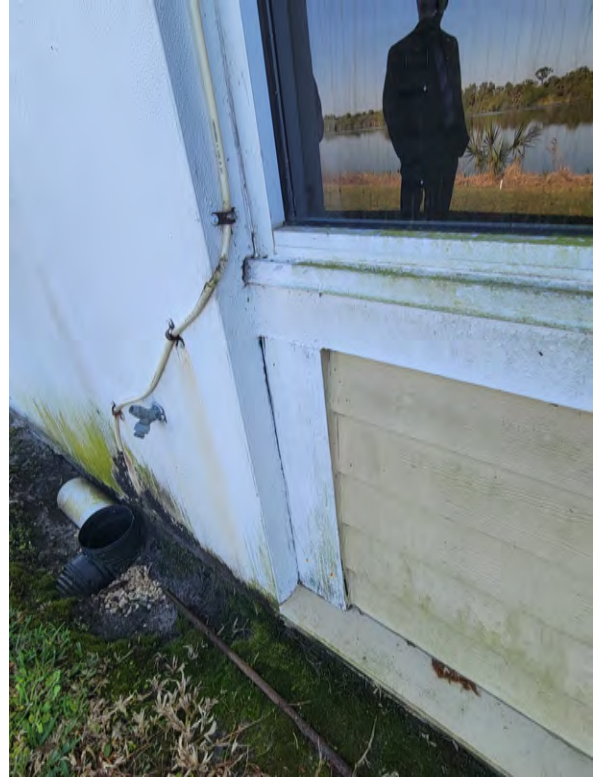
At multiple points along the perimeter of the facility, the downspouts were in disrepair. Each downspout feeds into an underground rain leader, draining into the lawn (Figure 14). In some locations, the downspouts were missing entirely, leaving the rain leader exposed (Figure 15).

**Figure 15:** Minor separation of the slab on grade from the building.

**Stormwater** At least four (4) downspouts were observed to be in disrepair, and it is recommended that they be replaced in kind. The gutter above was not accessible during the inspection, therefore it is recommended that the gutter be checked for damage prior to repair. Several locations at downspouts showed evidence of ponding indicating improper grading away from the building. There are an estimated five (5) locations equal to approximately 1,000 square feet where grade will need to be checked and potentially corrected. *All repairs shall comply with FBC Plumbing, Chapter 11.*

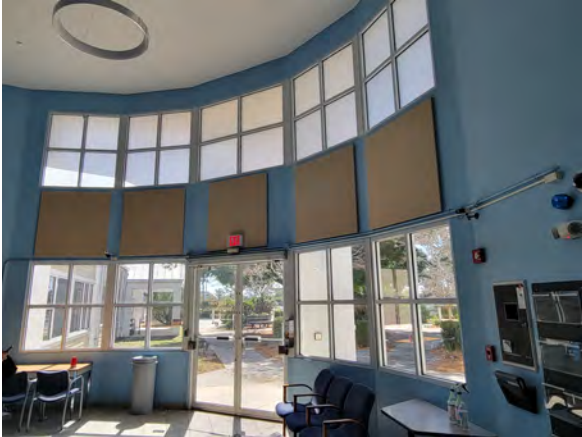
The lobby and reception area provides access to the two wings of the facility, with ceiling-height glazing present (Figure 16). Cracking in the drywall was visible at interior corners, as well as visible splitting and cracking in the window sill sealant (Figure 17).

**Figure 16:** Interior view of lobby, full height glazing visible.

**Windows/Glazing** Multiple windows exhibited signs of past water infiltration, indicating damage to the sealant along the edges. This included windows in the lobby and training room. While this may be addressed through regular maintenance procedures, if included in the scope of work, all windows shall be resealed. All exterior doors shall have their waterproofing seals and sweeps replaced in locations where evidence of water infiltration is noted at the two non-public entrances.

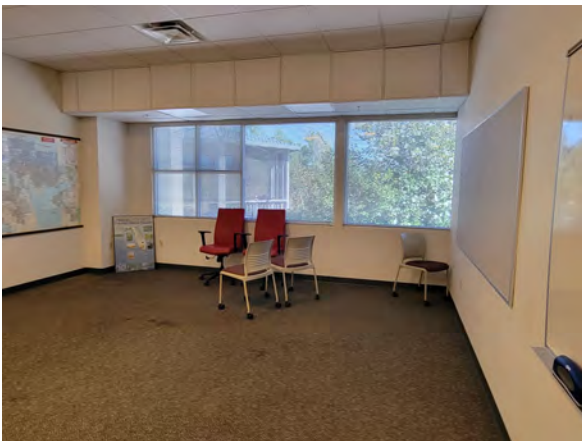
Inside the eastern wing of the building, a training/meeting room had further instances of window sill cracking (Figure 18). Along with splitting and cracking in the sealant, bubbling of paint was also present (Figure 19).

**Figure 18:** Training room interior condition.

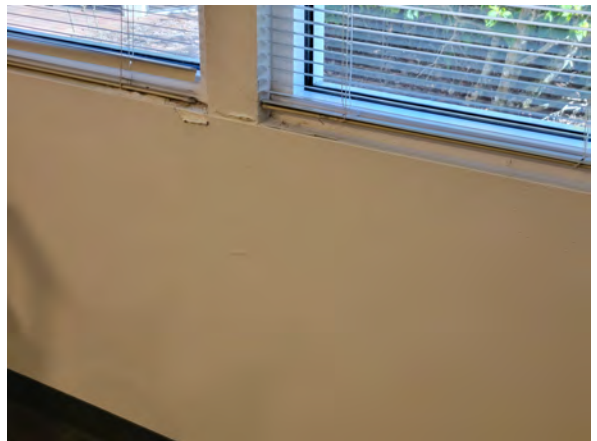
**Figure 19:** Close view of cracking at window sill.

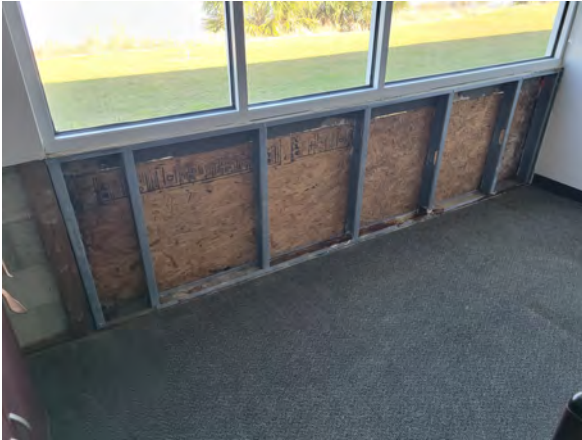
Along the westernmost wall of the building, drywall had been removed, exposing the underlying wall studs and the backside of the sheathing (Figure 20). It was noted that a strip of drywall, approximately four inches wide, was substituted for plywood, with an approximate half-inch gap visible between the panels (Figure 21). In the corner of multiple locations, corrosion was visible beneath the sill and down the studs, as well as what appeared to be white paint (Figure 22). Ant piles were visible in multiple locations, indicating gaps leading to outside (Figure 23).

**Figure 20:** Exposed wall studs and sheathing.

The existing plans for the building indicate concrete masonry infill walls were present along the northwest wall at several locations, including the rear entrance. The wall along the western side of the building with drywall (see Figures 20 through 23) has noticeable gaps between the sheathing panels, permitting vapor, moisture, and wind-driven rain to pass through into the wall cavity. Additionally, as noted in Figure 23, there were visible ant piles, indicating failure of sealant along the length of the wall. While these walls are not part of the overall supporting structural system, they are part of the structural wind envelope and are currently in sufficient disrepair to warrant repairs.

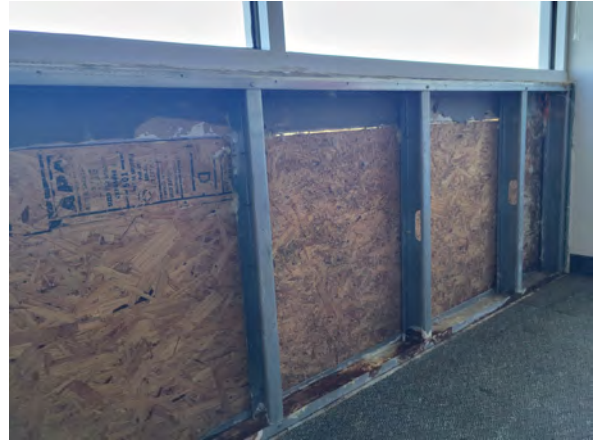
**Figure 21:** Drywall as sheathing visible with daylight through the cracks.

**Walls** The interior face of the exterior walls indicated water intrusion through the window or siding. As documented in Figure 21, drywall was utilized to fill an approximate 4-inch gap between the window sill and the top of the plywood sheathing. Additionally, due to the insufficient water barrier, the existing plywood sheathing has experienced delamination in multiple locations or is in otherwise poor condition. It is recommended that all locations where the plywood has delaminated and where drywall was used as sheathing have the existing sheathing removed and replaced with an appropriate waterproofed product. It was observed that a minimum estimated 215 linear feet (250 LF) of wall will require replacement and that the issue may extend up to a potentially estimated 600 linear feet (600 LF). *As previously mentioned, exterior walls shall meet the requirements of FBC-B Section 1403.2 for weather protection. Additionally, per FBC-B Section 1403.6, exterior walls below flood shall be constructed with flood-damage-resistant materials. All exterior wall studs and sections of bottom track exhibiting corrosion or other damage shall be replaced in kind.*

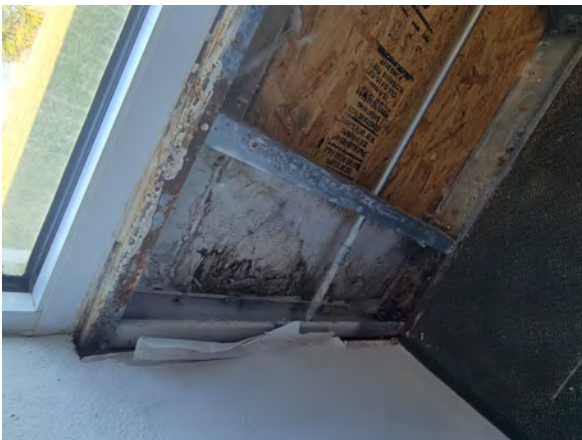
**Figure 22:** Condition of wall studs and sheathing at corner of wall.

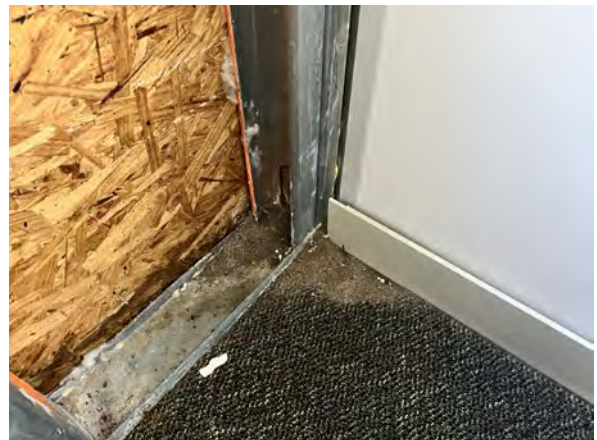
**Figure 23:** Ant pile visible adjacent and inside wall space.

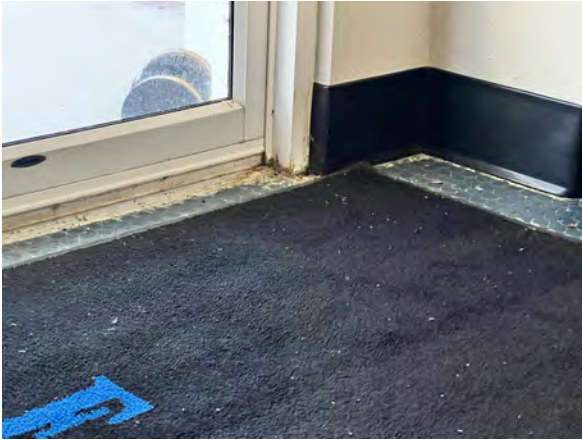
The western wing of the building provides access for employees. A pair of glazed doors were located approximately halfway along the westernmost wall (Figure 20). Upon closer view, a gap showing daylight between the threshold and bottom of the door was noted (Figure 21).

**Figure 24:** Western employee entrance.

Exterior doors on the building shall also be replaced with models designed to meet or exceed the requirements of the FBC. Additionally, to meet the requirements of ASCE 24-14, dry floodproofing such as flood panels shall be installed. This would require flood panels on six (6) exterior double doors, or about 36 linear feet.

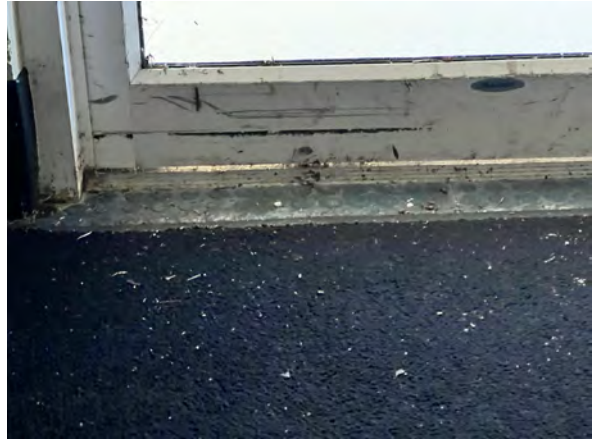
**Figure 25:** Daylight visible between door and threshold.

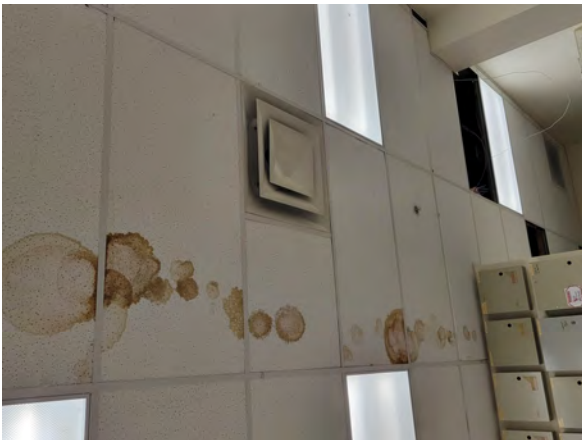
Running roughly northwest along the office area ceiling in the west wing, stains from water intrusion were visible (Figure 26). The attic space above the staining showed no clear source of the stains, with the stains approximately following the HVAC ducting above (Figure 27).

**Figure 26:** Water infiltration stains on acoustic ceiling tiles.

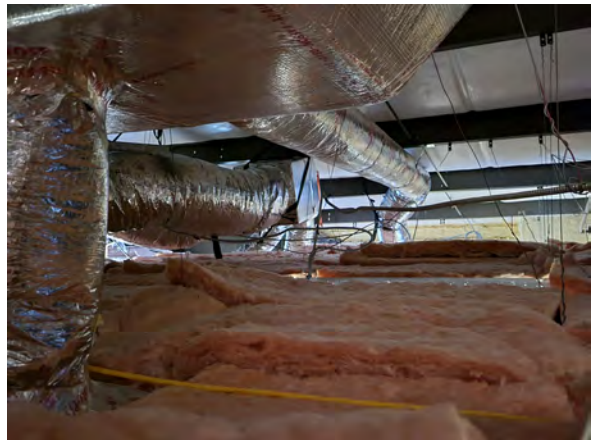
**Figure 27:** Attic space above ceiling stains showing HVAC ducting.

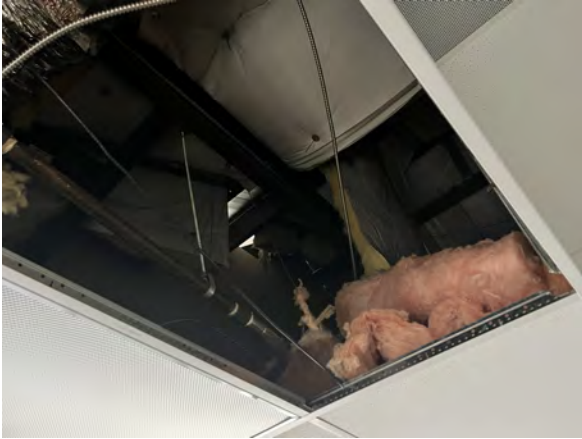
Multiple locations inside the building were missing acoustic tiles, allowing the attic above to be easily viewed (Figure 28). In multiple locations, daylight was visible through the roof above (Figure 29). The bag insulation along the roof was visible from the attic, with gaps noted in several locations (Figure 30). Deteriorated bag insulation was visible along the primary ridge of the building (Figure 31).

**Figure 28:** Missing acoustic tiles in ceiling.

Throughout the attic area, multiple locations where the bag insulation was deteriorated or damaged could be seen, such as in Figures 28 through 31. These were typically located above areas where ceiling tiles had previously been removed for being water damaged. While not structural components, proper thermal and moisture barriers are critical for the overall longevity and functionality of the building. Additionally, there were sufficient failures in the building envelope to permit the entrance of wildlife; while not photographed during the inspection, birds could be heard nesting within the attic area.

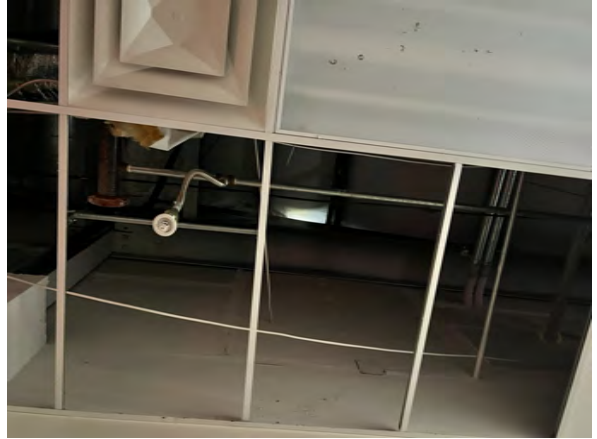
**Figure 29:** Daylight visible through missing tiles.

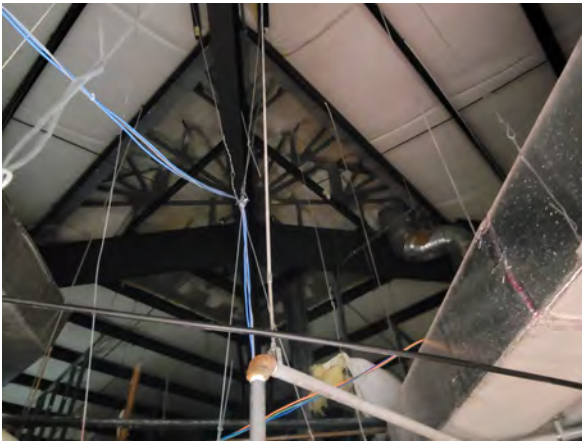
**Figure 30:** Roof ridge visible through attic space.

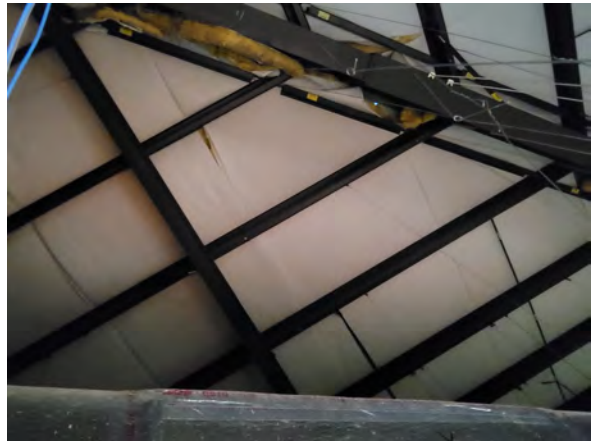
**Figure 31:** Insulation visible near roof ridge.
