**Site Inspection Report for  
Charlotte County –  
Centennial Park Campus  
Florida Hurricane Ian (DR-4673-FL)**

# Parks Mid County - Centennial Park Campus

Project# 714039 DI# 1308361

**Site Inspection Report for  
Charlotte County –  
Harold Avenue Regional Park  
Florida Hurricane Ian (DR-4673-FL)**

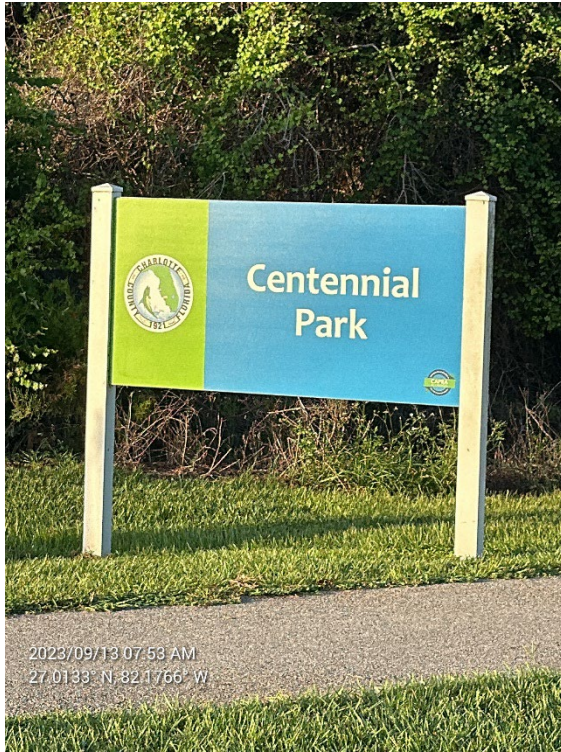
(1.)

**Created:** Wed 13 Sep 08:00 2023  
**Group:** Main Entry Signage  
**GPS Lat/Lon:** 27.01169, -82.17966  
**Cause of Damage:** N/A  
**Component Description:**

Overview Photo

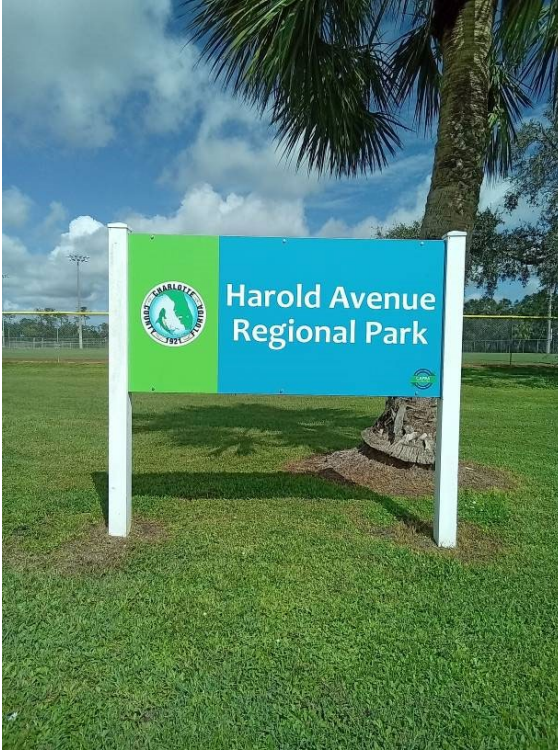
(1)

**Created:** Thu 21 Sep 11:14 2023  
**Group:** Signage  
**GPS Lat/Lon:** 27° 0'48.61"N, 82° 3'38.87"W  
**Cause of Damage:** N/A  
**Component Description:**  
Overview Photo.

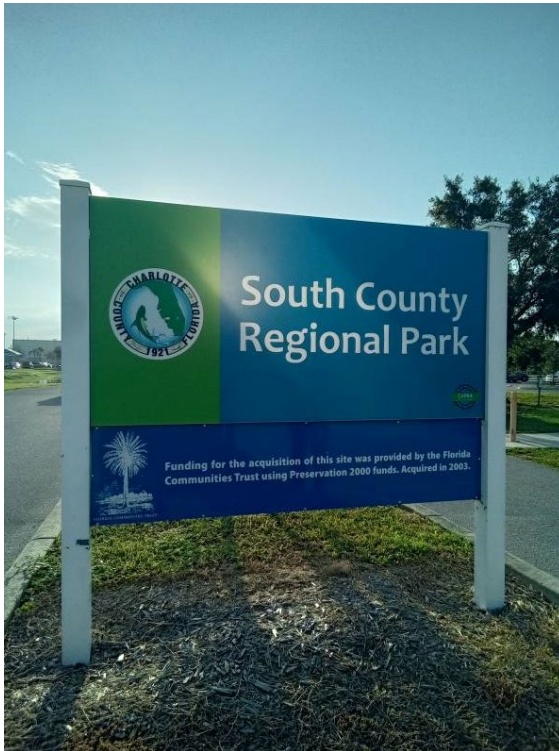
(1)

**Created:** Tue 12 Sep 08:09 2023  
**Group:** Park Entry Signage (A)  
**GPS Lat/Lon:** 26.932700, -82.039400  
**Cause of Damage:** N/A  
**Component Description:**  
No signs of storm-related damage to Park Entry Signage (A); it exhibits only normal wear and tear.

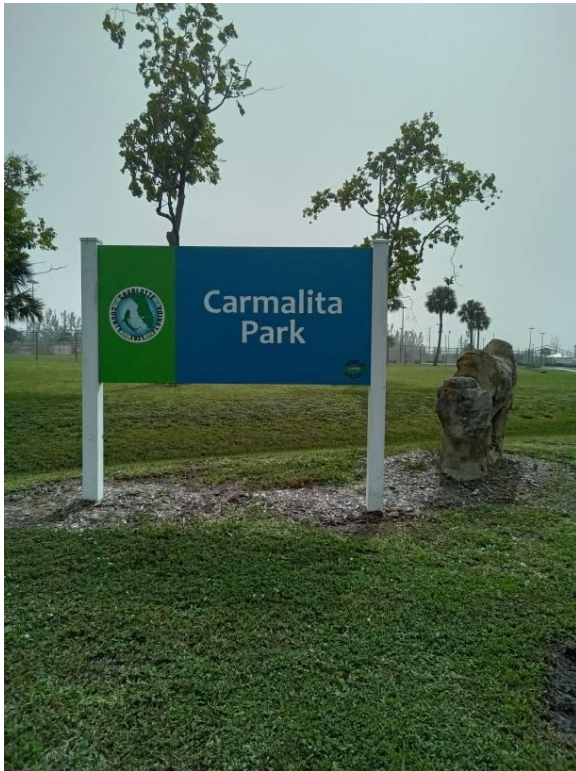
(1)

**Created:** Tue 03 Oct 15:10 2023  
**Group:** Signage  
**Cause of Damage:** N/A  
**GPS Lat/Long:** 26.92950, -82.01940

**Component Description:**  
Park Entry Signage reset.
